Repairs to English Monuments: Some Case Studies

Ian HUME

Chief Engineer
English Heritage
London, England

The English Heritage approach to the conservation and repair of historic buildings and structures in England is a minimalist approach. The main aim is to conserve the building as found and to carry out the minimum repairs necessary to ensure its safety and long life and to ensure that it will cause no danger either to its occupants or to passers-by. The aim of this paper will be to illustrate this philosophy by means of a series of brief case studies of structural repairs carried out under the direction of the author.

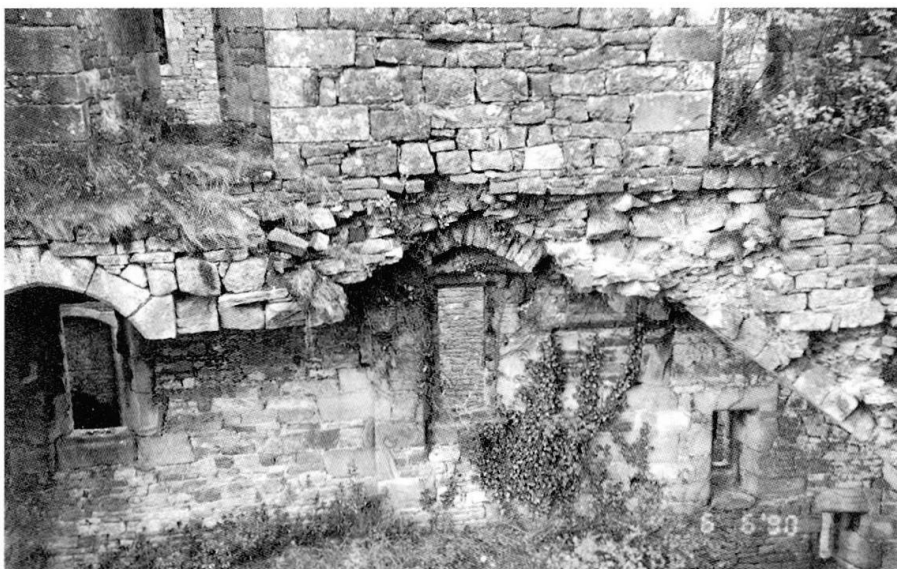
Figure 1.
Castle Bolton.

Major overhangs
of masonry now
supported by
stainless steel
posts.

- Additional supporting works. The additional supporting works thought necessary at Castle Bolton, apart from numbers of small stainless steel dowels to fix loose masonry back locally, consists of some vertical square tube supports in stainless steel. These have been installed to support major overhangs of potentially unstable masonry and are intended as a clear statement of 20th century minimal intervention.

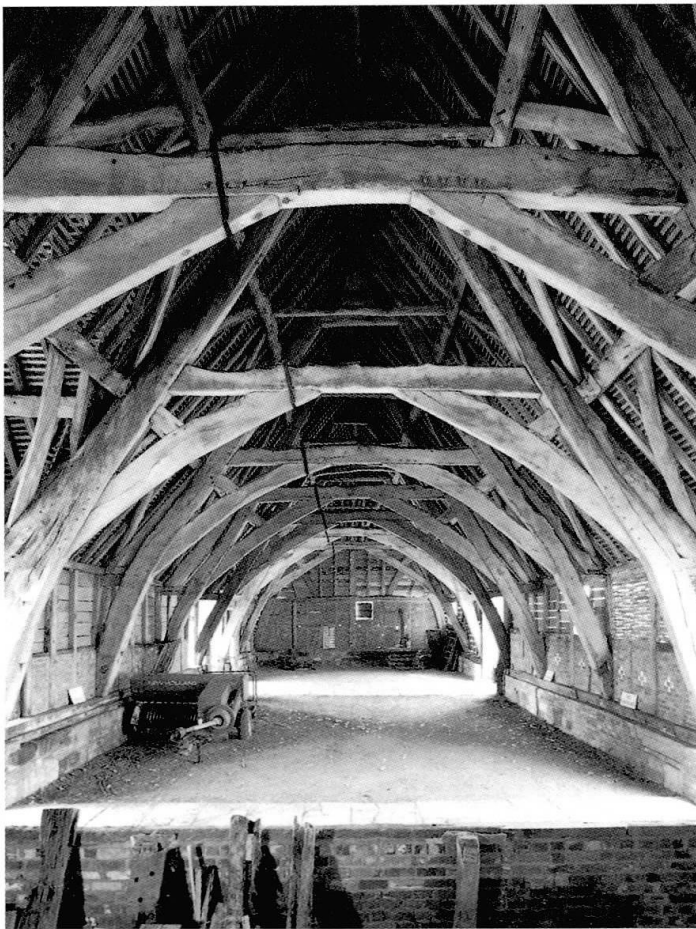
Figure 2.

5.1.2 The feet of the crucks sit on masonry walls approximately 1m above ground level. The ground conditions are often fairly wet. The thrusts from the feet of the crucks had pushed out these masonry walls to varying degrees and the barn had taken on a distinct lean lengthways. These quite considerable movements had caused some damage to bracing members in the timber frame.

Leigh Court Barn.

5.1.3 It was decided in this instance to partially dismantle the barn in order that the main cruck arch-braces could be pulled vertical, it being felt that the lean which had taken place was causing undue stress on the timber framework.

new foundations were installed. The foundations consisted of large concrete pads supporting steel columns, which in turn were connected to the bottom of the cruck arches. The concrete foundations being below ground were of course completely buried and the steel supporting posts have been totally surrounded in the original masonry, which was replaced in its original locations. The original timber work was replaced almost 100% with very few members being renewed. Some minor repairs were made to severely decayed members. In order to be certain of the structural adequacy of some of the more decayed rafters simple load tests were carried out to prove that these were strong enough for their purpose.

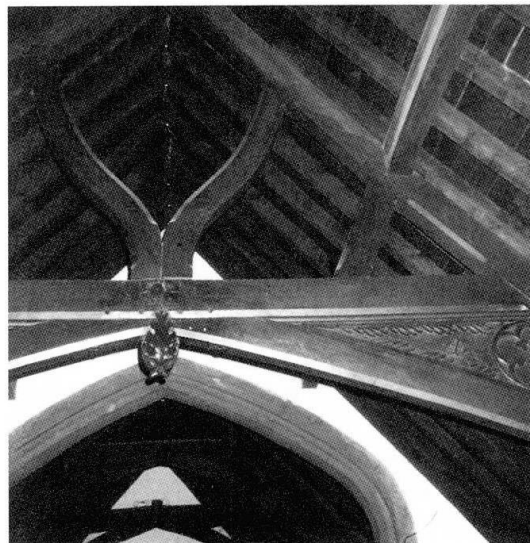
Figure 3.

6.1.2 It was noticed in early 1990 that one roof truss had broken. Further investigations showed that a second roof truss was also damaged and that the nave was beginning to lean to the north. A

Greensted Church.
The roof truss
joints had pulled
apart and the
principal rafter
had broken at the
purlin.

6.1.3 Although the roof covering was in good condition it was decided to strip this to expose the rafters to insert steel T-bars into the upper surface of the principal rafters and to introduce steel bracing to the upper faces of the secondary rafters.

6.1.4 The intention of this was to repair the fractures in the principal rafters rather than to replace them and to strengthen unbroken principal rafters. The bracing created a strong diaphragm on each slope of the nave roof such that sideways forces were transmitted to the substantial brick built chancel arch and the west gable of the nave. When the building was re-roofed all of the bracing work was hidden and the only visible signs of the repair works are some small steel brackets forming end plates to the principal rafter repairs hidden under the overhanging eaves of the nave.

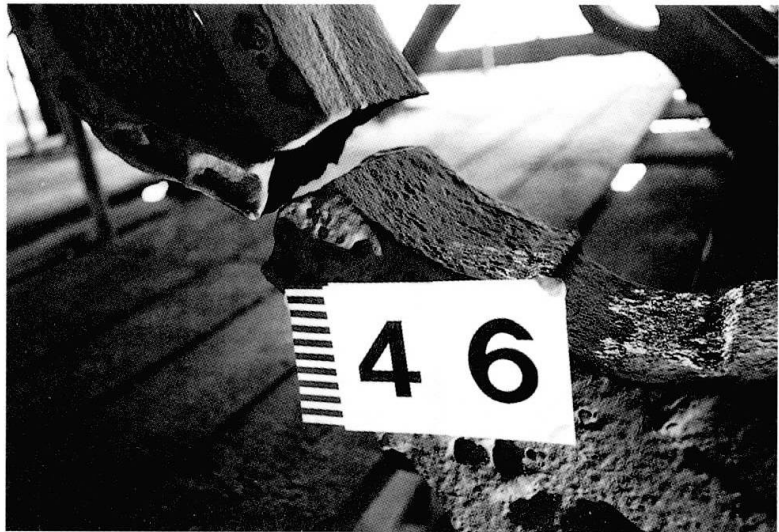
Figure 4.

Ironbridge.
A typical fractured
member.

9.1.2 The reasons for taking no action were:

- Some years previously a reinforced concrete strut had been put across the bed of the river to restrict movement of the bridge abutments.
- The arch crown connecting detail which connects the main arches together was a rigidly fixed detail and this had in no instance cracked or become deformed and this clearly showed that no major movements had taken place.
- There was concern that repairing any fracture could, if new movements occurred, create a further fracture rather than allowing the bridge to move on an old fracture point.
- No work was done on the understanding that regular inspections of the bridge were possible and that any further movement would be detected quickly.
