Repairs to English Monuments: Some Case Studies

Ian HUME

Chief Engineer
English Heritage
London, England

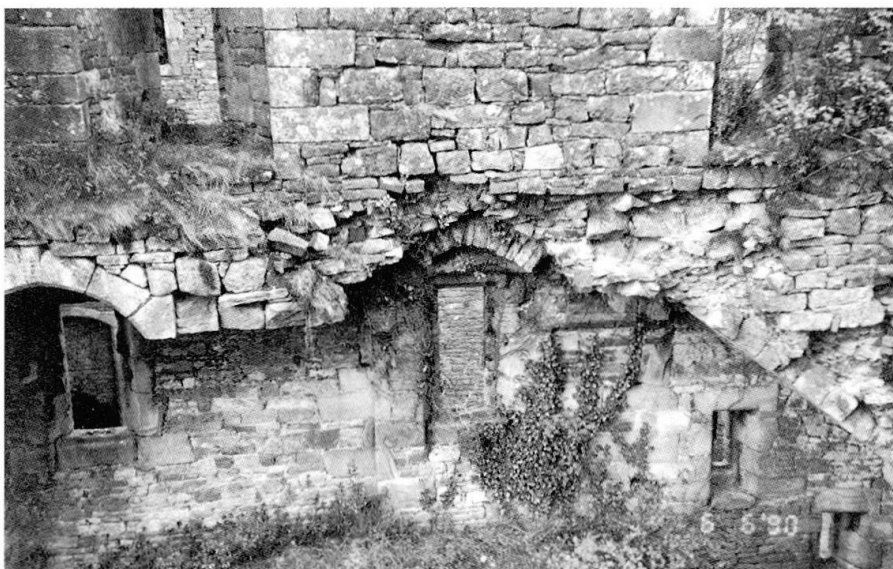
Figure 1.
Castle Bolton.

4.1.3 The major problems with Castle Bolton were due to the ingress of dampness into the masonry and the subsequent growth of weeds, plants and trees. In some cases some quite substantial trees were growing in the masonry in inaccessible positions.

Major overhangs of masonry now supported by stainless steel posts.

- Additional supporting works. The additional supporting works thought necessary at Castle Bolton, apart from numbers of small stainless steel dowels to fix loose masonry back locally, consists of some vertical square tube supports in stainless steel. These have been installed to support major overhangs of potentially unstable masonry and are intended as a clear statement of 20th century minimal intervention.
