Repairs to English Monuments: Some Case Studies

Ian HUME

Chief Engineer
English Heritage
London, England

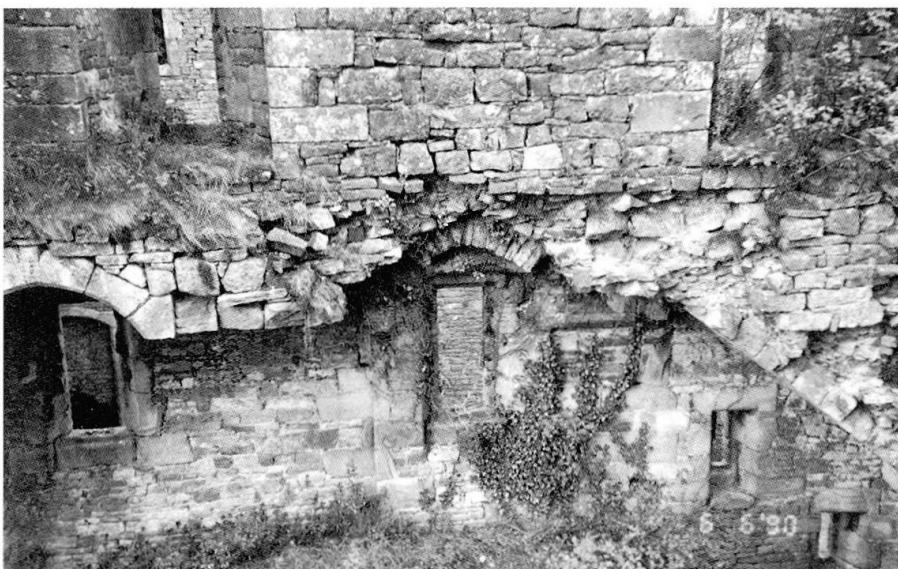
Figure 1.
Castle Bolton.

4.1.3 The major problems with Castle Bolton were due to the ingress of dampness into the masonry and the subsequent growth of weeds, plants and trees. In some cases some quite substantial trees were growing in the masonry in inaccessible positions.

Major overhangs
of masonry now
supported by
stainless steel
posts.

- Additional supporting works. The additional supporting works thought necessary at Castle Bolton, apart from numbers of small stainless steel dowels to fix loose masonry back locally, consists of some vertical square tube supports in stainless steel. These have been installed to support major overhangs of potentially unstable masonry and are intended as a clear statement of 20th century minimal intervention.

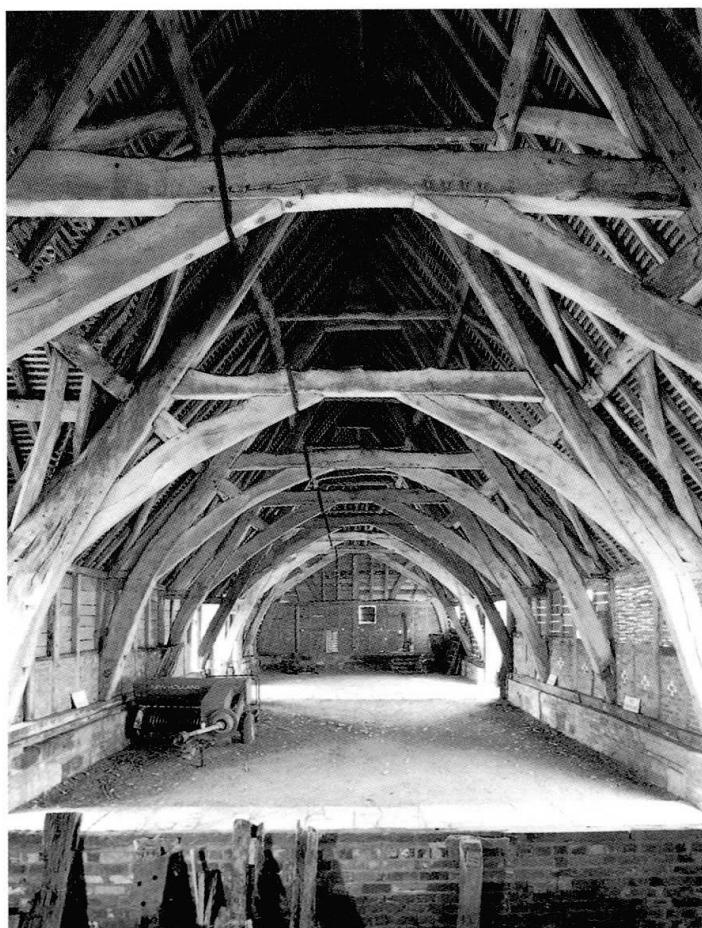
Figure 2.

5.1.2 The feet of the crucks sit on masonry walls approximately 1m above ground level. The ground conditions are often fairly wet. The thrusts from the feet of the crucks had pushed out these masonry walls to varying degrees and the barn had taken on a distinct lean lengthways. These quite considerable movements had caused some damage to bracing members in the timber frame.

Leigh Court Barn.

5.1.3 It was decided in this instance to partially dismantle the barn in order that the main cruck arch-braces could be pulled vertical, it being felt that the lean which had taken place was causing undue stress on the timber framework.

new foundations were installed. The foundations consisted of large concrete pads supporting steel columns, which in turn were connected to the bottom of the cruck arches. The concrete foundations being below ground were of course completely buried and the steel supporting posts have been totally surrounded in the original masonry, which was replaced in its original locations. The original timber work was replaced almost 100% with very few members being renewed. Some minor repairs were made to severely decayed members. In order to be certain of the structural adequacy of some of the more decayed rafters simple load tests were carried out to prove that these were strong enough for their purpose.

5.1.5 The whole barn was re-assembled with no signs of modern intervention whatever and few new timbers being used.

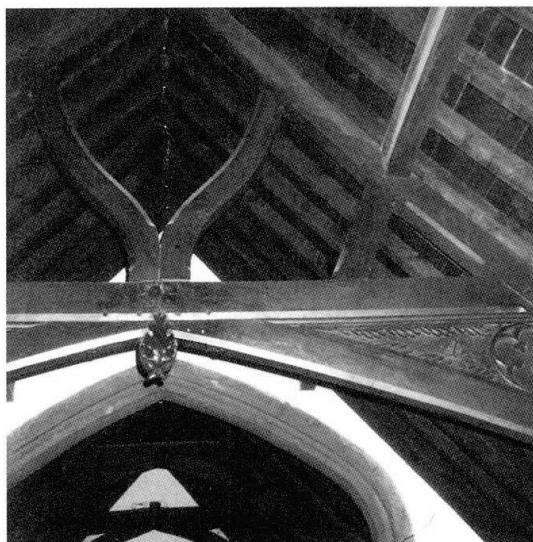
Figure 3.

6.1.2 It was noticed in early 1990 that one roof truss had broken. Further investigations showed that a second roof truss was also damaged and that the nave was beginning to lean to the north. A

Greensted Church.
The roof truss
joints had pulled
apart and the
principal rafter
had broken at the
purlin.

6.1.3 Although the roof covering was in good condition it was decided to strip this to expose the rafters to insert steel T-bars into the upper surface of the principal rafters and to introduce steel bracing to the upper faces of the secondary rafters.

6.1.4 The intention of this was to repair the fractures in the principal rafters rather than to replace them and to strengthen unbroken principal rafters. The bracing created a strong diaphragm on each slope of the nave roof such that sideways forces were transmitted to the substantial brick built chancel arch and the west gable of the nave. When the building was re-roofed all of the bracing work was hidden and the only visible signs of the repair works are some small steel brackets forming end plates to the principal rafter repairs hidden under the overhanging eaves of the nave.

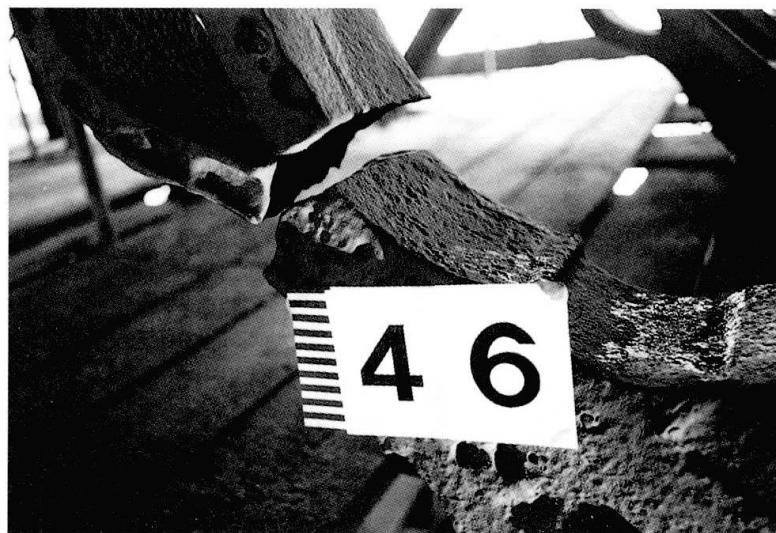
Figure 4.

9.1.1 The Iron Bridge in Shropshire, as will be well known, is the world's first cast iron bridge, being built in 1779 and opened for traffic in 1781. It spans the river Severn at Coalbrookdale with a span of some 32m. In 1981 a scaffold was erected to enable access to be gained to all parts of the bridge. Subsequent survey work showed that there were 83 cracks to various members of the bridge structure. It was decided after considerable thought and a certain amount of computer analysis of the structure, that no action need be taken to repair any of these fractures and therefore work was restricted to thoroughly repainting the bridge and some cosmetic repairs to items such as railings.

Ironbridge.
A typical fractured member.

9.1.2 The reasons for taking no action were:

- Some years previously a reinforced concrete strut had been put across the bed of the river to restrict movement of the bridge abutments.
- The arch crown connecting detail which connects the main arches together was a rigidly fixed detail and this had in no instance cracked or become deformed and this clearly showed that no major movements had taken place.
- There was concern that repairing any fracture could, if new movements occurred, create a further fracture rather than allowing the bridge to move on an old fracture point.
- No work was done on the understanding that regular inspections of the bridge were possible and that any further movement would be detected quickly.
