Artikel: Repairs to English monuments: some case studies

Autor: Hume, Ian

Ian HUME Chief Engineer English Heritage London, England

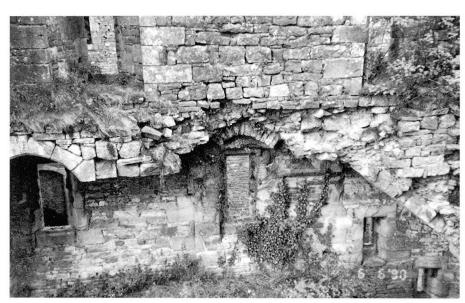
Figure 1. Castle Bolton.

- 4.1.3 The major problems with Castle Bolton were due to the ingress of dampness into the masonry and the subsequent growth of weeds, plants and trees. In some cases some quite substantial trees were growing in the masonry in inaccessible positions.

Major overhangs of masonry now supported by stainless steel posts.

- Additional supporting works. The additional supporting works thought necessary at Castle Bolton, apart from numbers of small stainless steel dowels to fix loose masonry back locally, consists of some vertical square tube supports in stainless steel. These have been installed to support major overhangs of potentially unstable masonry and are intended as a clear statement of 20th century minimal intervention.

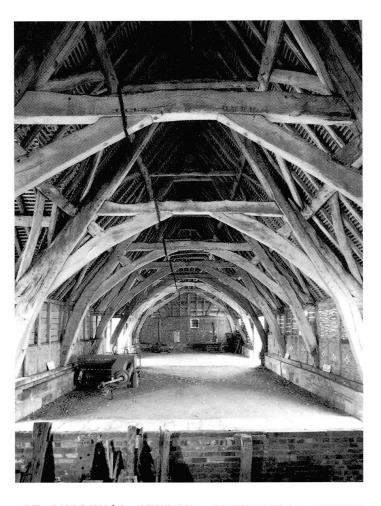
Figure 2.
Leigh Court Barn.

- 5.1.2 The feet of the crucks sit on masonry walls approximately 1m above ground level. The ground conditions are often fairly wet. The thrusts from the feet of the crucks had pushed out these masonry walls to varying degrees and the barn had taken on a distinct lean lengthways. These quite considerable movements had caused some damage to bracing members in the timber frame.

- 5.1.3 It was decided in this instance to partially dismantle the barn in order that the main cruck arch-braces could be pulled vertical, it being felt that the lean which had taken place was causing undue stress on the timber framework.

new foundations were installed. The foundations consisted of large concrete pads supporting steel columns, which in turn were connected to the bottom of the cruck arches. The concrete foundations being below ground were of course completely buried and the steel supporting posts have been totally surrounded in the original masonry, which was replaced in its original locations. The original timber work was replaced almost 100% with very few members being renewed. Some minor repairs were made to severely decayed members. In order to be certain of the structural adequacy of some of the more decayed rafters simple load tests were carried out to prove that these were strong enough for their purpose.

5.1.5 The whole barn was re-assembled with no signs of modern intervention whatever and few new timbers being used.

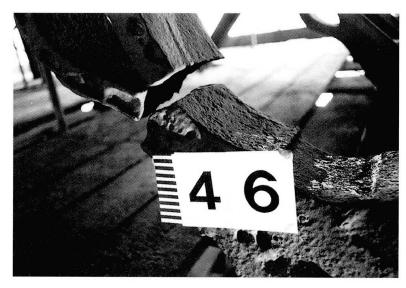
9.1.1 The Iron Bridge in Shropshire, as will be well known, is the world's first cast iron bridge, being built in 1779 and opened for traffic in 1781. It spans the river Severn at Coalbrookdale with a span of some 32m. In 1981 a scaffold was erected to enable access to be gained to all parts of the bridge. Subsequent survey work showed that there were 83 cracks to various members of the bridge structure. It was decided after considerable thought and a certain amount of computer analysis of the structure, that no action need be taken to repair any of these fractures and therefore work was restricted to thoroughly repainting the bridge and some cosmetic repairs to items such as railings.

Ironbridge.
A typical fractured member.

- Some years previously a reinforced concrete strut had been put across the bed of the river to restrict movement of the bridge abutments.
- The arch crown connecting detail which connects the main arches together was a rigidly fixed detail and this had in no instance cracked or become deformed and this clearly showed that no major movements had taken place.
- There was concern that repairing any fracture could, if new movements occurred, create a further fracture rather than allowing the bridge to move on an old fracture point.
- No work was done on the understanding that regular inspections of the bridge were possible and that any further movement would be detected quickly.
