Artikel: An engineering view of the Statue of Liberty restoration

An Engineering View of the Statue of Liberty Restoration

Edward COHEN

Managing Partner
Ammann & Whitney
New York, NY, USA

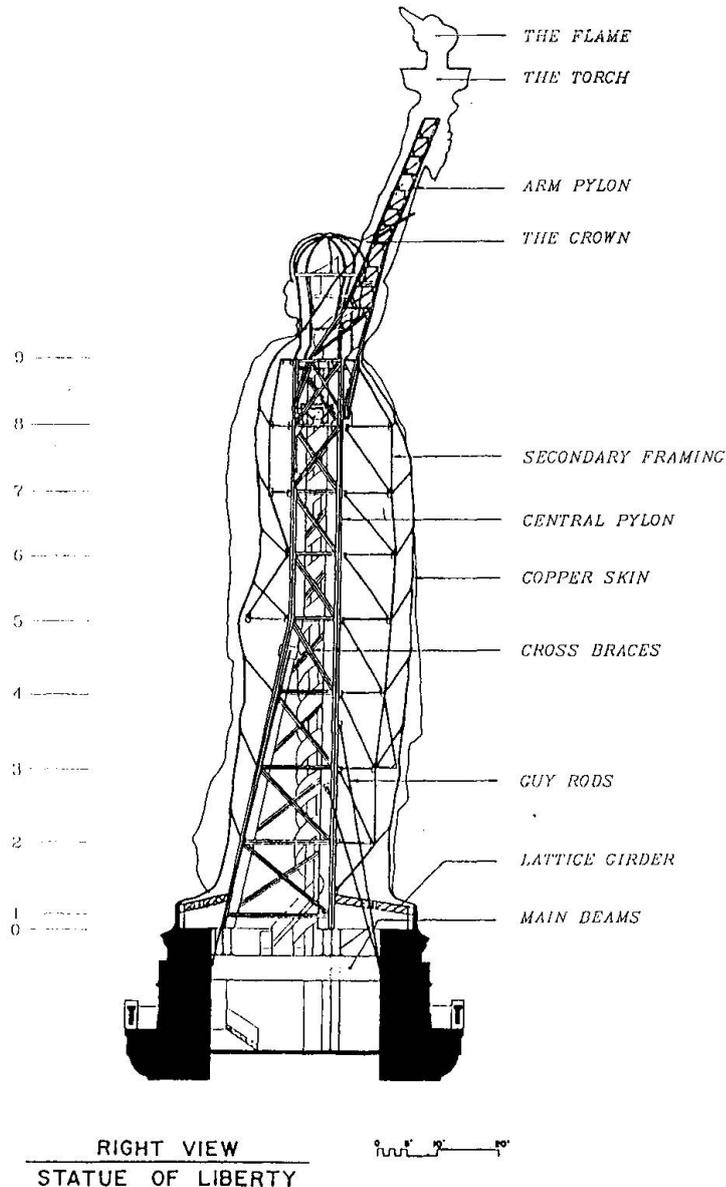
Fig. 1 The Structure of the Statue

Eiffel's design for the structure was innovative for his time (Fig. 1). This unique system consists of a trussed central pylon and secondary framing to support the copper skin and iron armature through an assembly of sliding and articulated elements which permitted "breathing" of the Statue under thermal and wind loadings. The most ingenious aspect of his design is the concept of flat bars to connect the skin support system to the secondary framework. The steeply inclined bars are installed in compression and provide the resilience to allow adjustment to changes due to temperature and

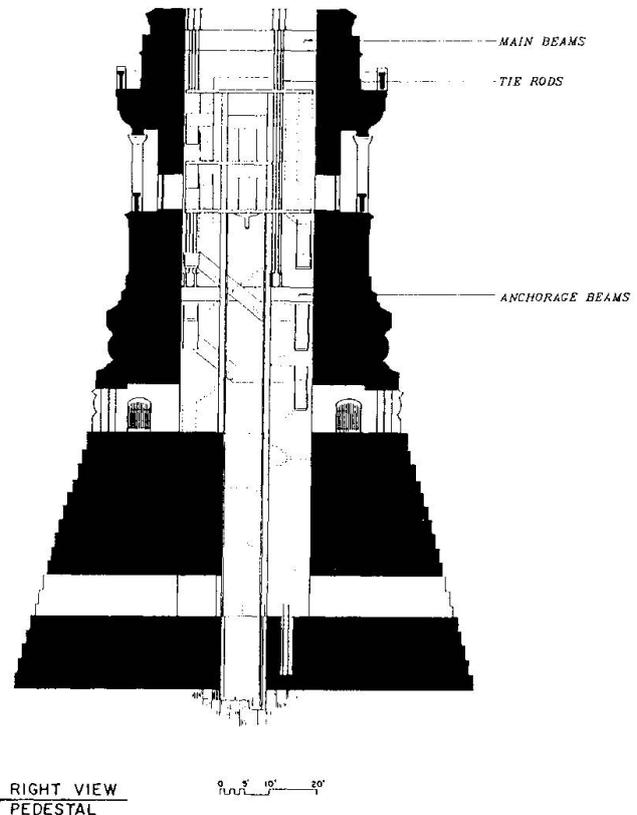
Fig. 2 Foundation, Pedestal and Anchorage

The pedestal (Fig. 2) is constructed of concrete of various mix designs. Above ground, the pedestal is faced with granite. At the time of its construction, the pedestal was the largest mass concrete structure ever built.

The anchorage system for the Statue was produced in the United States and consisted of two (2) levels of dunnage beams, the main beams at the top and the anchor beams located about 60 feet below. The pylon is anchored to the main beams. Transfer of the overturning moment from the pylon is made from the main beams to the anchorage beams through tie rods. The anchorage beams are embedded into the concrete walls of the pedestal structure at each of their ends, engaging sufficient concrete to stabilize the structure against overturning.

helped to identify two potential problems: weakness in the right shoulder and looseness of the anchorage of the Statue. The accelerometer measurements were taken to verify the results of the dynamic analyses in terms of the dynamic response of the Statue to wind, i.e., frequencies, accelerations and displacements. These measurements were correlated with wind measurements taken from an anemometer mounted on the torch platform.

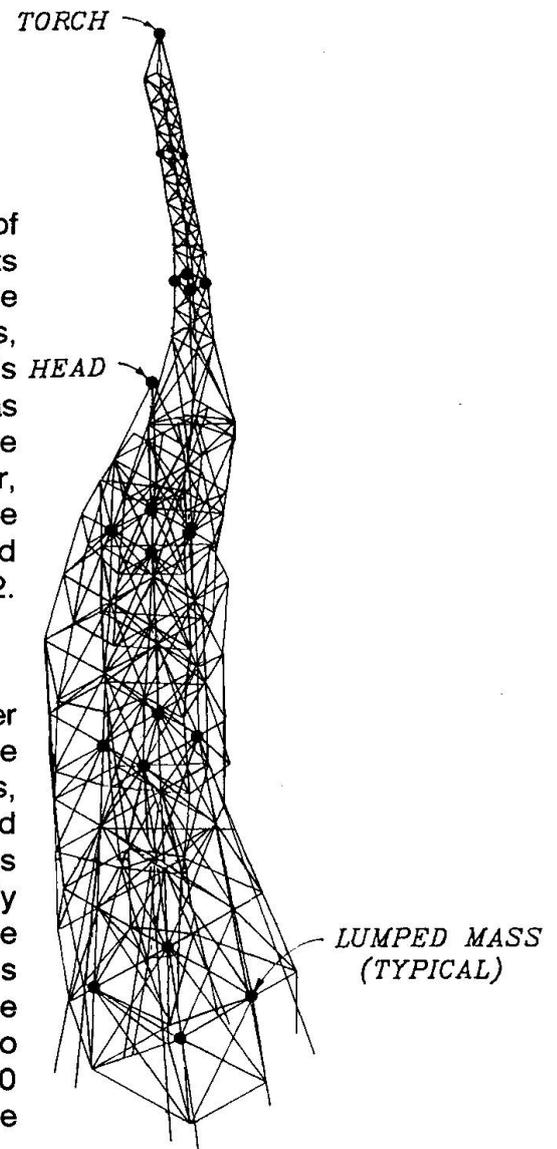
Fig. 3 Finite Element Model

The main pylon of the Statue, including the shoulder and the arm framing, was modelled as a three dimensional space truss. The geometric properties, including member sizes and makeup, were obtained largely from field reconnaissance surveys. Any stiffness contributed by the copper skin was conservatively omitted from the model; however, the influence of the "secondary" framework, which transfers the reactions from the skin to the main pylon, was included. The results of the dynamic analysis show that the two lowest modes, having frequencies of 1.66 hz and 1.90 hz, contribute over 95 percent to the response of the Statue under wind loads.

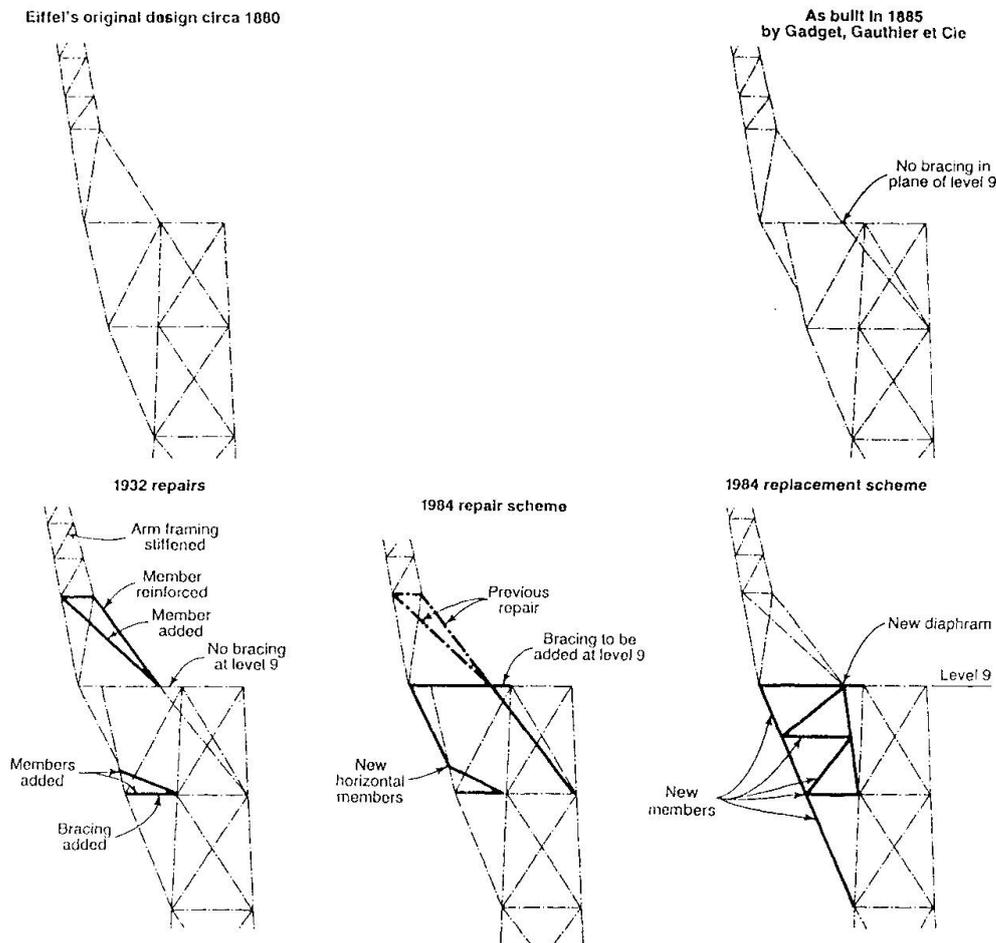
Fig. 4 History and Proposed Repairs of the Right Shoulder

The shoulder and head arch problems have existed since the Statue was constructed, a result of the misalignment of the head and shoulders from the originally designed positions, which created flexibility and overstresses in these areas. In the shoulder, the main deficiency was lack of torsional resistance which resulted in dangerous levels of axial stresses in critical members.

Several attempts to repair the weak shoulder were made in the past, most apparent of these is the unsuccessful attempt made by the U.S. Army in 1932. During the current project, two alternative solutions were proposed. The first alternative, termed the replacement scheme, consisted of removal of several members of the existing deficient shoulder and reconstructing the shoulder with a new truss, to achieve structural continuity to the main pylon. The second alternative, the repair scheme, adds several members to the existing structure to achieve the required rigidity and factor of safety. The history of the problem and proposed repairs of the shoulder are illustrated in Fig. 4.

Because the existing structure had historical significance, being as initially erected in Paris, it was decided to implement the repair scheme.
