**Artikel:** An engineering view of the Statue of Liberty restoration

Autor: Cohen, Edward / Dinapoli, Pasquale / Vellozzi, Joseph

# An Engineering View of the Statue of Liberty Restoration

Edward COHEN
Managing Partner
Ammann & Whitney
New York, NY, USA

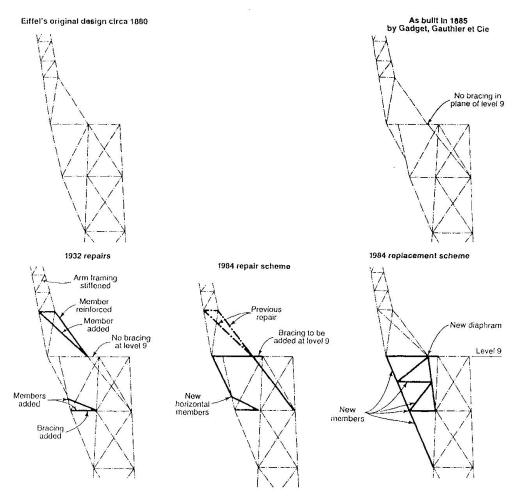
Fig. 4 History and Proposed Repairs of the Right Shoulder

The shoulder and head arch problems have existed since the Statue was constructed, a result of the misalignment of the head and shoulders from the originally designed positions, which created flexibility and overstresses in these areas. In the shoulder, the main deficiency was lack of torsional resistance which resulted in dangerous levels of axial stresses in critical members.

Several attempts to repair the weak shoulder were made in the past, most apparent of these is the unsuccessful attempt made by the U.S. Army in 1932. During the current project, two alternative solutions were proposed. The first alternative, termed the replacement scheme, consisted of removal of several members of the existing deficient shoulder and reconstructing the shoulder with a new truss, to achieve structural continuity to the main pylon. The second alternative, the repair scheme, adds several members to the existing structure to achieve the required rigidity and factor of safety. The history of the problem and proposed repairs of the shoulder are illustrated in Fig. 4.

Because the existing structure had historical significance, being as initially erected in Paris, it was decided to implement the repair scheme.
