**Artikel:** An engineering view of the Statue of Liberty restoration  
**Autor:** Cohen, Edward / Dinapoli, Pasquale / Vellozzi, Joseph  
**DOI:** <https://doi.org/10.5169/seals-53354>

## **An Engineering View of the Statue of Liberty Restoration**

The restoration of the Statue of Liberty was completed in 1986, in time for its centennial celebration. This paper describes the original structural system, its history, the materials and its analysis and design. Also described are the studies, surveys, investigations and analyses conducted to determine the conditions existing and the repairs and modifications necessary for the restoration of the structure. Finally, the solutions considered for the long term preservation of the Statue are discussed, the decision-making process is described and the solutions implemented are presented.

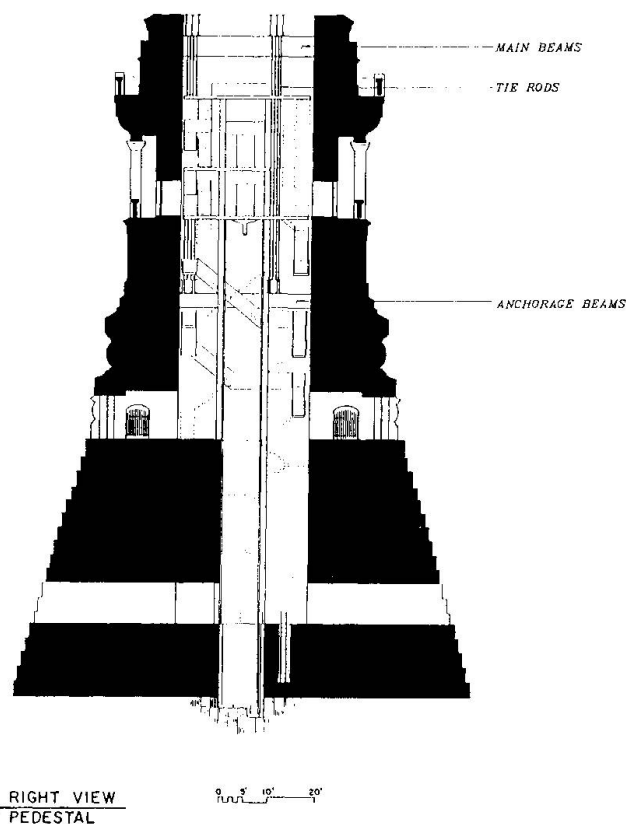
*Fig. 2 Foundation, Pedestal and Anchorage*

The anchorage system for the Statue was produced in the United States and consisted of two (2) levels of dunnage beams, the main beams at the top and the anchor beams located about 60 feet below. The pylon is anchored to the main beams. Transfer of the overturning moment from the pylon is made from the main beams to the anchorage beams through tie rods. The anchorage beams are embedded into the concrete walls of the pedestal structure at each of their ends, engaging sufficient concrete to stabilize the structure against overturning.

helped to identify two potential problems: weakness in the right shoulder and looseness of the anchorage of the Statue. The accelerometer measurements were taken to verify the results of the dynamic analyses in terms of the dynamic response of the Statue to wind, i.e., frequencies, accelerations and displacements. These measurements were correlated with wind measurements taken from an anemometer mounted on the torch platform.

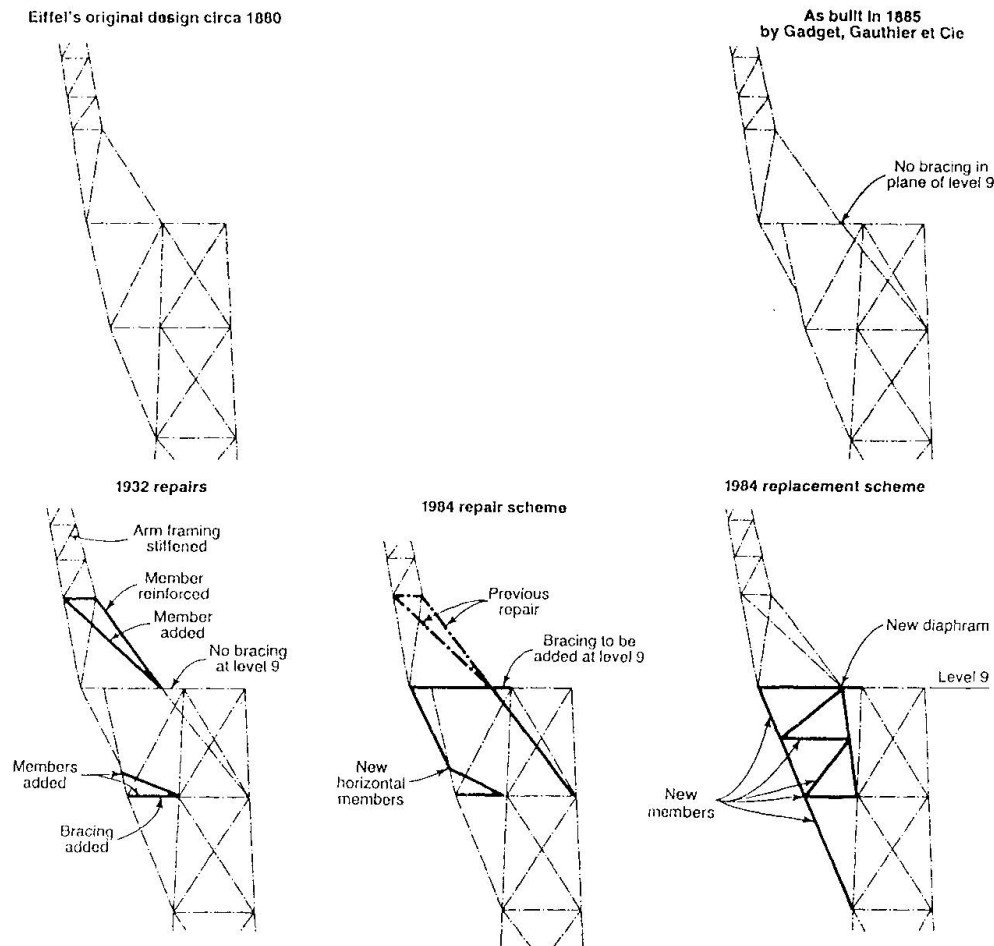
**Fig. 4** History and Proposed Repairs of the Right Shoulder

The shoulder and head arch problems have existed since the Statue was constructed, a result of the misalignment of the head and shoulders from the originally designed positions, which created flexibility and overstresses in these areas. In the shoulder, the main deficiency was lack of torsional resistance which resulted in dangerous levels of axial stresses in critical members.

Several attempts to repair the weak shoulder were made in the past, most apparent of these is the unsuccessful attempt made by the U.S. Army in 1932. During the current project, two alternative solutions were proposed. The first alternative, termed the replacement scheme, consisted of removal of several members of the existing deficient shoulder and reconstructing the shoulder with a new truss, to achieve structural continuity to the main pylon. The second alternative, the repair scheme, adds several members to the existing structure to achieve the required rigidity and factor of safety. The history of the problem and proposed repairs of the shoulder are illustrated in Fig. 4.

Because the existing structure had historical significance, being as initially erected in Paris, it was decided to implement the repair scheme.
