Artikel: An engineering view of the Statue of Liberty restoration
Autor: Cohen, Edward / Dinapoli, Pasquale / Vellozzi, Joseph
DOI: <https://doi.org/10.5169/seals-53354>

An Engineering View of the Statue of Liberty Restoration

The restoration of the Statue of Liberty was completed in 1986, in time for its centennial celebration. This paper describes the original structural system, its history, the materials and its analysis and design. Also described are the studies, surveys, investigations and analyses conducted to determine the conditions existing and the repairs and modifications necessary for the restoration of the structure. Finally, the solutions considered for the long term preservation of the Statue are discussed, the decision-making process is described and the solutions implemented are presented.

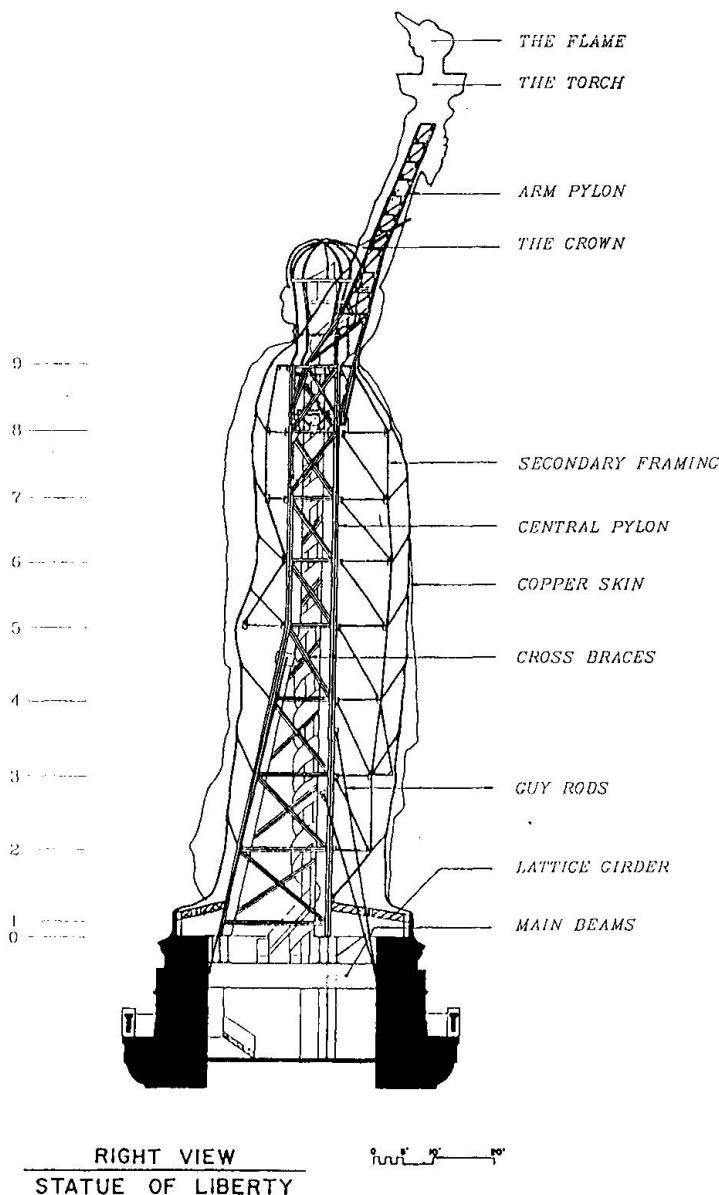
Fig. 1 The Structure of the Statue

Eiffel's design for the structure was innovative for his time (Fig. 1). This unique system consists of a trussed central pylon and secondary framing to support the copper skin and iron armature through an assembly of sliding and articulated elements which permitted "breathing" of the Statue under thermal and wind loadings. The most ingenious aspect of his design is the concept of flat bars to connect the skin support system to the secondary framework. The steeply inclined bars are installed in compression and provide the resilience to allow adjustment to changes due to temperature and

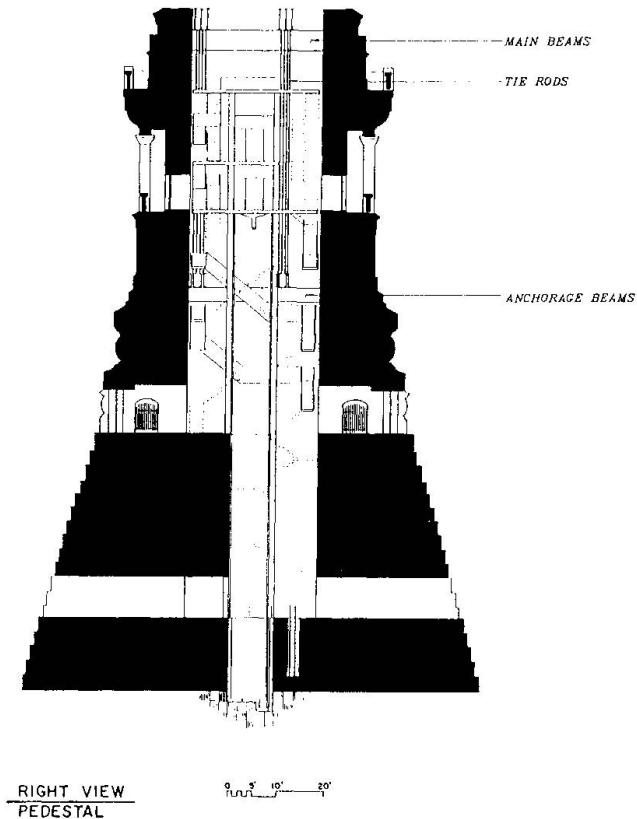
Fig. 2 Foundation, Pedestal and Anchorage

The pedestal (Fig. 2) is constructed of concrete of various mix designs. Above ground, the pedestal is faced with granite. At the time of its construction, the pedestal was the largest mass concrete structure ever built.

The anchorage system for the Statue was produced in the United States and consisted of two (2) levels of dunnage beams, the main beams at the top and the anchor beams located about 60 feet below. The pylon is anchored to the main beams. Transfer of the overturning moment from the pylon is made from the main beams to the anchorage beams through tie rods. The anchorage beams are embedded into the concrete walls of the pedestal structure at each of their ends, engaging sufficient concrete to stabilize the structure against overturning.

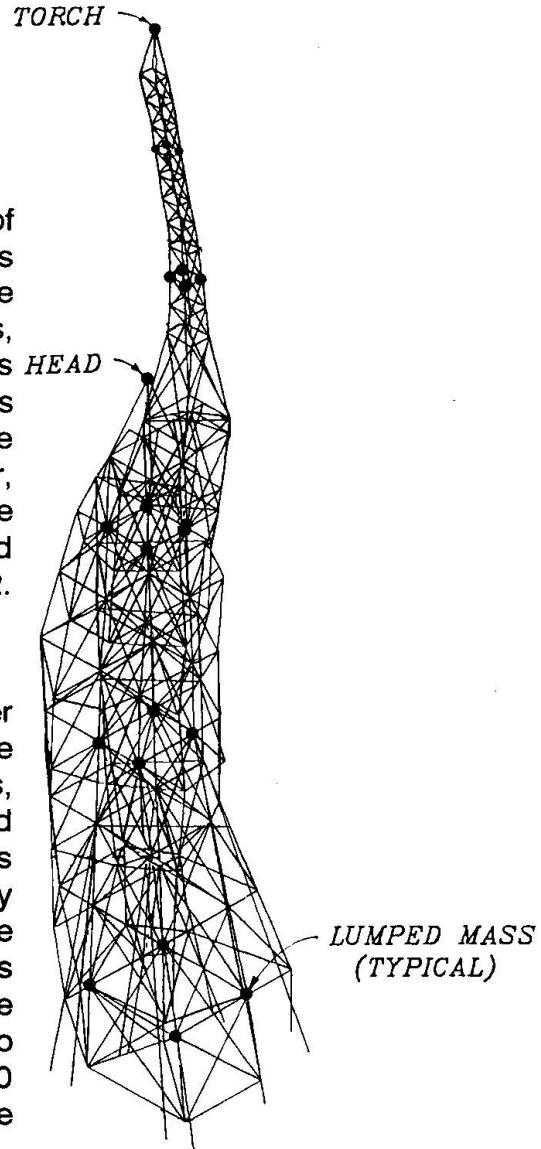
Fig. 3 Finite Element Model

The main pylon of the Statue, including the shoulder and the arm framing, was modelled as a three dimensional space truss. The geometric properties, including member sizes and makeup, were obtained largely from field reconnaissance surveys. Any stiffness contributed by the copper skin was conservatively omitted from the model; however, the influence of the "secondary" framework, which transfers the reactions from the skin to the main pylon, was included. The results of the dynamic analysis show that the two lowest modes, having frequencies of 1.66 hz and 1.90 hz, contribute over 95 percent to the response of the Statue under wind loads.

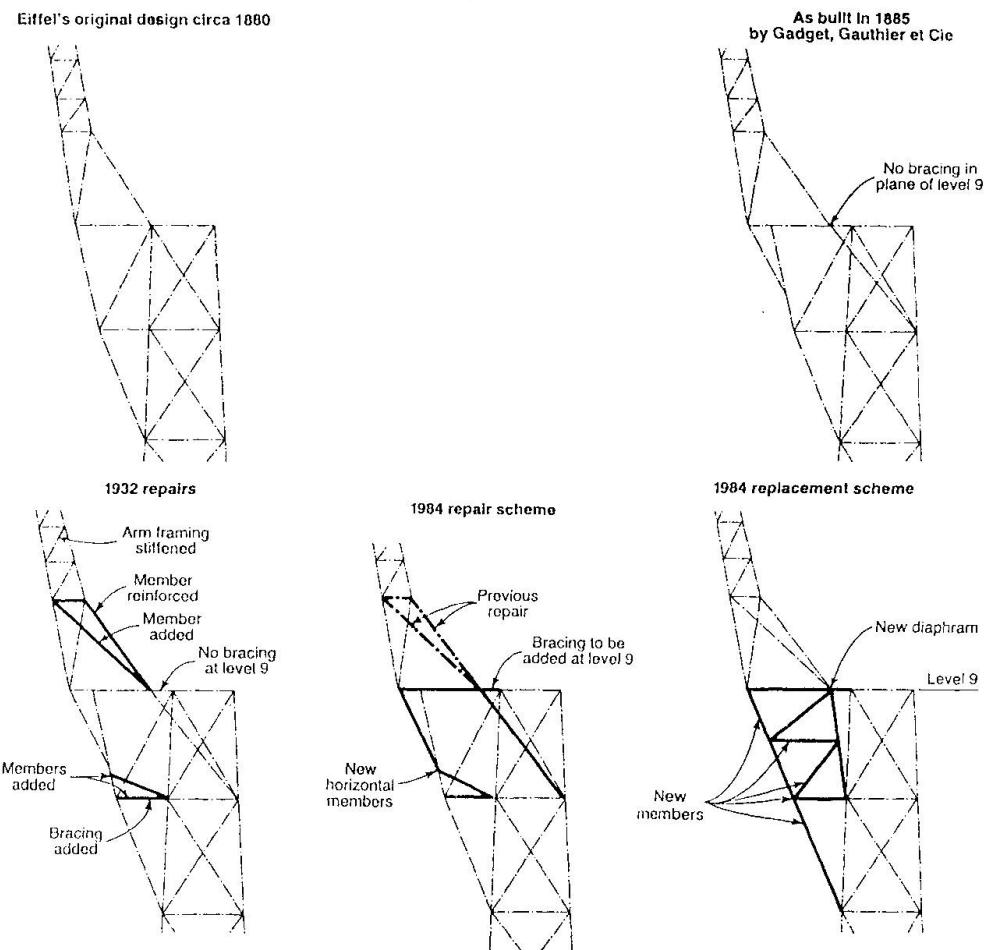
Fig. 4 History and Proposed Repairs of the Right Shoulder

The shoulder and head arch problems have existed since the Statue was constructed, a result of the misalignment of the head and shoulders from the originally designed positions, which created flexibility and overstresses in these areas. In the shoulder, the main deficiency was lack of torsional resistance which resulted in dangerous levels of axial stresses in critical members.

Several attempts to repair the weak shoulder were made in the past, most apparent of these is the unsuccessful attempt made by the U.S. Army in 1932. During the current project, two alternative solutions were proposed. The first alternative, termed the replacement scheme, consisted of removal of several members of the existing deficient shoulder and reconstructing the shoulder with a new truss, to achieve structural continuity to the main pylon. The second alternative, the repair scheme, adds several members to the existing structure to achieve the required rigidity and factor of safety. The history of the problem and proposed repairs of the shoulder are illustrated in Fig. 4.

Because the existing structure had historical significance, being as initially erected in Paris, it was decided to implement the repair scheme.
