The Study of an Old Palace Structure and its Repair

Ibrahim MOHARRAM

Assist. Professor
Ain Shams University
Cairo, Egypt

This is a comprehensive study carried out to diagnose and assess the reinforced concrete quality and structural safety of an old historic palace in Alexandria. The study covered different in-situ non-destructive tests carried out on concrete as well as mechanical tests carried out on steel bars to assess the materials quality and performance. Wooden trusses which represent the structural system on one of the main palace halls were structurally checked. Repair recommendations and techniques for the reinforced concrete elements and the wooden trusses have been brought up based on the corresponding study and analysis.

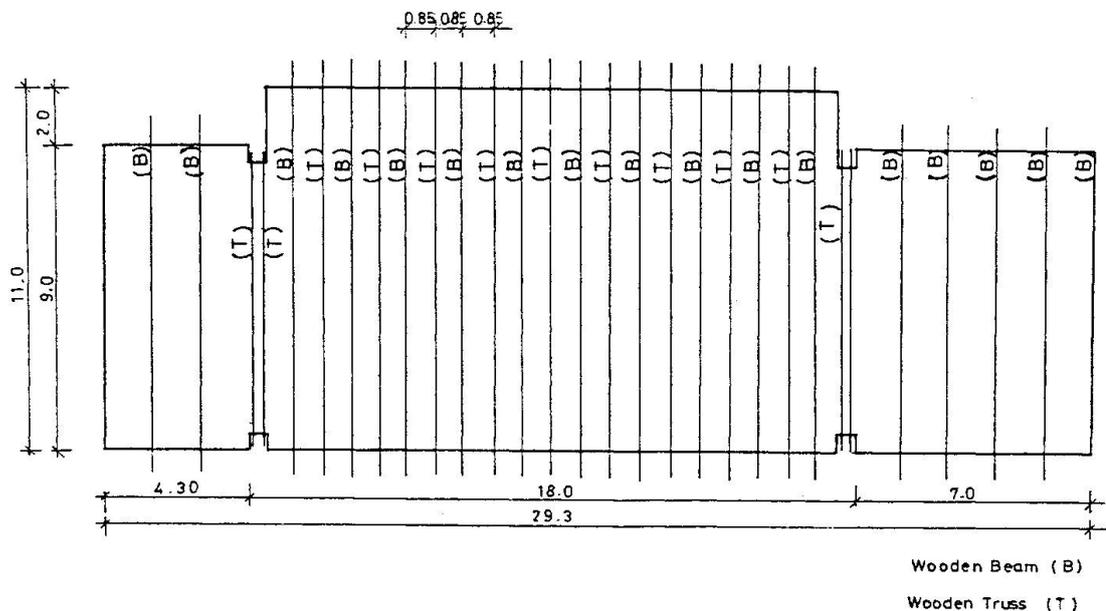
Fig. (1) Layout of the Hall (in the Old Building) showing Locations of Beams and Trusses

This building was well maintained and in a good condition. Nevertheless, there was water leakage in one of its major halls. Figure (1) shows the layout of the hall under study. This hall is one of the most luxurious halls in the palace. The ceiling and walls contain precious masterpiece decorations. The main hall was 18 meters long and 11 meters wide. Connected to this hall from one side was an entrance hall (9 m x 7 m) and from the other side to a hall (9 m x 4.3 m) connecting it to the main throne hall.

The structural system consists of load-bearing masonry wall with a thickness of about 70 cm. The precious decorative false ceiling was hung by means of wooden trusses and beams resting on the bearing walls. The spacings between the trusses were 1.70 m, and between the trusses there was a wooden beam at the same level of the bottom chord of the trusses, as shown in Figure (1). Figure (4) shows the dimensions of a typical truss.

From inspecting the hall false ceiling of the main building, sagging of the decorated false ceiling was noticed as well as traces of water leakage. But nevertheless, from inspecting the hall from the space between the false decorated ceiling and the roof, longitudinal cracks were quite visible in beams and trusses.

Figure (4 and 5) illustrates the method used in repairing and strengthening the trusses of the hall. The following procedure was adopted:

- Collars were primarily loosely installed every about 50 cm to the truss members.
- The cracks were filled with a bonding material consisting of saw dust and an epoxy adhesive. Care was taken during filling to avoid any voids.
- The bolts of the collars were then tightened (during the initial drying period), thus forcing out any voids in the viscous epoxy and providing uniform bonding between the sides of the crack.
- Finally, the wooden structure was painted by an epoxy resin protecting it from humidity, decay and any environmental conditions.
- Leakage of water at the roof was fully checked and repair was carried out to ensure that no leakage would occur in the future.

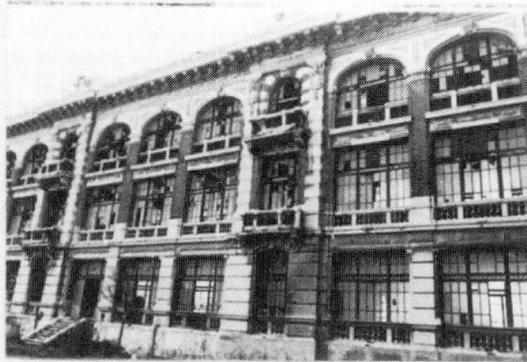
Figure (2) shows the extension building and a sample of the damaged parts. The building was abandoned for sometime and badly maintained. Traces of water leakage could be seen from water piping system at the basement, at the bathroom and at ceiling walls of the top floor (due to rain). Cracks and spalling of concrete could be seen in reinforced concrete elements, while some uncovered corroded steel reinforcement bars were detected.

(a) Part of the Extension Building

Fig. (2) Photos taken to the Extension Building showing a sample of the damaged parts

- A full check and repair of the rain water drainage system, plumbing and maintenance of the building.
- Removal of all concrete cover for steel reinforcement where concrete has been affected and removal of all rust that might be found on the reinforcement bars by means of sand blasting.
- Areas where steel reinforcement was excessively corroded should be replaced by new bars.
- Steel bars should be covered by a protective layer against rust and bars should be covered by a bonding agent layer to ensure a good bonding between steel and newly placed concrete cover.
- Shot creting with a dense mix ensuring that the mix fills in all the voids between steel bars and main concrete body.

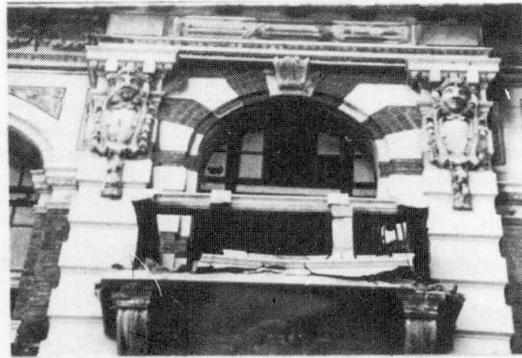
(b) A Balcony

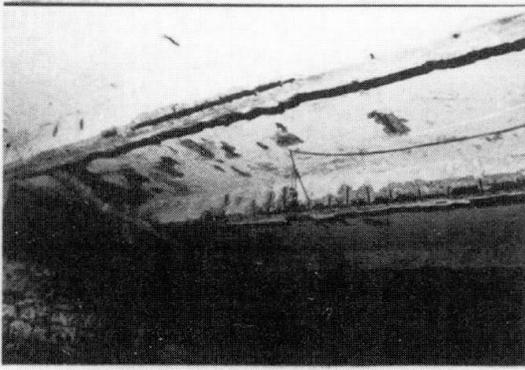
diameters were quite visible especially in parts where pitting corrosion was observed. In general, pitting corrosion was obtained in bars embedded in concrete of the basement and ground floors where a large amount of CI% was obtained by means of the chemical tests. While uniform corrosion on bars was detected in the first and second floors where leaking water was observed as could be seen from Table (1).

(c) The Basement

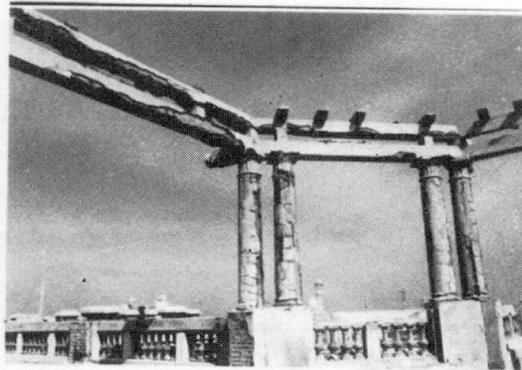
(d) The Terrace

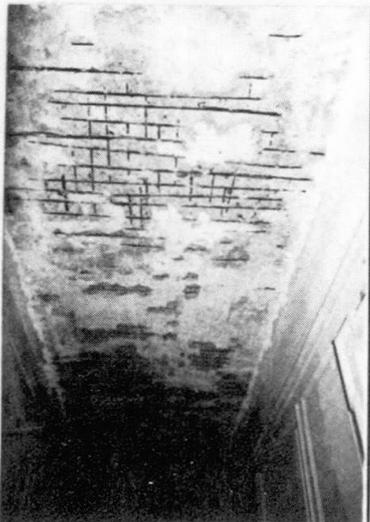
(e) A Slab

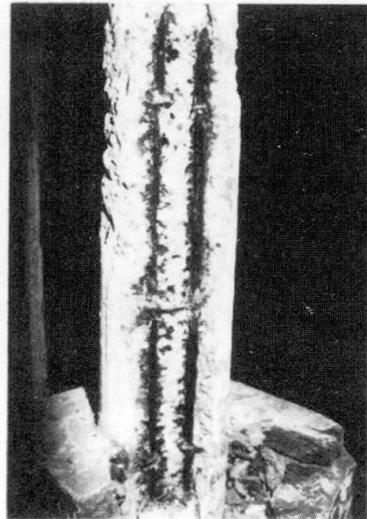
(f) A Column
