Artikel: The study of an old palace structure and its repair

The Study of an Old Palace Structure and its Repair

Assist. Professor Ain Shams University Cairo, Egypt

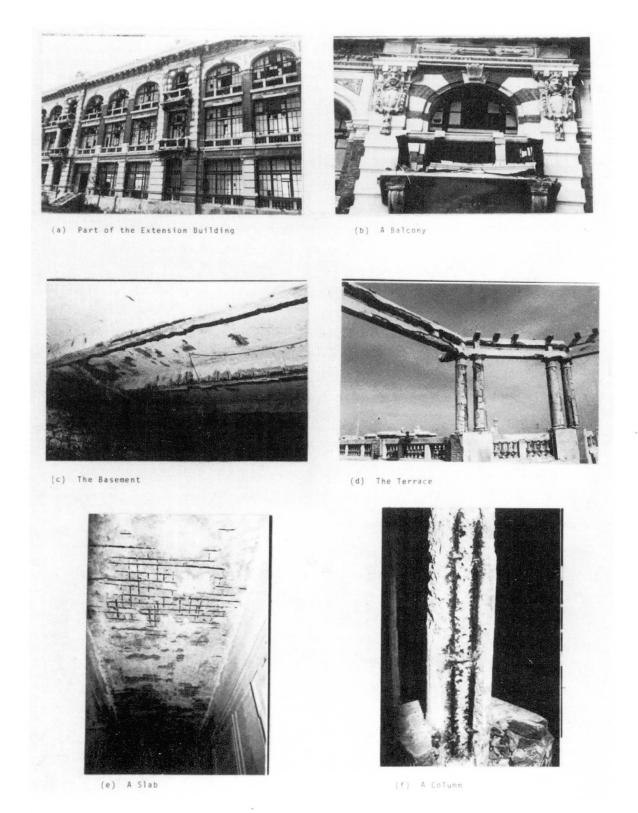
Fig. (2) Photos taken to the Extension Building showing a sample of the damaged parts

Figure (2) shows the extension building and a sample of the damaged parts. The building was abandoned for sometime and badly maintained. Traces of water leakage could be seen from water piping system at the basement, at the bathroom and at ceiling walls of the top floor (due to rain). Cracks and spalling of concrete could be seen in reinforced concrete elements, while some uncovered corroded steel reinforcement bars were detected.

diameters were quite visible especially in parts where pitting corrosion was observed. In general, pitting corrosion was obtained in bars embedded in concrete of the basement and ground floors where a large amount of CI% was obtained by means of the chemical tests. While uniform corrosion on bars was detected in the first and second floors where leaking water was observed as could be seen from Table (1).

- 3. Deterioration of the extension building (reinforced concrete elements) as a whole was due to bad usage and poor maintenance. Corrosion of steel bars was mainly due to high chloride percent (>0.3%) and water penetration in concrete.
- 4. Old historical buildings based on old structural designs and methods of construction should be periodically checked and maintained as they are a symbol of national heritage and assets.

- A full check and repair of the rain water drainage system, plumbing and maintenance of the building.
- Removal of all concrete cover for steel reinforcement where concrete has been affected and removal of all rust that might be found on the reinforcement bars by means of sand blasting.
- Areas where steel reinforcement was excessively corroded should be replaced by new bars.
- Steel bars should be covered by a protective layer against rust and bars should be covered by a bonding agent layer to ensure a good bonding between steel and newly placed concrete cover.
- Shot creeting with a dense mix ensuring that the mix fills in all the voids between steel bars and main concrete body.

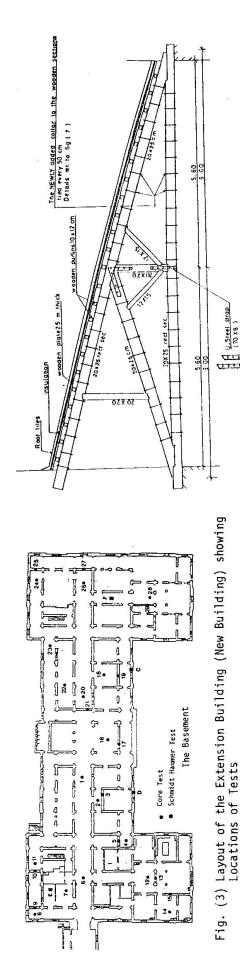
Fig. (4) A Typical Truss of the Old Building Hall (after repair).

From inspecting the hall false ceiling of the main building, sagging of the decorated false ceiling was noticed as well as traces of water leakage. But nevertheless, from inspecting the hall from the space between the false decorated ceiling and the roof, longitudinal cracks were quite visible in beams and trusses.

The dimensions and features of the supporting trusses as well as beams were all measured from the site condition. Loads acting on the truss due to the top roof and decorated false ceiling were calculated. Stresses were checked for all critical sections and were within the permissible values.

- 1. The hall of the old building which is bearing wall with a false ceiling suspended by wooden trusses was proven safe. The deterioration of the ceiling was mainly due to water leakage while the cracks in the wooden truss members were mainly due to old age and lack of maintenance.
- 2. The method used in repairing the wooden trusses proved to be reliable on the grounds that the repair works has already been completed and no signs of cracks has appeared.

Figure (4 and 5) illustrates the method used in repairing and strengthening the trusses of the hall. The following procedure was adopted:

- Collars were primarily loosely installed every about 50 cm to the truss members.
- The cracks were filled with a bonding material consisting of saw dust and an epoxy adhesive. Care was taken during filling to avoid any voids.
- The bolts of the collars were then tightened (during the initial drying period), thus forcing out any voids in the viscous epoxy and providing uniform bonding between the sides of the crack.
- Finally, the wooden structure was painted by an epoxy resin protecting it from humidity, decay and any environmental conditions.
- Leakage of water at the roof was fully checked and repair was carried out to ensure that no leakage would occur in the future.
