Zeitschrift: IABSE reports = Rapports AIPC = IVBH Berichte
Band: 70 (1993)

Rubrik: Posters: Session 4

Posters - Session 4

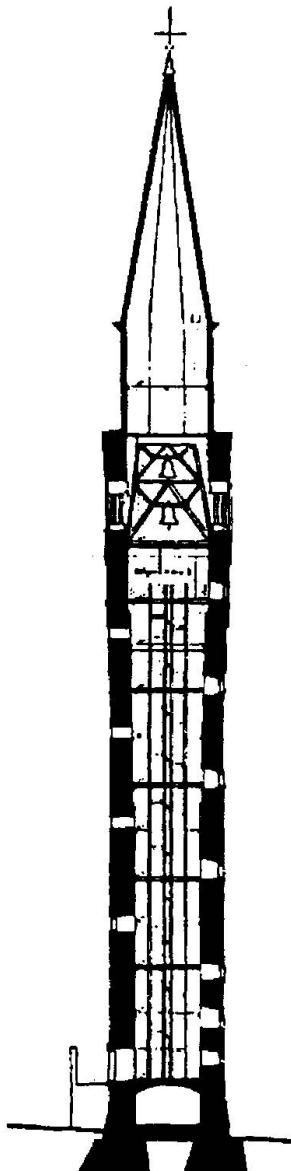
Figure 1

The described case study is the evaluation, repair and strengthening of the bell tower of the Cathedral of Pordenone, in Friuli, the Italy's region stricken by a strong earthquake in 1976. The structure, built during the last years of the 13th century, is 72 m high (Figure 1) and dominates with its imposing mass the historical center of the town.

Some major concerns about its actual safety level were however justified by the not negligible inclination (about 1%) and by evident traces of past heavy damages, often caused by lightnings, which were repaired between the end of the last century and the beginning of the present one.

In particular, pictures exist of the damages at the northern corner of the tower, which was near to collapse at the beginning of this century, and the inner part of such corner still presented damages and cracks in 1990.

This was obtained first by reconstructing damaged masonry portions using traditional materials and techniques. In particular hand made solid clay units and mortars and injections made with hydrated lime mixed with "cocciopesto", which gives hydraulic properties to the admixtures, have been used.

Then, the inactive ties have been substituted and some new ties have been added. Finally, the confinement of the inner parts of the masonry walls have been substantially improved where an external confinement is already provided by the existing iron ties by means of five steel diaphragms in the positions indicated in Figure 1. They are included in the system of the internal stairs as shown in Figure 2 a. Their principal characteristics are shown in Figure 2 b.

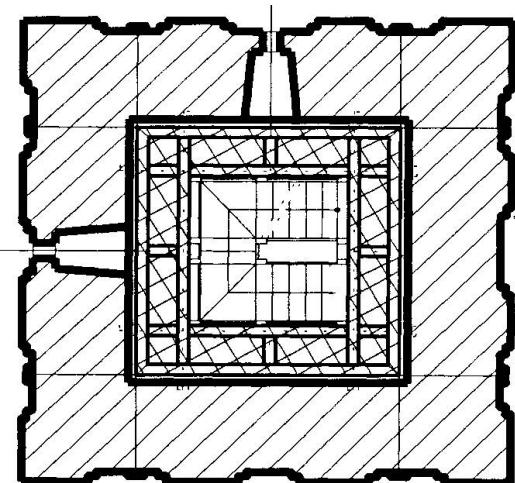
Figure 2 a: section of the tower at the level of one of the diaphragms.

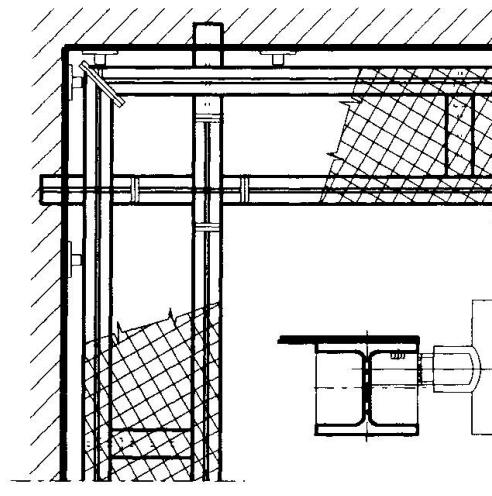
Figure 2 b: details of the steel diaphragms and of the devices used to put them in contact with the masonry walls.

The installation of the diaphragms inside the tower has been made possible by the use of several bolted joints. This construction technique allows the maintenance and, in case, the removal or substitution to be easily executed.

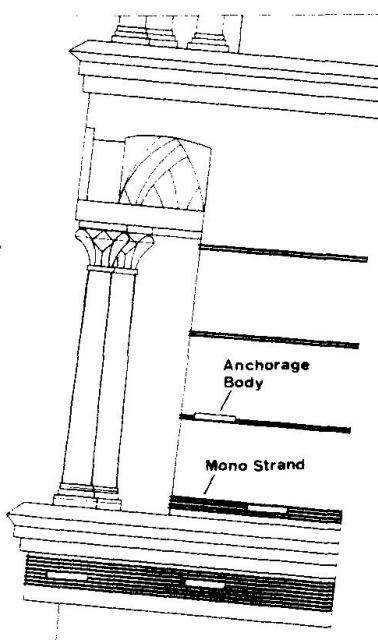
Fig. 1:
Tendon Lay-Out
at First Loggia

The idea was to wrap a number of prestressing strands around the circumference of the tower in the area of the first loggia as shown in Fig. 1. It was decided to place monostrands distributed over the height of the loggia wall. In addition, 8 monostrands were placed above the arches of the lowest level columns. The tendons were initially stressed to 50 % of their guaranteed ultimate strength. Very strict requirements with regard to the visual and functional effect on the tower were set:

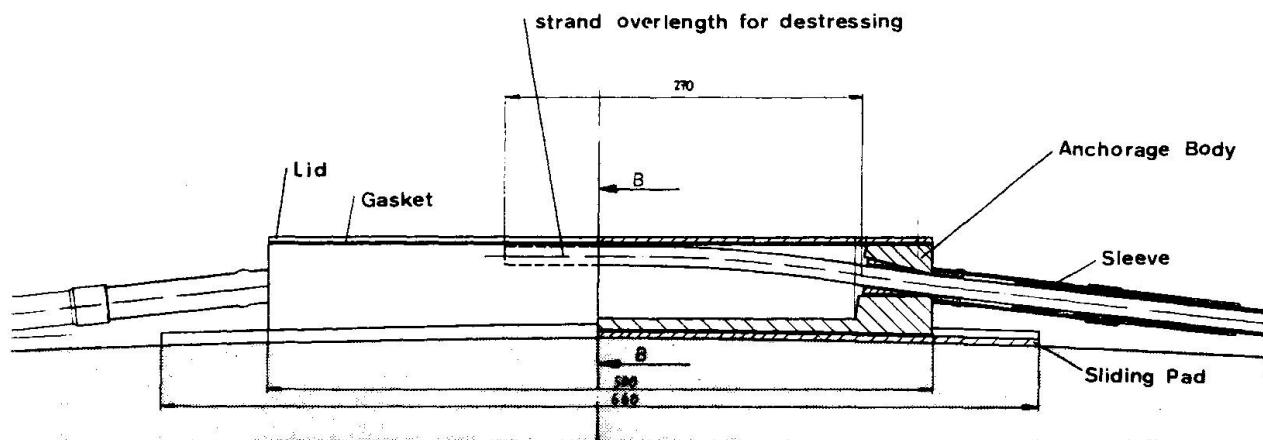
Fig. 2: Specially Designed Monostrand Anchorage Body on Sliding Pad

The anchorage system has minimized outside dimensions, thus causing hardly any visual impact on the structure. After stressing, the strand overlength is hidden in the anchorage body and covered by closing the lid as shown in Fig. 2.

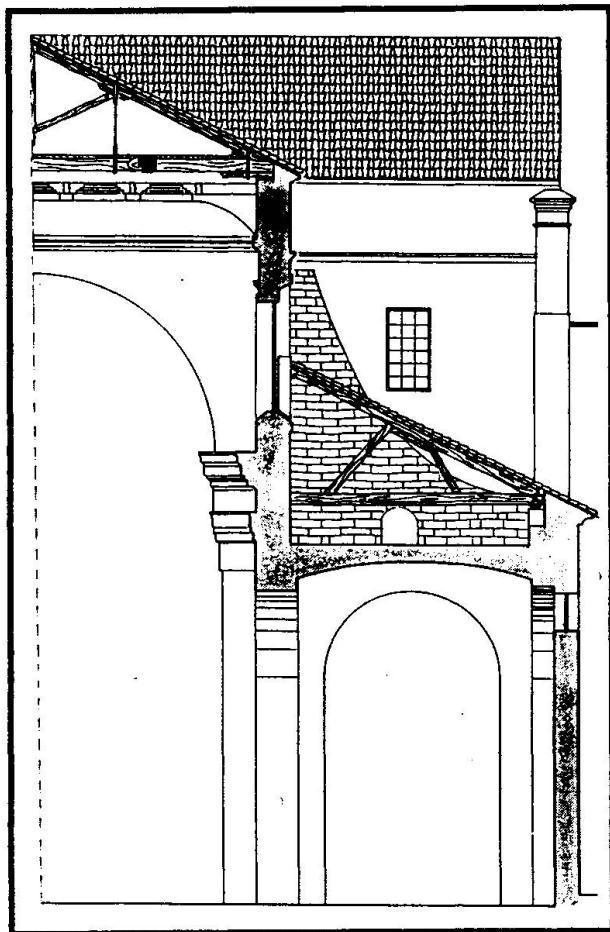
The main diseases were: deep fractures in the arches and in the vaults of both the side aisles, compression failure of some masonry pillars and a substantial foundation settlements in a wide zone between the principal facade and the right side aisle.

The masonry buttresses, built to contrast the seismic lateral loads, fulfilled their function during last earthquake event, but disjoined from the bearing walls and plasticized in the cross sections of lowest strength. The principal facade presented dangerous slipping surfaces and disjunction from the aisles walls, and the outbuildings were diffusely damaged. The wooden coverings were in a severely degraded state.

Fig. 1 Cross-section of the right side aisle before structural rehabilitation

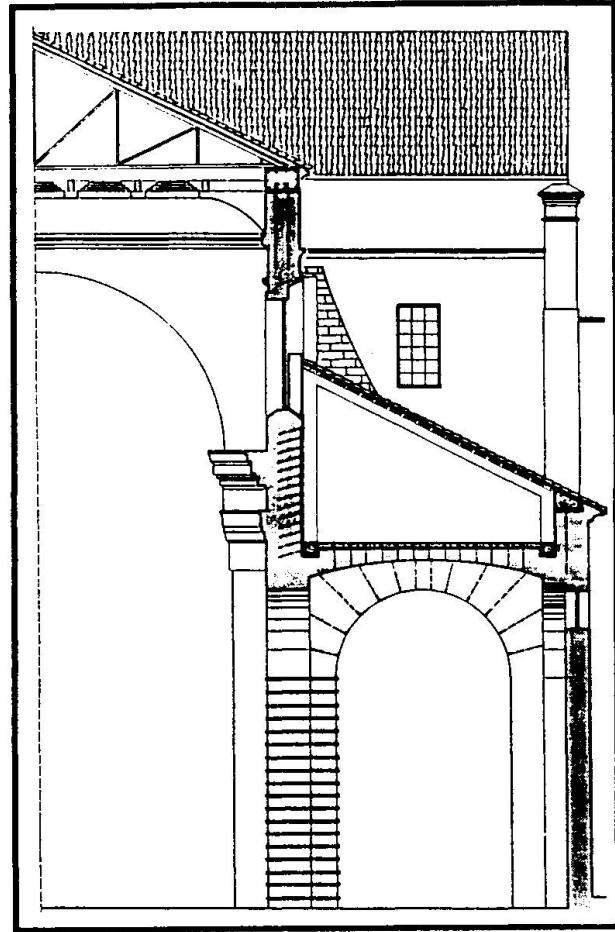
Fig. 2 Cross-section of the right side aisle after structural rehabilitation

- confinement of the damaged masonry pillars, using closed steel plates as stirrups and an external cover of spritz-beton;
- sewing of the arches fractures through insertion of radial steel bars and injection of grouting mortar;
- strengthening of the vaults through superposition of a reinforced concrete slab, connected to the vaults by means of glued steel nails.

The task of contrasting the seismic lateral loads is now performed by reinforced concrete frames effectively shaped, which are much lighter than the demolished tuff buttresses and have a much higher strength per unit volume. These elements bear the new r.c. pitch roof of the lateral aisle, and allow a complete connection between the pillars-arches complex and the masonry walls of the central nave: r.c. and masonry are linked together by means of steel nails.

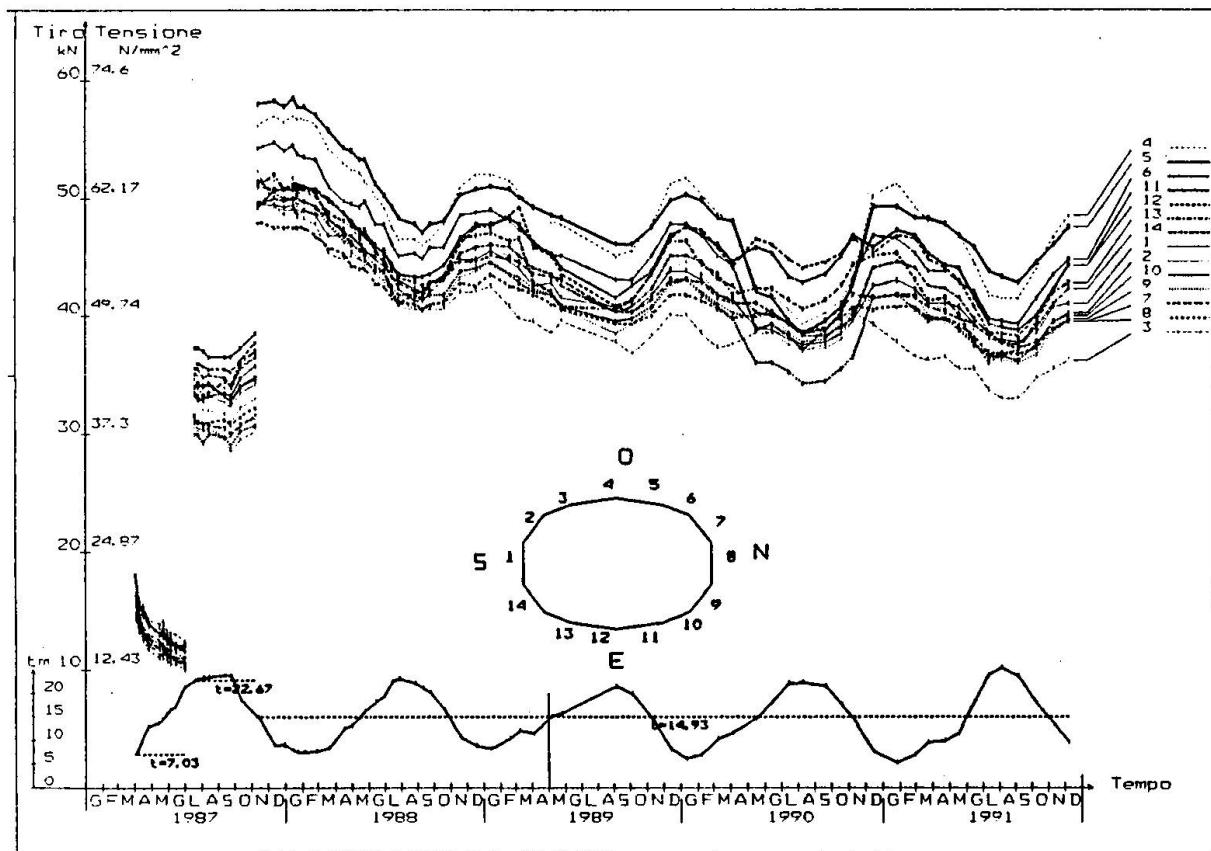
Diagrams of the variation in time of the stresses in the bars over 5 years (as obtained by the monitoring system) have been analysed and a separation between the relaxation of the stresses in the bars (due to plastic flow of the masonry) and parasite stress effects due to the differential thermal dilatation of masonry and steel bars has been tried. Maximum value of mean relaxation of stresses in the 56 tensioning bars has reached the order of 20% of initial values (stress decrease from 50 to 40 KN per bar) in the four years following initial tensioning. (fig.1)

Correlation of these data with monitored movements of the main cracks of the dome leads to the conclusion of the need for a recalibration of the stress levels in the post-tensioning system to be performed in 1993. The need of more reliable data on the internal temperatures in the dome masonry has led to a program for measuring and monitoring these parameters to be operative also in 1993.

Fig.1 Variation in time of forces and stresses in the post-tensioning ring (mean values of 4 bars for each of the 14 sections of the ring) and variation of inside temperatures.

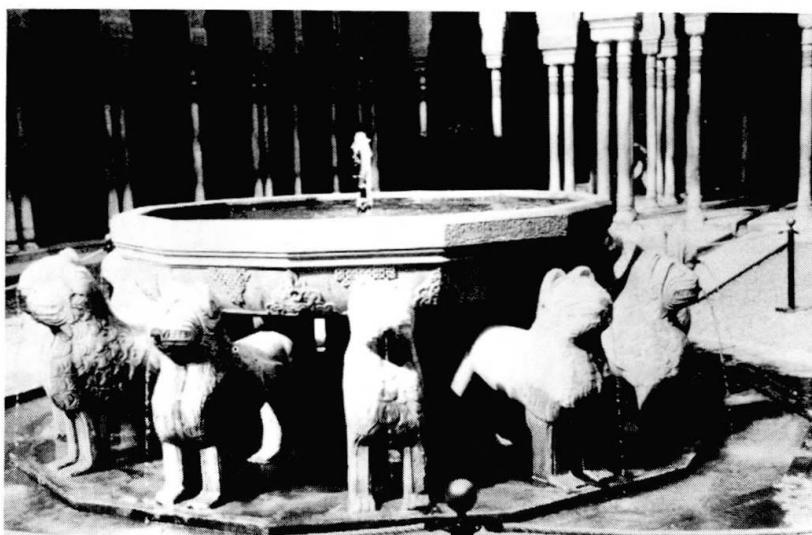
The whole of the Macael marble artifacts, in different structures of the Arab Palaces, show a satisfactory conservation stage, with some exceptions: e.g., colonnades in "Patio de los Leones" (figure 1).

Fig. 1 "Patio de los Leones", Alhambra.

A convenient control on stability conditions of the colonnades appears useful to find the adequate maintenance interventions, before carrying out replacements of damaged marble artifacts and/or protective treatments.

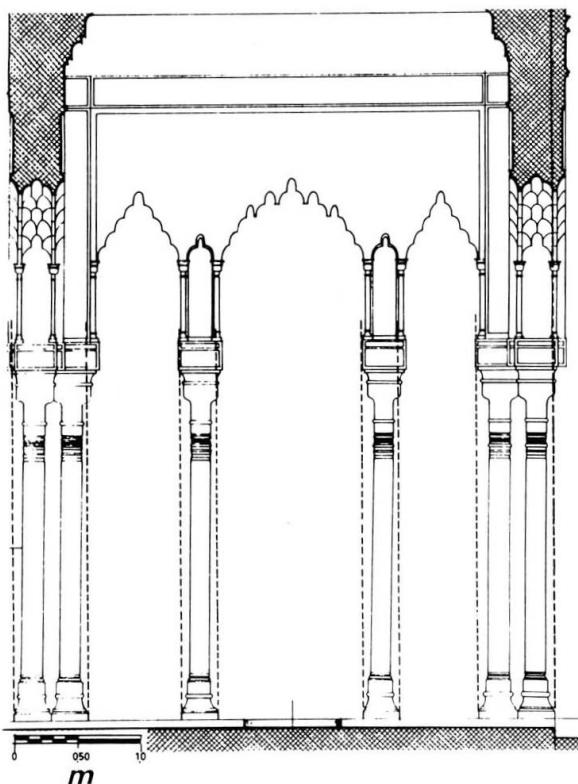
Fig. 2 Static situation, drawn in 1976, for "Templete de los Mocarabes", Court of the Lions.

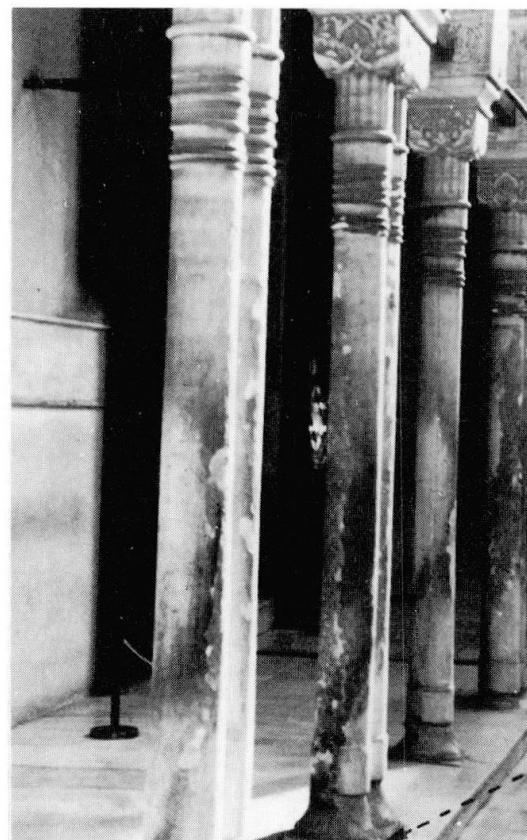
Fig. 3 Progressive reduction in height of bases, and damaged shafts according to mechanical weakness plane.

by direct correlations between the increases of the apparent decay degree and total anisotropy index, measured in marble artifacts. Moreover, this evolution has been related to: a) rotation of the foliation plane, consistent with the shaft placement, influencing the durability of the artifacts under the same exposure conditions; and b) evident displacements of the original static conditions (figure 2), and new signs of differential settlement and plumb-line diversifications in severely damaged shafts, recognized particularly in the "Galeria de Dos Hermanas" colonnade (figure 3).
