Zeitschrift: IABSE reports = Rapports AIPC = IVBH Berichte
Band: 70 (1993)

Rubrik: Posters: Session 4

Posters - Session 4

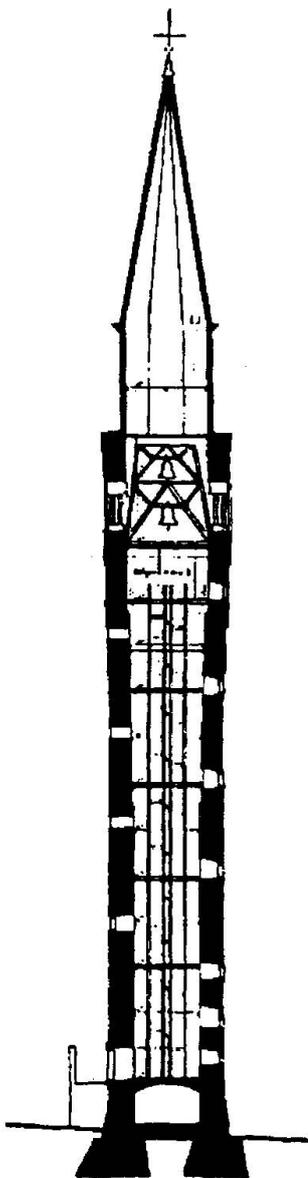
Figure 1

The described case study is the evaluation, repair and strengthening of the bell tower of the Cathedral of Pordenone, in Friuli, the Italy's region stricken by a strong earthquake in 1976. The structure, built during the last years of the 13th century, is 72 m high (Figure 1) and dominates with its imposing mass the historical center of the town.

Some major concerns about its actual safety level were however justified by the not negligible inclination (about 1%) and by evident traces of past heavy damages, often caused by lightnings, which were repaired between the end of the last century and the beginning of the present one.

In particular, pictures exist of the damages at the northern corner of the tower, which was near to collapse at the beginning of this century, and the inner part of such corner still presented damages and cracks in 1990.

This was obtained first by reconstructing damaged masonry portions using traditional materials and techniques. In particular hand made solid clay units and mortars and injections made with hydrated lime mixed with "cocciopesto", which gives hydraulic properties to the admixtures, have been used.

Then, the inactive ties have been substituted and some new ties have been added. Finally, the confinement of the inner parts of the masonry walls have been substantially improved where an external confinement is already provided by the existing iron ties by means of five steel diaphragms in the positions indicated in Figure 1. They are included in the system of the internal stairs as shown in Figure 2 a. Their principal characteristics are shown in Figure 2 b.

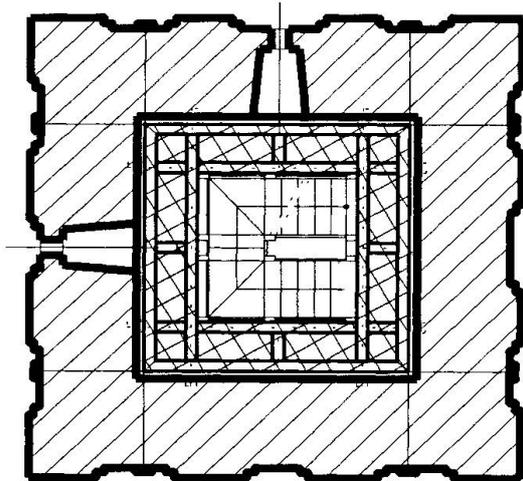
Figure 2 a: section of the tower at the level of one of the diaphragms.

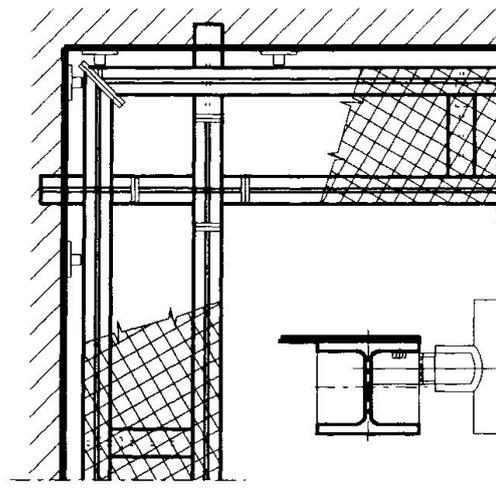
Figure 2 b: details of the steel diaphragms and of the devices used to put them in contact with the masonry walls.

The installation of the diaphragms inside the tower has been made possible by the use of several bolted joints. This construction technique allows the maintenance and, in case, the removal or substitution to be easily executed.

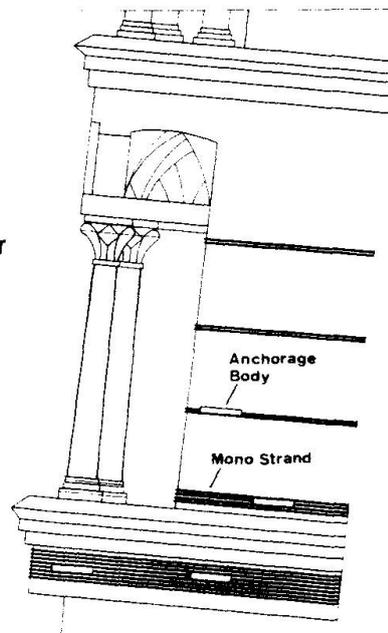
Fig. 1:
Tendon Lay-Out
at First Loggia

The idea was to wrap a number of prestressing strands around the circumference of the tower in the area of the first loggia as shown in Fig. 1. It was decided to place monostrands distributed over the height of the loggia wall. In addition, 8 monostrands were placed above the arches of the lowest level columns. The tendons were initially stressed to 50 % of their guaranteed ultimate strength. Very strict requirements with regard to the visual and functional effect on the tower were set:

These requirements called for a design which allows the tendons to be force-monitored, retensioned, detensioned and removed. The chosen prestressing system does not interfere with existing materials. The tendons are finally held in place by their prestressing force.

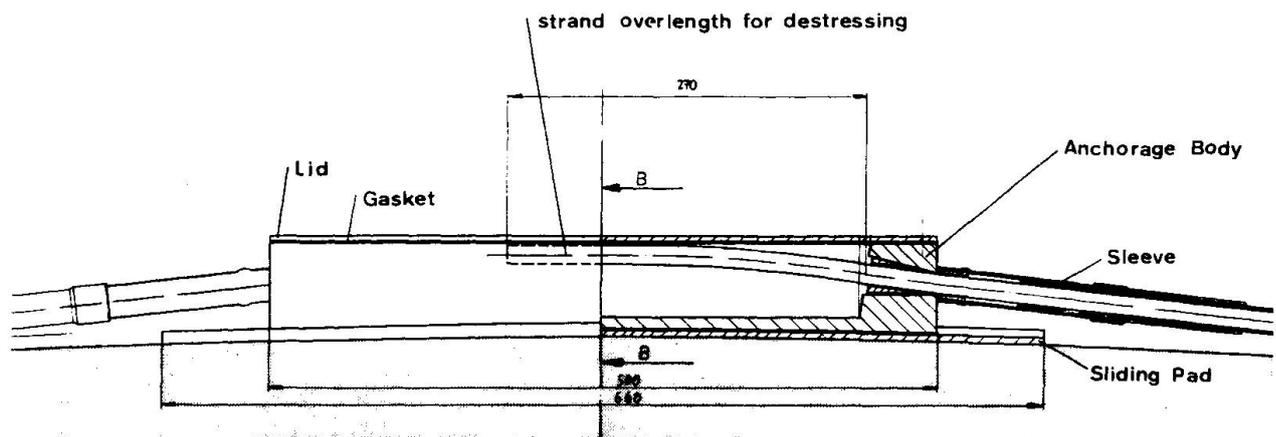
Fig. 2: Specially Designed Monostrand Anchorage Body on Sliding Pad

The anchorage system has minimized outside dimensions, thus causing hardly any visual impact on the structure. After stressing, the strand overlength is hidden in the anchorage body and covered by closing the lid as shown in Fig. 2.

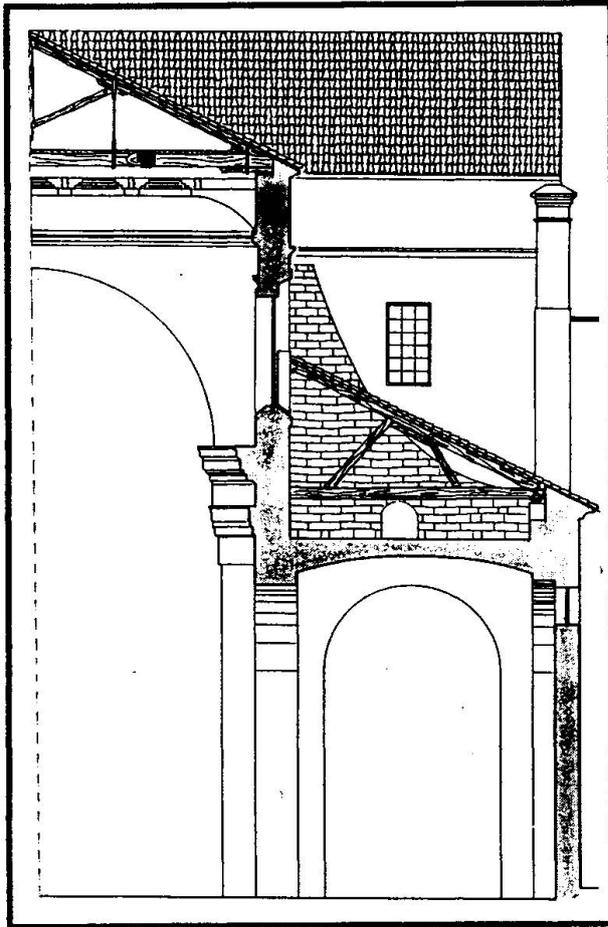
The main diseases were: deep fractures in the arches and in the vaults of both the side aisles, compression failure of some masonry pillars and a substantial foundation settlements in a wide zone between the principal facade and the right side aisle.

The masonry buttresses, built to contrast the seismic lateral loads, fulfilled their function during last earthquake event, but disjoined from the bearing walls and plasticized in the cross sections of lowest strength. The principal facade presented dangerous slipping surfaces and disjunction from the aisles walls, and the outbuildings were diffusely damaged. The wooden coverings were in a severely degraded state.

Fig. 1 Cross-section of the right side aisle before structural rehabilitation

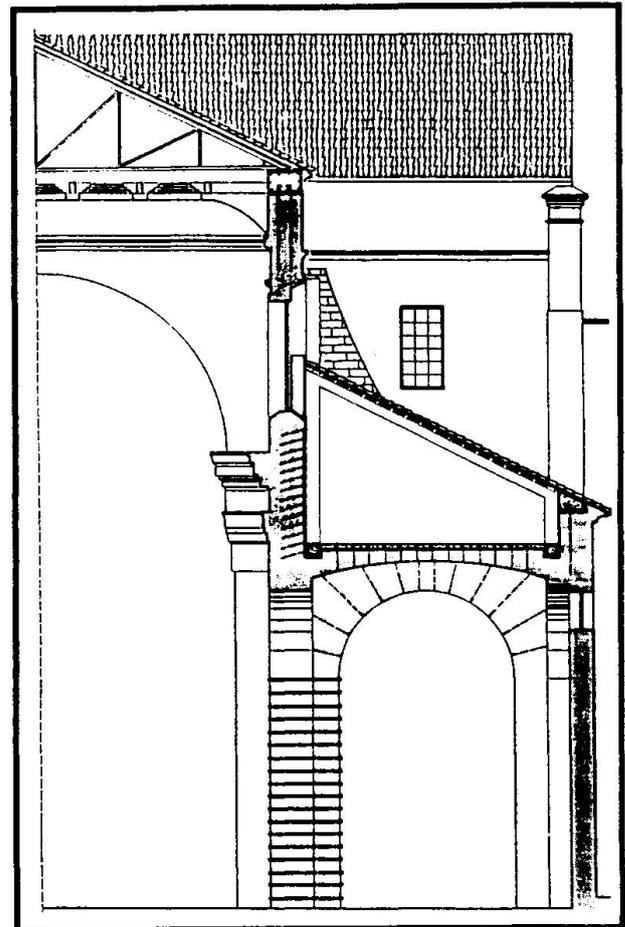
Fig. 2 Cross-section of the right side aisle after structural rehabilitation

- confinement of the damaged masonry pillars, using closed steel plates as stirrups and an external cover of spritz-beton;
- sewing of the arches fractures through insertion of radial steel bars and injection of grouting mortar;
- strengthening of the vaults through superposition of a reinforced concrete slab, connected to the vaults by means of glued steel nails.

The task of contrasting the seismic lateral loads is now performed by reinforced concrete frames effectively shaped, which are much lighter than the demolished tuff buttresses and have a much higher strength per unit volume. These elements bear the new r.c. pitch roof of the lateral aisle, and allow a complete connection between the pillars-arches complex and the masonry walls of the central nave: r.c. and masonry are linked together by means of steel nails.

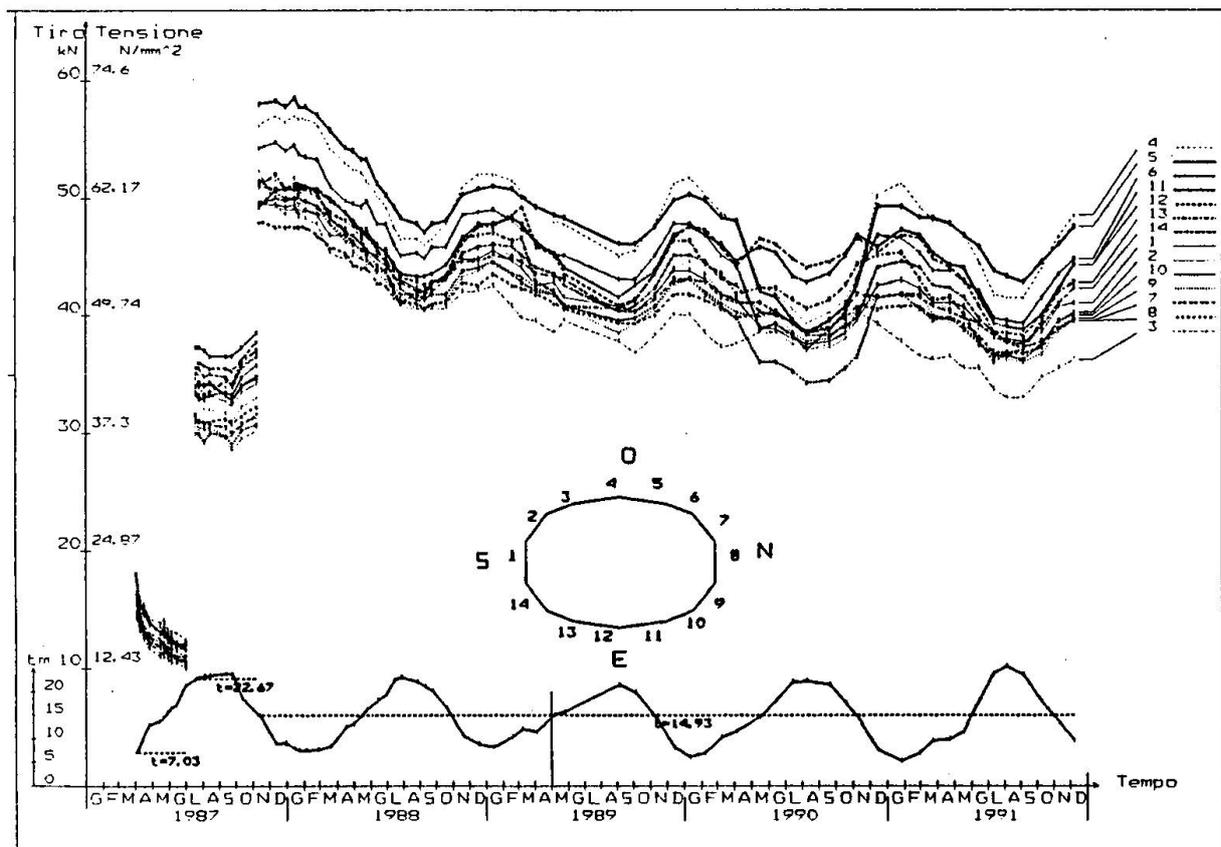
Diagrams of the variation in time of the stresses in the bars over 5 years (as obtained by the monitoring system) have been analysed and a separation between the relaxation of the stresses in the bars (due to plastic flow of the masonry) and parasite stress effects due to the differential thermal dilatation of masonry and steel bars has been tried. Maximum value of mean relaxation of stresses in the 56 tensioning bars has reached the order of 20% of initial values (stress decrease from 50 to 40 KN per bar) in the four years following initial tensioning. (fig.1)

Fig.1 Variation in time of forces and stresses in the post-tensioning ring (mean values of 4 bars for each of the 14 sections of the ring) and variation of inside temperatures.

Correlation of these data with monitored movements of the main cracks of the dome leads to the conclusion of the need for a recalibration of the stress levels in the post-tensioning system to be performed in 1993. The need of more reliable data on the internal temperatures in the dome masonry has led to a program for measuring and monitoring these parameters to be operative also in 1993.

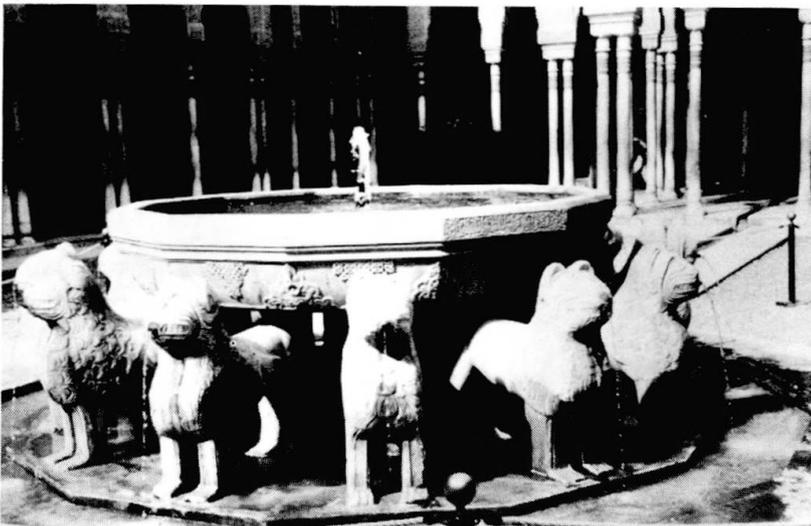
The whole of the Macael marble artifacts, in different structures of the Arab Palaces, show a satisfactory conservation stage, with some exceptions: e.g., colonnades in "Patio de los Leones" (figure 1).

Fig. 1 "Patio de los Leones", Alhambra.

A convenient control on stability conditions of the colonnades appears useful to found the adequate maintenance interventions, before carrying out replacements of damaged marble artifacts and/or protective treatments.

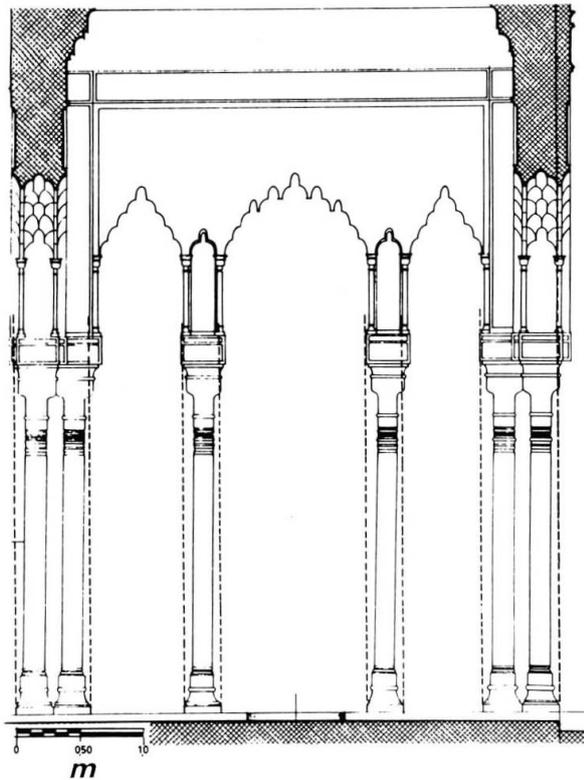
Fig. 2 Static situation, drawn in 1976, for "Templete de los Mocarabes", Court of the Lions.

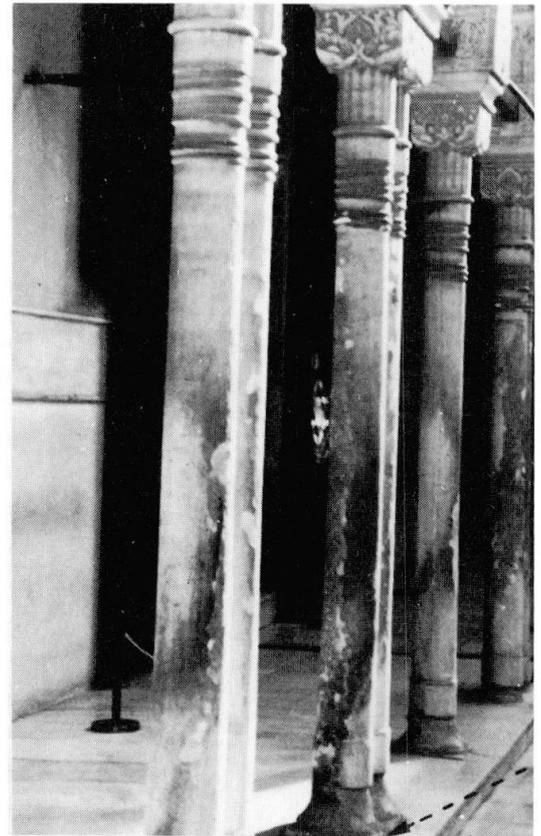
Fig. 3 Progressive reduction in height of bases, and damaged shafts according to mechanical weakness plane.

by direct correlations between the increases of the apparent decay degree and total anisotropy index, measured in marble artifacts. Moreover, this evolution has been related to: a) rotation of the foliation plane, consistent with the shaft placement, influencing the durability of the artifacts under the same exposure conditions; and b) evident displacements of the original static conditions (figure 2), and new signs of differential settlement and plumb-line diversifications in severe damaged shafts, recognized particularly in the "Galeria de Dos Hermanas" colonnade (figure 3).
