**Zeitschrift:** IABSE reports = Rapports AIPC = IVBH Berichte  
**Band:** 70 (1993)  
**Rubrik:** Posters: Session 4

## **Posters - Session 4**

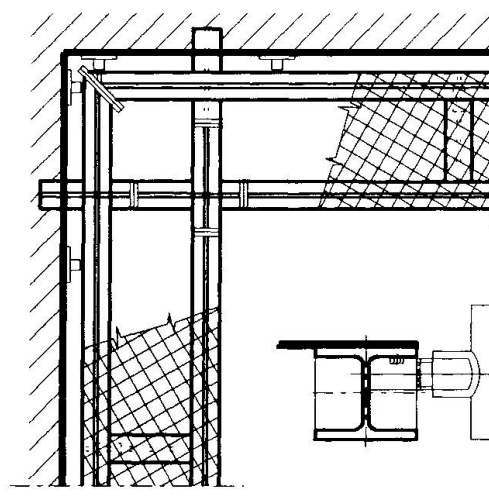
Figure 2 b: details of the steel diaphragms and of the devices used to put them in contact with the masonry walls.

Then, the inactive ties have been substituted and some new ties have been added. Finally, the confinement of the inner parts of the masonry walls have been substantially improved where an external confinement is already provided by the existing iron ties by means of five steel diaphragms in the positions indicated in Figure 1. They are included in the system of the internal stairs as shown in Figure 2 a. Their principal characteristics are shown in Figure 2 b.

The installation of the diaphragms inside the tower has been made possible by the use of several bolted joints. This construction technique allows the maintenance and, in case, the removal or substitution to be easily executed.

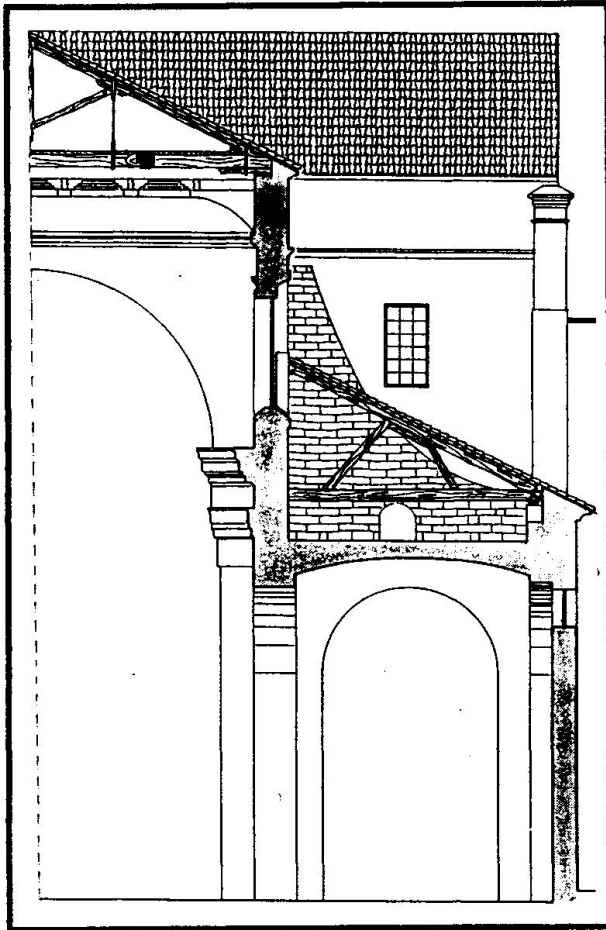
The main diseases were: deep fractures in the arches and in the vaults of both the side aisles, compression failure of some masonry pillars and a substantial foundation settlements in a wide zone between the principal facade and the right side aisle.

The masonry buttresses, built to contrast the seismic lateral loads, fulfilled their function during last earthquake event, but disjoined from the bearing walls and plasticized in the cross sections of lowest strength. The principal facade presented dangerous slipping surfaces and disjunction from the aisles walls, and the outbuildings were diffusely damaged. The wooden coverings were in a severely degraded state.

Fig. 1 Cross-section of the right side aisle before structural rehabilitation

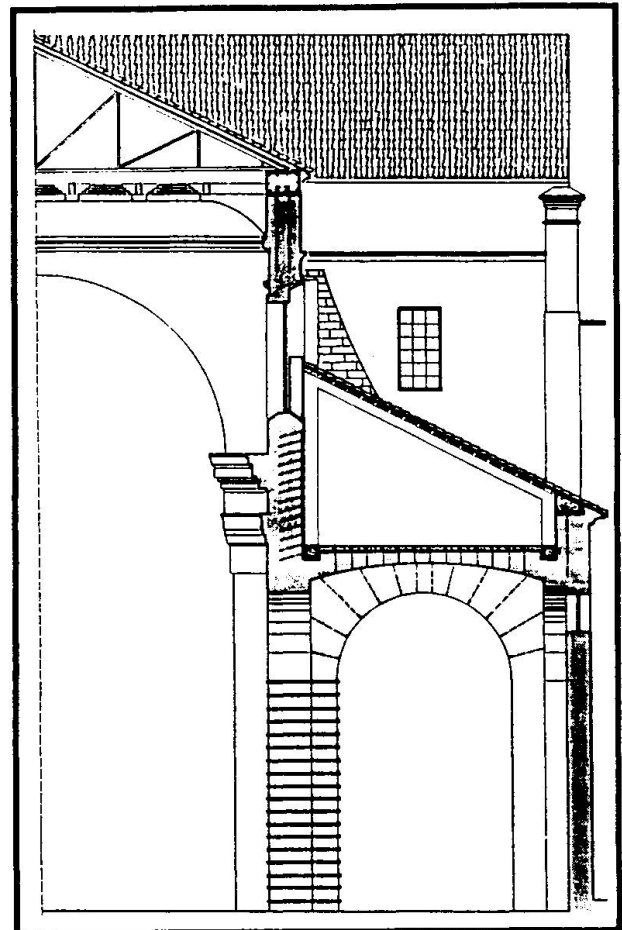
Fig. 2 Cross-section of the right side aisle after structural rehabilitation

- confinement of the damaged masonry pillars, using closed steel plates as stirrups and an external cover of spritz-beton;
- sewing of the arches fractures through insertion of radial steel bars and injection of grouting mortar;
- strengthening of the vaults through superposition of a reinforced concrete slab, connected to the vaults by means of glued steel nails.

The task of contrasting the seismic lateral loads is now performed by reinforced concrete frames effectively shaped, which are much lighter than the demolished tuff buttresses and have a much higher strength per unit volume. These elements bear the new r.c. pitch roof of the lateral aisle, and allow a complete connection between the pillars-arches complex and the masonry walls of the central nave: r.c. and masonry are linked together by means of steel nails.

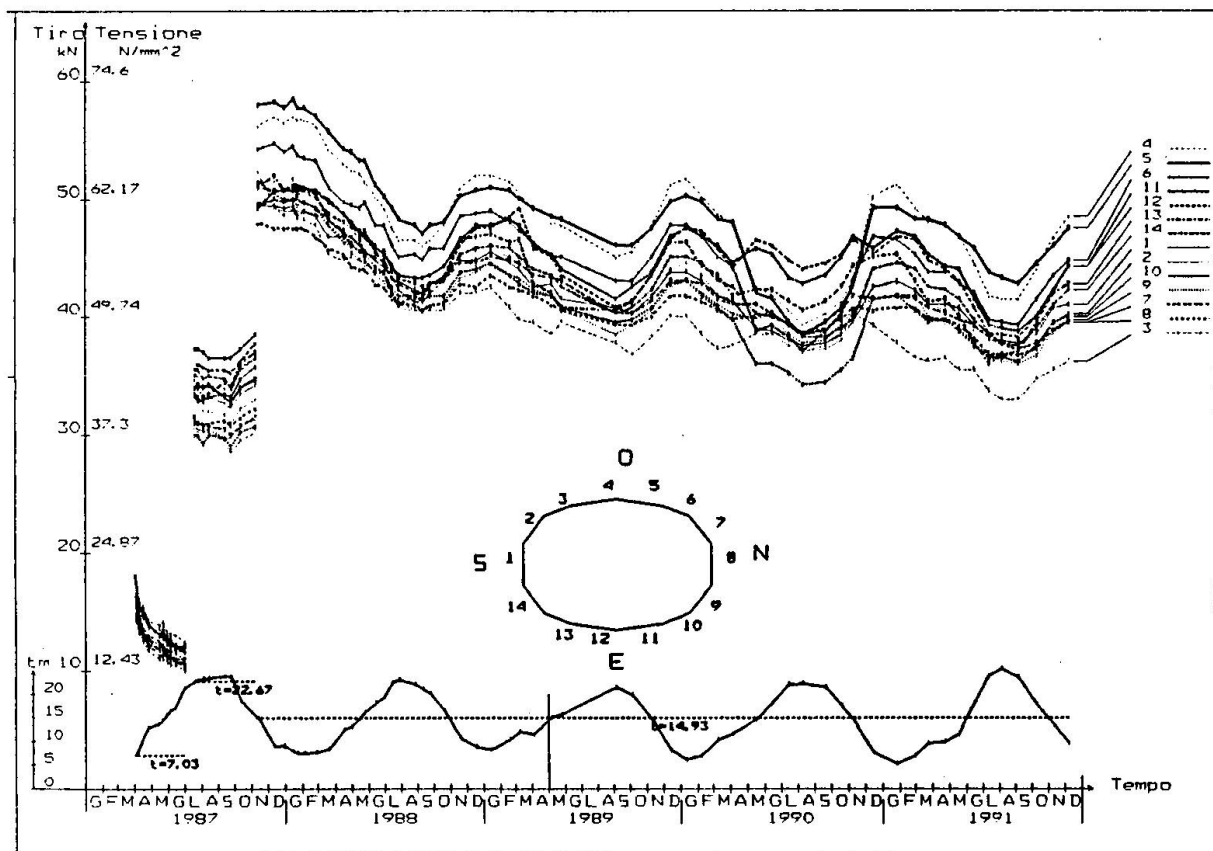
Diagrams of the variation in time of the stresses in the bars over 5 years (as obtained by the monitoring system) have been analysed and a separation between the relaxation of the stresses in the bars (due to plastic flow of the masonry) and parasite stress effects due to the differential thermal dilatation of masonry and steel bars has been tried. Maximum value of mean relaxation of stresses in the 56 tensioning bars has reached the order of 20% of initial values (stress decrease from 50 to 40 KN per bar) in the four years following initial tensioning. (fig.1)

Fig.1 Variation in time of forces and stresses in the post-tensioning ring (mean values of 4 bars for each of the 14 sections of the ring) and variation of inside temperatures.

Correlation of these data with monitored movements of the main cracks of the dome leads to the conclusion of the need for a recalibration of the stress levels in the post-tensioning system to be performed in 1993. The need of more reliable data on the internal temperatures in the dome masonry has led to a program for measuring and monitoring these parameters to be operative also in 1993.

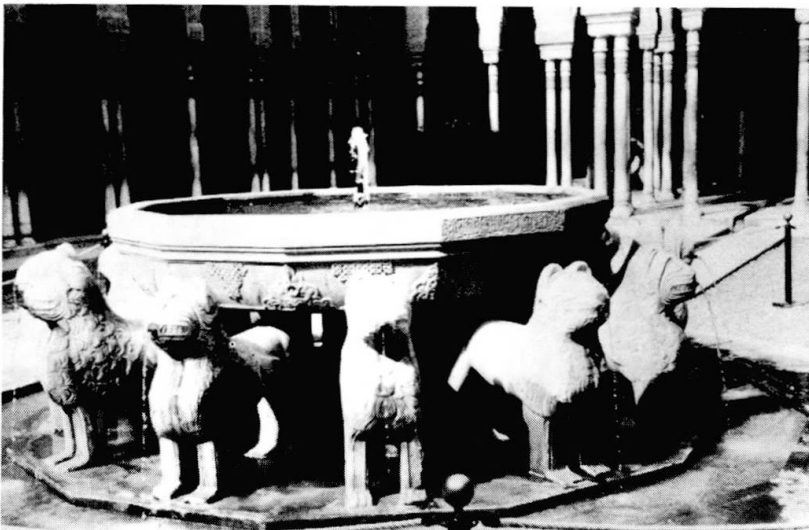
Fig. 1 "Patio de los Leones", Alhambra.

The whole of the Macael marble artifacts, in different structures of the Arab Palaces, show a satisfactory conservation stage, with some exceptions: e.g., colonnades in "Patio de los Leones" (figure 1).

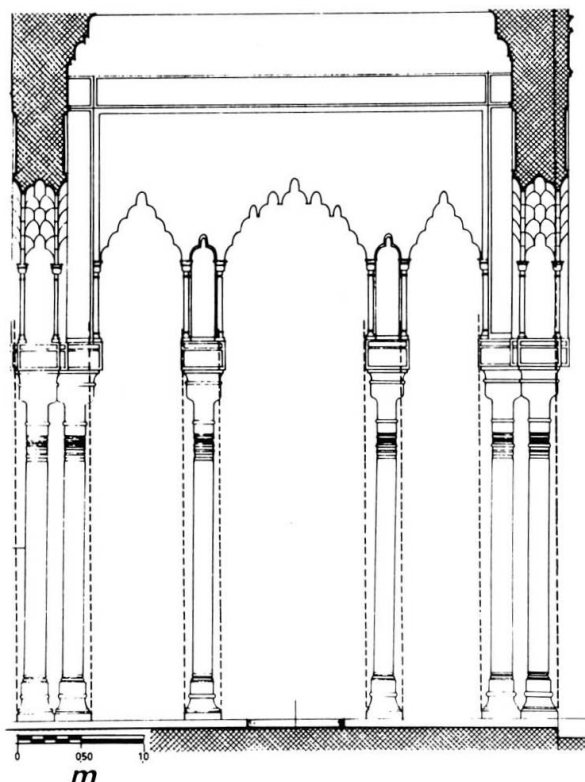
Fig. 2 Static situation, drawn in 1976, for "Templete de los Mocarabes", Court of the Lions.

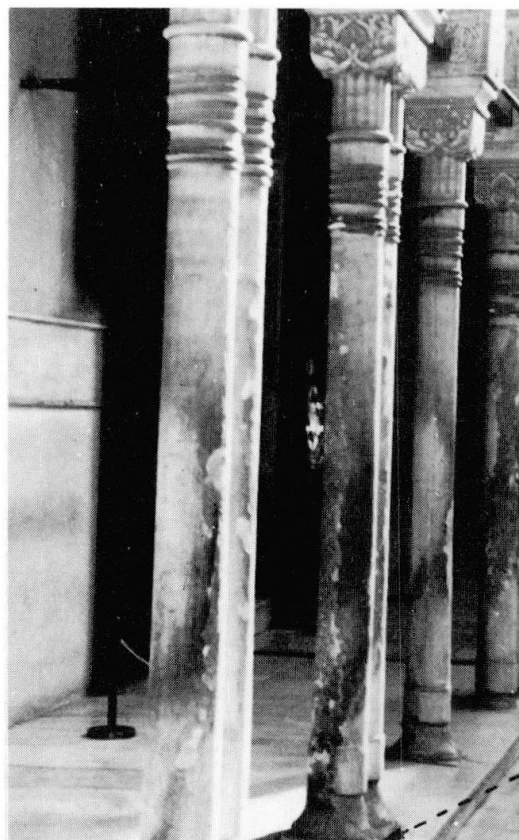
Fig. 3 Progressive reduction in height of bases, and damaged shafts according to mechanical weakness plane.

by direct correlations between the increases of the apparent decay degree and total anisotropy index, measured in marble artifacts. Moreover, this evolution has been related to: a) rotation of the foliation plane, consistent with the shaft placement, influencing the durability of the artifacts under the same exposure conditions; and b) evident displacements of the original static conditions (figure 2), and new signs of differential settlement and plumb-line diversifications in severe damaged shafts, recognized particularly in the "Galeria de Dos Hermanas" colonnade (figure 3).

A convenient control on stability conditions of the colonnades appears useful to found the adequate maintenance interventions, before carrying out replacements of damaged marble artifacts and/or protective treatments.
