**Zeitschrift:** IABSE reports = Rapports AIPC = IVBH Berichte  
**Band:** 71 (1994)

**Artikel:** Experience of cupola collapse with a diameter of 237 m  
**Autor:** Rasha, Jossif / Lubarov, Boris / Jouravlev, Anatoly  
**DOI:** <https://doi.org/10.5169/seals-54158>

## **Experience of Cupola Collapse with a Diameter of 237 m**

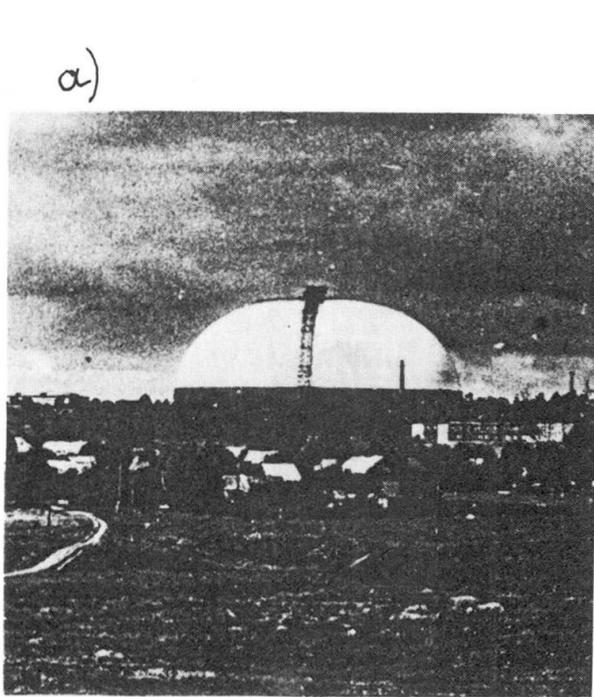
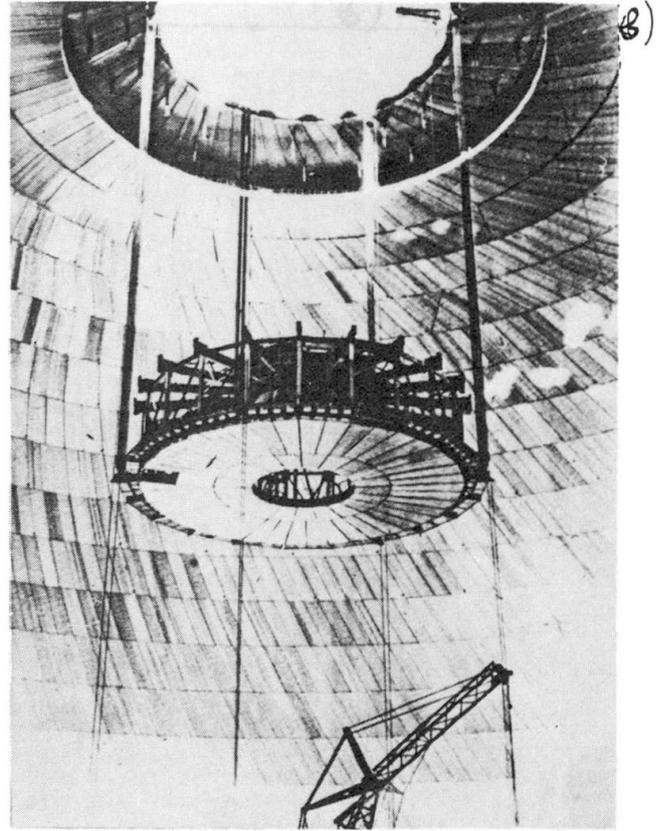
Fig. 3.

The main structures of the dome were erected by the middle of 1984. See Fig.3a. The erection and construction work completed in 1985. The overloaded members were checked for force increment at erection of technological equipment premises 600 tN in weight

In 1986 the dome collapsed. Since it was early morning, there were no victims. Before the collapse took place, the construction site underwent very rare meteorological condition. The air temperature remained  $-20^{\circ}\text{C}$  during 20 days. Then during 6 hours the temperature changed to  $+1^{\circ}\text{C}$ . Three hours after this the dome collapsed.

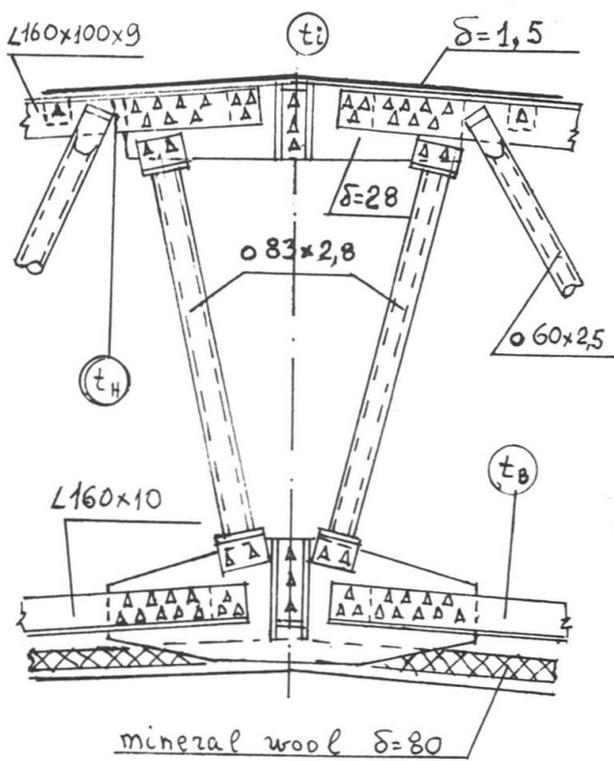
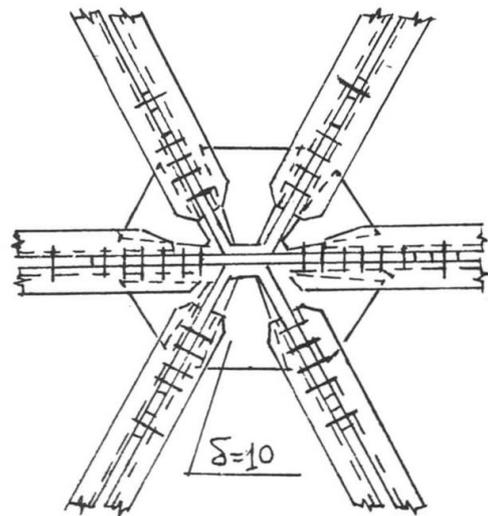
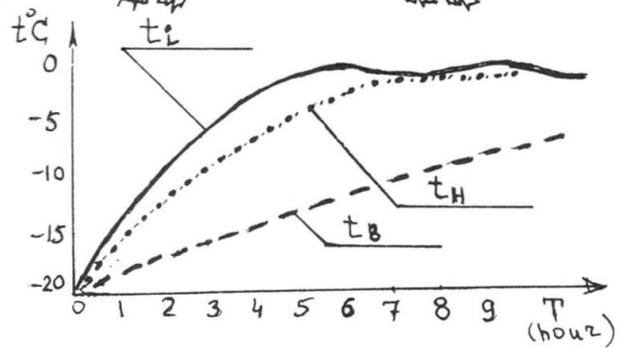
Fig. 4.

Let us analyse what changes happened in the stress conditions of the structures under such a sudden change of air temperature. The space 2.5 m high between the upper chord covered with cold steel sheets and the lower lagged chord turned to something like a thermos with a temperature of  $-20^{\circ}\text{C}$ . The bars of the upper cold chord warmed up faster under the outside sharp heating than the bars of the lagged lower chord - see Fig.4. The difference in temperature of the chords according to the calculations could reach  $15^{\circ}\text{C}$ . Nonuniform heating of one chord to  $1^{\circ}\text{C}$  gave the stress increment to 3 MPa in some of the bars and at  $15^{\circ}\text{C}$  this value made 45 MPa or almost 30% critical strength of the steel. Most probable the additional stresses brought mostly loaded bars to the loss of stability and caused the collapse.

The imperfectly thought-out solution of the enclosing structures resulted in the design diagram in the form of a latticed dome highly sensitive to the nonuniform temperature effect.

1. When designing long-span structures it is necessary to use statistically treated meteorological data on the sharp changes of outdoor air temperature with determination of the temperature change speed and range and probability for 25, 50 and 100 years.
2. It is necessary to perform heat engineering and static calculations for the long-span structures for the stage of construction and operation in sharp condition of air temperature change in the building area.
3. When designing the enclosing structures it is necessary to provide for equal temperature conditions of the load carrying structures.
