**Zeitschrift:** IABSE reports = Rapports AIPC = IVBH Berichte  
**Band:** 73/1/73/2 (1995)

**Artikel:** Reinforced concrete framed building strengthened by prestressing  
**Autor:** Najdanovic, Dusan / Alendar, Vanja  
**DOI:** <https://doi.org/10.5169/seals-55296>

## Reinforced Concrete Framed Building Strengthened by Prestressing

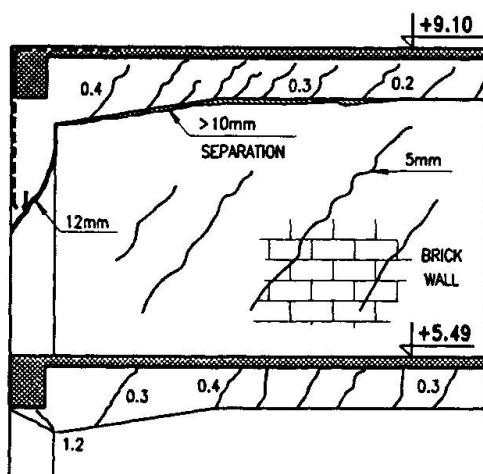
The most outstanding cracks, up to 0.5 mm wide, appeared in the structure beams. In the span cracks spread in vertical direction along the entire depth of the beam, up to the roof slab. Towards the ends of the beams, the cracks gradually incline up to an angle of approximately 60 degrees regarding the horizontal plane, Fig. 2.

Appearance of inclined cracks at the top of the short columns in the top story, up to 12 mm wide, indicates failure of the column, Fig. 2. Due to increased deflections of frame beams, up to 60 mm in case of roof beam (span-deflection ratio 255), the functionality of the structure was violated, specially at the top story: appearance of doors and windows distortion and jamming, discomfort while walking, separation of partition brick walls from frame beams and columns, in some places more than 1 cm which violated their lateral stability as well as functionality of the installations. Excessive deflections of the roof beams caused loss of the draining layer slope and therefore retaining of water on the roof.

Fig. 2 Characteristic detail 'A' of damages

The intensity of columns loading was additionally underestimated, since the stiffness of the beam haunches was not taken into account. As it is common in design of buildings, control of shear strength of columns was not carried out. In case of the third floor 'shallow frame' columns, that was an unacceptable oversight. Inspection of performed column reinforcement details showed that the tensioned reinforcement at the column-roof beam joint was not anchored deep enough into the column, which created conditions of "pulling out" the beam from the column, Fig. 2. At the same time, the lateral reinforcement of the columns is not sufficient to resist developed large shear forces, therefore, failure of column, decrease of rigidity of this story and increase of deformations of roof frame beam occurred.

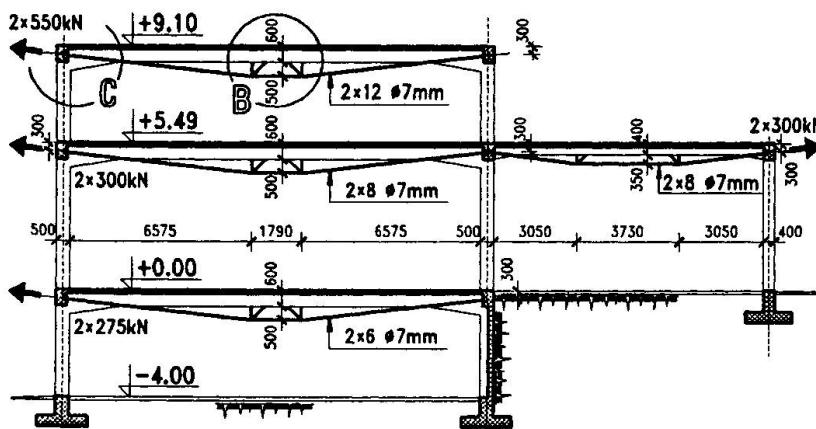
Fig. 3 Tendon layout

two prestressing tendons (6-12) #7, Yugoslav IMS system, conducted below the beams, Fig. 3. Required sag of 500 mm between the tendons and the beam soffit in the main span, and 350 mm in the annex was provided by inserting steel deviators - "chairs", constructed of steel tubes 63.5 mm in diameter, Fig. 4. Deviator verticals are placed in such a way that tendons equivalent forces

Correction of stresses and deformations of the structure as a whole was performed by shoring each frame beam with

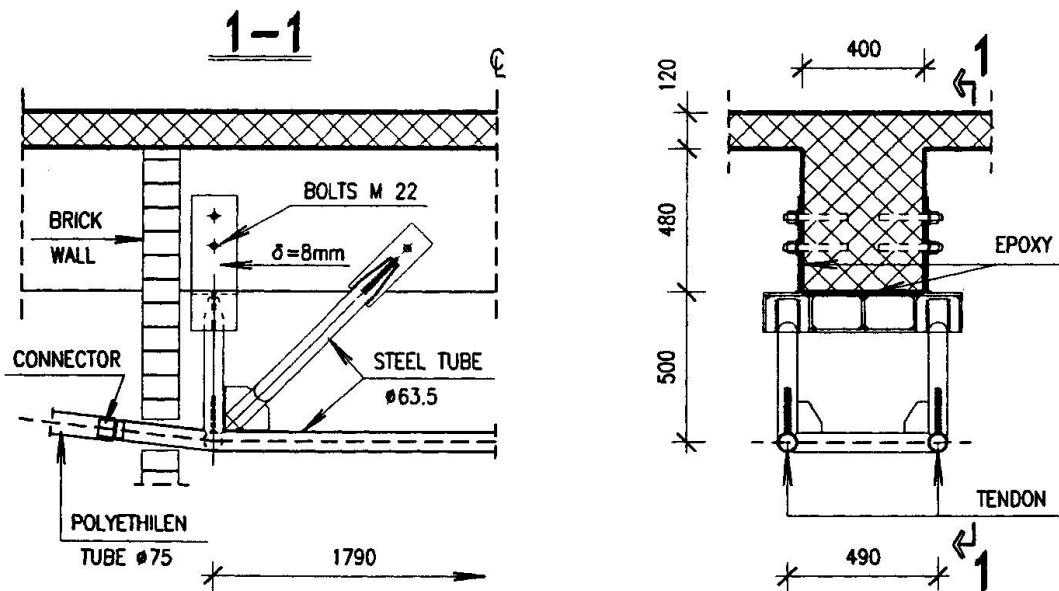
Fig. 4 Deviator detail 'B'

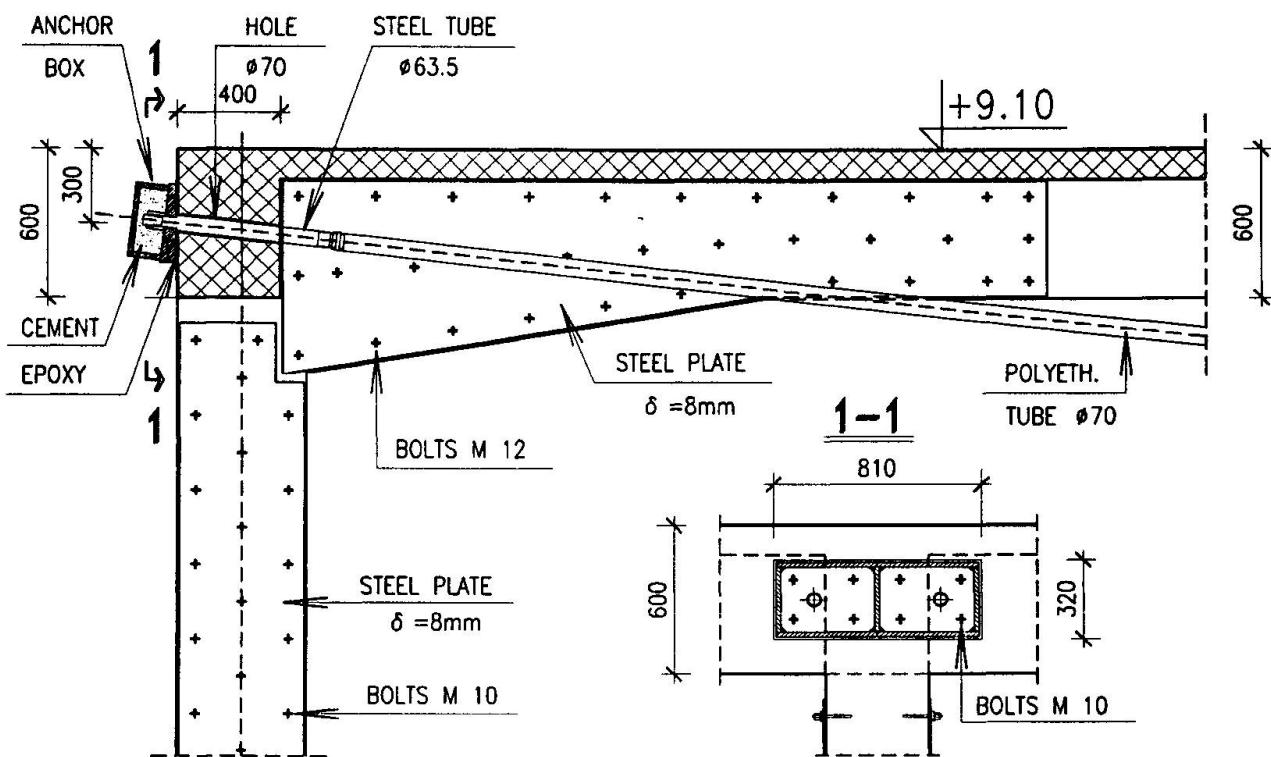
Fig. 5 Detail 'C' of tendon anchoring and lateral strengthening with steel sheets

external side of the columns, Fig. 5. At straight segments the tendons are performed through polyethilen tubes, which are connected to steel elements after tensioning the tendons. Tubes and anchor boxes are injected with cement emulsion.

Before tensioning of the tendons, injecting of cracks and local strengthening of beam and column ultimate shear capacity was carried out by well experienced method of glueing steel sheets onto lateral sides, by glue on the basis of low viscosity epoxy raisins with addition of filler [1]. Firm contact and glue spreading was achieved by bolts, Fig. 5.

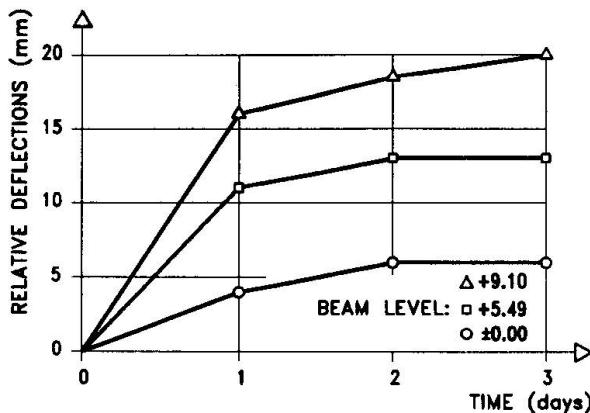
**Fig. 6 - Stabilization of deflection in course of time**

Results of performed measurements show good correspondence between measured and calculated relative deflections, with average stabilization time of three days following tensioning, Fig. 6. Measured values of change in strains of steel elements indicate well spreading of prestressing force, with expected level of friction, as well as that glued lateral steel sheets become activated.
