**Artikel:** Reinforced concrete framed building strengthened by prestressing  
**Autor:** Najdanovic, Dusan / Alendar, Vanja  
**DOI:** <https://doi.org/10.5169/seals-55296>

## Reinforced Concrete Framed Building Strengthened by Prestressing

Administration building within an industrial complex in Arandjelovac, Yugoslavia, was constructed in 1978. During construction, and very soon after the building was furnished, appearance of cracks and appreciable deformations of the structure was noted. The condition of the building got worst in course of time, caused fear and uncertainty, until the owner has decided to call for help.

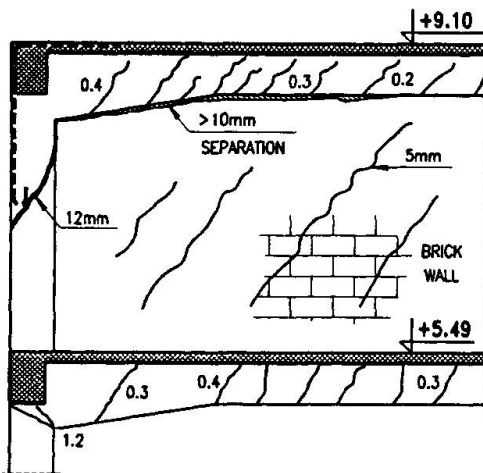
**Fig. 2** Characteristic detail 'A' of damages

The most outstanding cracks, up to 0.5 mm wide, appeared in the structure beams. In the span cracks spread in vertical direction along the entire depth of the beam, up to the roof slab. Towards the ends of the beams, the cracks gradually incline up to an angle of approximately 60 degrees regarding the horizontal plane, Fig. 2.

Appearance of inclined cracks at the top of the short columns in the top story, up to 12 mm wide, indicates failure of the column, Fig. 2. Due to increased deflections of frame beams, up to 60 mm in case of roof beam (span-deflection ratio 255), the functionality of the structure was violated, specially at the top story: appearance of doors and windows distortion and jamming, discomfort while walking, separation of partition brick walls from frame beams and columns, in some places more than 1 cm which violated their lateral stability as well as functionality of the installations. Excessive deflections of the roof beams caused loss of the draining layer slope and therefore retaining of water on the roof.

Subsequent structural analysis showed that, due to omission in load estimation and pattern, safety coefficients regarding the ultimate limit state in the large part of the structure are considerably smaller than required, and that the cross-sections are under-reinforced. For example, original structural analysis was carried out with assumption of uniformly distributed load, which underestimated "concentrated" effect of load from partition brick walls 120 mm thick, which are perpendicular to transverse frames in the corridor zone, Fig. 1. During service of the building, permissible tensile stresses in reinforcement in a large number of beam and column sections were exceeded, and notable cracks and deformations appeared.

The intensity of columns loading was additionally underestimated, since the stiffness of the beam haunches was not taken into account. As it is common in design of buildings, control of shear strength of columns was not carried out. In case of the third floor 'shallow frame' columns, that was an unacceptable oversight. Inspection of performed column reinforcement details showed that the tensioned reinforcement at the column-roof beam joint was not anchored deep enough into the column, which created conditions of "pulling out" the beam from the column, Fig. 2. At the same time, the lateral reinforcement of the columns is not sufficient to resist developed large shear forces, therefore, failure of column, decrease of rigidity of this story and increase of deformations of roof frame beam occurred.

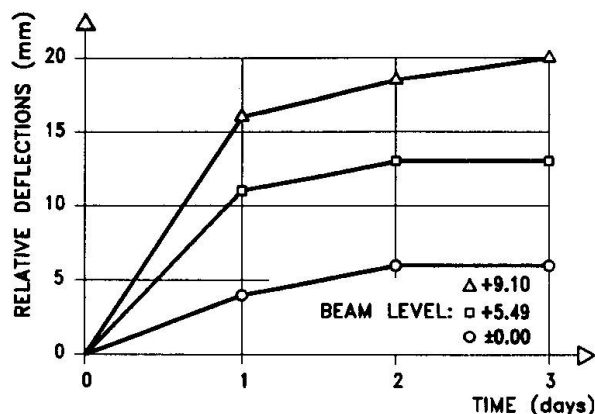
Fig. 6 - Stabilization of deflection in course of time

Results of performed measurements show good correspondence between measured and calculated relative deflections, with average stabilization time of three days following tensioning, Fig. 6. Measured values of change in strains of steel elements indicate well spreading of prestressing force, with expected level of friction, as well as that glued lateral steel sheets become activated.
