Repair of Precast, Prestressed Bridge Beams Using External Prestressing

Andreas B.R. KERKOVIOUS

Stewart Scott Inc.
Pretoria, South Africa

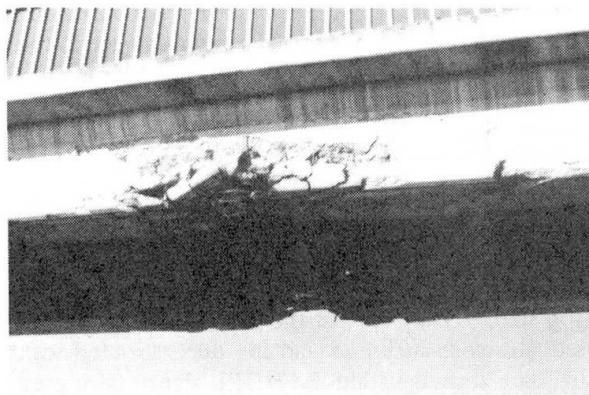
The beams of the western span were severely damaged between the $\frac{1}{4}$ and $\frac{1}{3}$ span position approximately halfway between transverse diaphragms by a transported excavator whose boom was too high to pass under the bridge. The boom struck the bottom flanges of both beams and the impact shattered the concrete exposing the reinforcement and the prestressing ducts and strands, and sections of the webs. The reinforcement was completely sheared and some strands of the lower prestress tendons of both beams were severed or damaged at the impact area, (Photo 1). The prestress effect on the concrete in the damaged area was lost, but the span was in no immediate danger of collapse. Since both beams were damaged to a similar extent, a simple longitudinal strut and tie system prevailed with no transverse redistribution of loads.

The nominal reinforcement in the beams for the two bridges was very different and the pattern of damage to the beams was different as can be seen on Photos 1 & 2. It is difficult to ascribe the form of the damage to the impact object or to the reinforcement containment. It is felt that the amount of reinforcement present and the bar spacing play a significant role in containing the damage. Nevertheless, the nature of the damage was very similar. The bottom flange was shattered between the transverse diaphragm beams. An elliptical shaped zone of the web was either shattered or displaced with heavy shear and torsion cracking extending to the underside of the top flange. Reflective impact spalling on the far face of the beam resulted in more extensive damage than on the impact face. The lateral resistance of the bottom compression flange is very low and it is clearly demonstrated that the transverse diaphragms play a very positive role of limiting the damage to the area between adjacent diaphragms.

Photo 1 : Damage to Seventh Ave

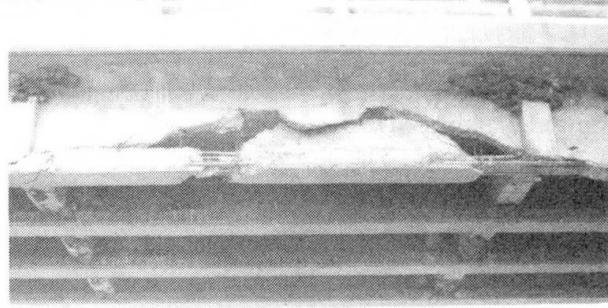
The western outer edge beam of the southern span was severely damaged between the $\frac{1}{4}$ and $\frac{1}{2}$ span transverse diaphragms by a tipper truck whose tipper pan was raised during travel. The tipper pan struck the bottom flange of the edge beam and the lateral impact caused a block type shearing failure exposing the reinforcement and the prestress ducts at discrete locations and displacing sections of the bottom flange and the web, (Photo 2). The prestress effect on the concrete in the damaged area was lost, however the span was in no danger of collapse as redistribution of load could take place via the transverse diaphragms to the adjacent undamaged beams.

Photo 2 : Damage to Candy Cornelia

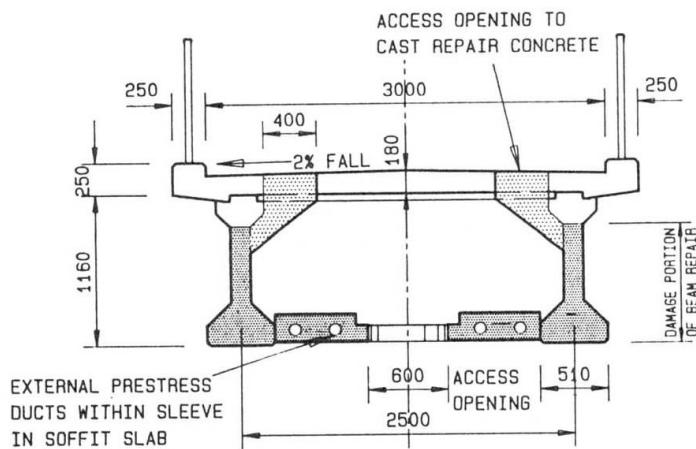
The bridge consists of simply supported decks supported on single column piers with stairs at either end. Each deck comprises two precast, prestressed concrete I-beams with a composite in situ reinforced concrete top slab spanning 20,73 m over a carriageway. The precast beams are 1160 mm deep spaced at 2,35 m and the slab is up to 180 mm thick. The deck cross section is illustrated in Figure 1 which also shows the repair detail.

Figure 1 : Seventh Ave deck section indicating beam repair

The damaged beam sections between the diaphragms were removed to vertical faces at the ends and to a horizontal line following the web/top flange bulb junction. The concrete was carefully chipped away to prevent damage to the embedded reinforcement and prestressing ducts. New reinforcement was fixed and the beam formwork placed.

The flowable micro-concrete was batched and mixed on top of the deck and placed through carefully located access openings in the top slab to ensure complete filling of the voids. Light surface vibration on the outside of the formwork was applied to assist the flow and self-compaction of the micro-concrete, especially at the contact surfaces of existing concrete. The access openings were sealed with the last batch. The formwork was kept in place for 7 days for the initial curing of the micro-concrete.

The anchors were cast into a new anchor block just below the top slab, bearing against the exposed slab edge and the transverse diaphragm. The prestress tendons were installed, stressed, anchored and the ducts grouted with cementitious grout. External tendons comprising 7/12,9 mm dia. bare strands within the HDPE sleeve were used and no special provisions were made for monitoring or adjustments. The deviators were located at the diaphragm beams adjacent to the repaired beam sections. The tendon profile followed straightline segments between anchors and deviators.

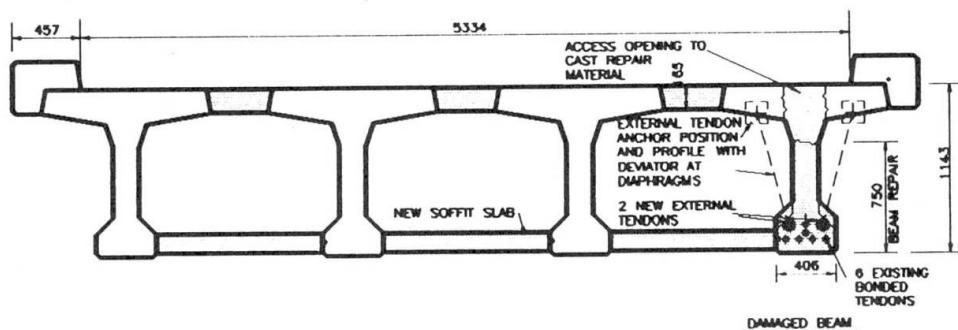
The bridge consists of simply supported decks supported on wall type piers. Each deck comprises four precast, prestressed concrete T-beams with a composite in situ reinforced concrete top link slab spanning 21,2 m over a carriageway. The precast beams are 1143 mm deep spaced at 1,524 m, and the slab is up to 165 mm thick. The deck cross-section is illustrated in Figure 2 which also shows the repair detail.

Figure 2 : Candy Cornelia deck section indicating beam repair

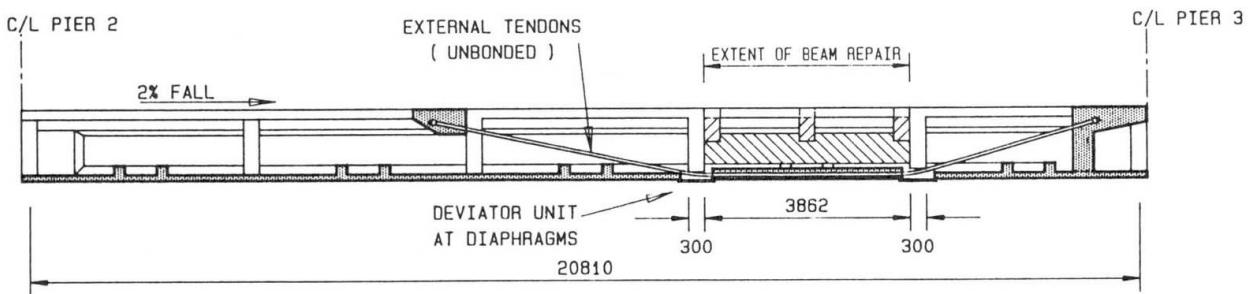
Figure 3 : Typical elevation of beam reconstruction (Seventh Ave)
