**Artikel:** Repair of precast, prestressed bridge beams using external prestressing  
**Autor:** Kerkovius, Andreas B.R.  
**DOI:** <https://doi.org/10.5169/seals-55298>

## **Repair of Precast, Prestressed Bridge Beams Using External Prestressing**

**Andreas B.R. KERKOVIVUS**  
Associate  
Stewart Scott Inc.  
Pretoria, South Africa

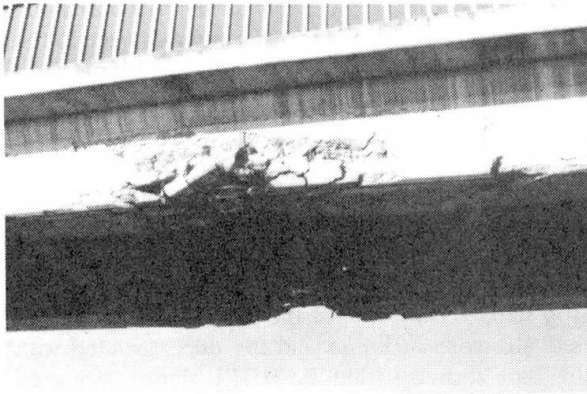
The beams of the western span were severely damaged between the  $\frac{1}{4}$  and  $\frac{1}{2}$  span position approximately halfway between transverse diaphragms by a transported excavator whose boom was too high to pass under the bridge. The boom struck the bottom flanges of both beams and the impact shattered the concrete exposing the reinforcement and the prestressing ducts and strands, and sections of the webs. The reinforcement was completely sheared and some strands of the lower prestress tendons of both beams were severed or damaged at the impact area, (Photo 1). The prestress effect on the concrete in the damaged area was lost, but the span was in no immediate danger of collapse. Since both beams were damaged to a similar extent, a simple longitudinal strut and tie system prevailed with no transverse redistribution of loads.

The nominal reinforcement in the beams for the two bridges was very different and the pattern of damage to the beams was different as can be seen on Photos 1 & 2. It is difficult to ascribe the form of the damage to the impact object or to the reinforcement containment. It is felt that the amount of reinforcement present and the bar spacing play a significant role in containing the damage. Nevertheless, the nature of the damage was very similar. The bottom flange was shattered between the transverse diaphragm beams. An elliptical shaped zone of the web was either shattered or displaced with heavy shear and torsion cracking extending to the underside of the top flange. Reflective impact spalling on the far face of the beam resulted in more extensive damage than on the impact face. The lateral resistance of the bottom compression flange is very low and it is clearly demonstrated that the transverse diaphragms play a very positive role of limiting the damage to the area between adjacent diaphragms.

Photo 1 : Damage to Seventh Ave

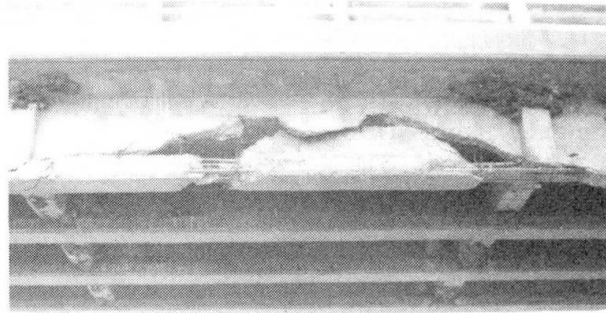
The western outer edge beam of the southern span was severely damaged between the  $\frac{1}{4}$  and  $\frac{1}{2}$  span transverse diaphragms by a tipper truck whose tipper pan was raised during travel. The tipper pan struck the bottom flange of the edge beam and the lateral impact caused a block type shearing failure exposing the reinforcement and the prestress ducts at discrete locations and displacing sections of the bottom flange and the web, (Photo 2). The prestress effect on the concrete in the damaged area was lost, however the span was in no danger of collapse as redistribution of load could take place via the transverse diaphragms to the adjacent undamaged beams.

Photo 2 : Damage to Candy Cornelia

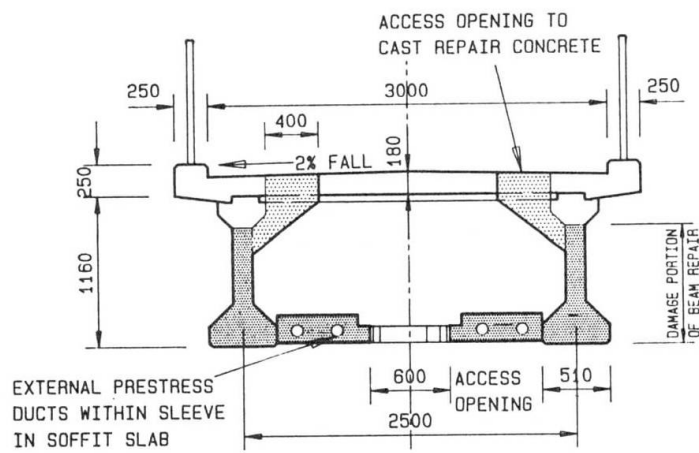
The bridge consists of simply supported decks supported on single column piers with stairs at either end. Each deck comprises two precast, prestressed concrete I-beams with a composite in situ reinforced concrete top slab spanning 20,73 m over a carriageway. The precast beams are 1160 mm deep spaced at 2,35 m and the slab is up to 180 mm thick. The deck cross section is illustrated in Figure 1 which also shows the repair detail.

Figure 1 : Seventh Ave deck section indicating beam repair

The repair of the beams to their original load carrying capacities centred around the use of high strength, shrinkage compensating micro-concrete and external unbonded prestress tendons. The accommodation of the anchors and the deviators, and the force transfer into the structure required careful evaluation of the load paths and details to ensure that the structural action could be accommodated.

The anchors were cast into a new anchor block just below the top slab, bearing against the exposed slab edge and the transverse diaphragm. The prestress tendons were installed, stressed, anchored and the ducts grouted with cementitious grout. External tendons comprising 7/12,9 mm dia. bare strands within the HDPE sleeve were used and no special provisions were made for monitoring or adjustments. The deviators were located at the diaphragm beams adjacent to the repaired beam sections. The tendon profile followed straightline segments between anchors and deviators.

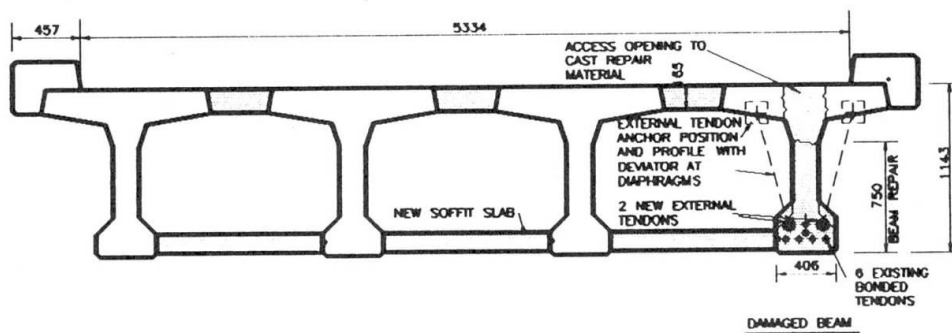
The bridge consists of simply supported decks supported on wall type piers. Each deck comprises four precast, prestressed concrete T-beams with a composite in situ reinforced concrete top link slab spanning 21,2 m over a carriageway. The precast beams are 1143 mm deep spaced at 1,524 m, and the slab is up to 165 mm thick. The deck cross-section is illustrated in Figure 2 which also shows the repair detail.

Figure 2 : Candy Cornelia deck section indicating beam repair

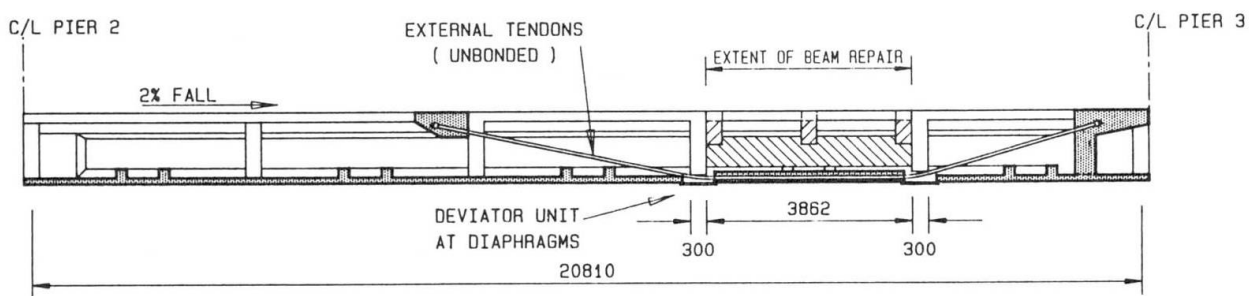
Figure 3 : Typical elevation of beam reconstruction (Seventh Ave)

The damaged beam sections between the diaphragms were removed to vertical faces at the ends and to a horizontal line following the web/top flange bulb junction. The concrete was carefully chipped away to prevent damage to the embedded reinforcement and prestressing ducts. New reinforcement was fixed and the beam formwork placed.

The flowable micro-concrete was batched and mixed on top of the deck and placed through carefully located access openings in the top slab to ensure complete filling of the voids. Light surface vibration on the outside of the formwork was applied to assist the flow and self-compaction of the micro-concrete, especially at the contact surfaces of existing concrete. The access openings were sealed with the last batch. The formwork was kept in place for 7 days for the initial curing of the micro-concrete.
