Artikel: Repair of precast, prestressed bridge beams using external prestressing
Autor: Kerkovius, Andreas B.R.
DOI: <https://doi.org/10.5169/seals-55298>

Repair of Precast, Prestressed Bridge Beams Using External Prestressing

Andreas B.R. KERKOVIVUS
Associate
Stewart Scott Inc.
Pretoria, South Africa

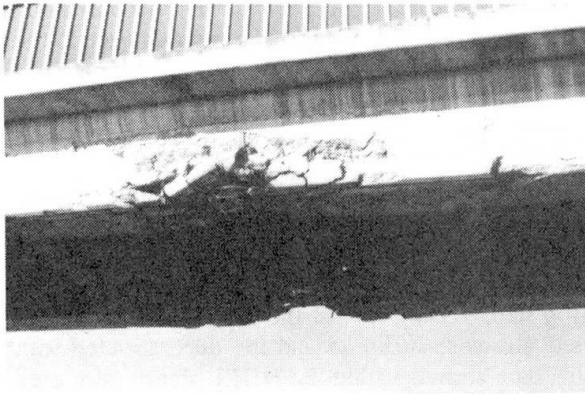
The beams of the western span were severely damaged between the $\frac{1}{4}$ and $\frac{1}{2}$ span position approximately halfway between transverse diaphragms by a transported excavator whose boom was too high to pass under the bridge. The boom struck the bottom flanges of both beams and the impact shattered the concrete exposing the reinforcement and the prestressing ducts and strands, and sections of the webs. The reinforcement was completely sheared and some strands of the lower prestress tendons of both beams were severed or damaged at the impact area, (Photo 1). The prestress effect on the concrete in the damaged area was lost, but the span was in no immediate danger of collapse. Since both beams were damaged to a similar extent, a simple longitudinal strut and tie system prevailed with no transverse redistribution of loads.

The nominal reinforcement in the beams for the two bridges was very different and the pattern of damage to the beams was different as can be seen on Photos 1 & 2. It is difficult to ascribe the form of the damage to the impact object or to the reinforcement containment. It is felt that the amount of reinforcement present and the bar spacing play a significant role in containing the damage. Nevertheless, the nature of the damage was very similar. The bottom flange was shattered between the transverse diaphragm beams. An elliptical shaped zone of the web was either shattered or displaced with heavy shear and torsion cracking extending to the underside of the top flange. Reflective impact spalling on the far face of the beam resulted in more extensive damage than on the impact face. The lateral resistance of the bottom compression flange is very low and it is clearly demonstrated that the transverse diaphragms play a very positive role of limiting the damage to the area between adjacent diaphragms.

Photo 1 : Damage to Seventh Ave

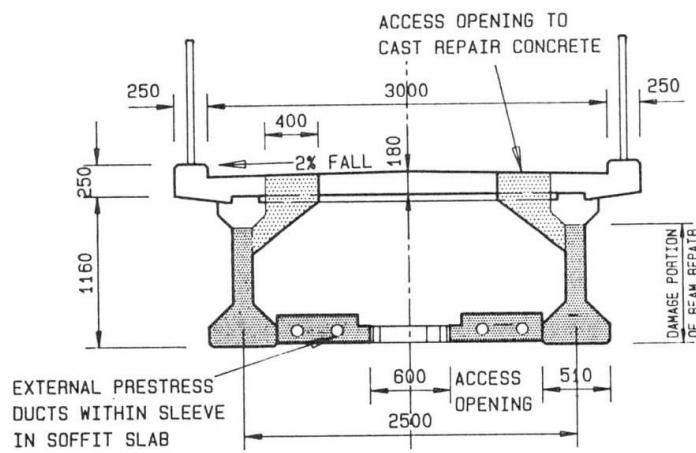
The bridge consists of simply supported decks supported on single column piers with stairs at either end. Each deck comprises two precast, prestressed concrete I-beams with a composite in situ reinforced concrete top slab spanning 20,73 m over a carriageway. The precast beams are 1160 mm deep spaced at 2,35 m and the slab is up to 180 mm thick. The deck cross section is illustrated in Figure 1 which also shows the repair detail.

Figure 1 : Seventh Ave deck section indicating beam repair

The damaged beam sections between the diaphragms were removed to vertical faces at the ends and to a horizontal line following the web/top flange bulb junction. The concrete was carefully chipped away to prevent damage to the embedded reinforcement and prestressing ducts. New reinforcement was fixed and the beam formwork placed.

The flowable micro-concrete was batched and mixed on top of the deck and placed through carefully located access openings in the top slab to ensure complete filling of the voids. Light surface vibration on the outside of the formwork was applied to assist the flow and self-compaction of the micro-concrete, especially at the contact surfaces of existing concrete. The access openings were sealed with the last batch. The formwork was kept in place for 7 days for the initial curing of the micro-concrete.

The anchors were cast into a new anchor block just below the top slab, bearing against the exposed slab edge and the transverse diaphragm. The prestress tendons were installed, stressed, anchored and the ducts grouted with cementitious grout. External tendons comprising 7/12,9 mm dia. bare strands within the HDPE sleeve were used and no special provisions were made for monitoring or adjustments. The deviators were located at the diaphragm beams adjacent to the repaired beam sections. The tendon profile followed straightline segments between anchors and deviators.

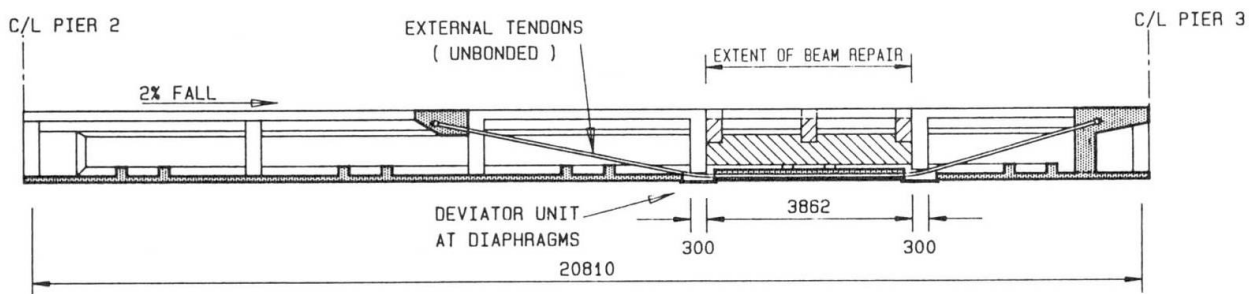
Figure 3 : Typical elevation of beam reconstruction (Seventh Ave)

Certain of the cracks in the bottom flange and webs of the beams extending past the area of reconstruction were carefully injected with low viscosity epoxy resin to reinstate the material integrity.
