Zeitschrift: IABSE reports = Rapports AIPC = IVBH Berichte
Band: 73/1/73/2 (1995)

Artikel: Rehabilitation of the Gardiner Expressway, Toronto, Canada
Autor: Li, Edward K. / Woodman, Carl W.
DOI: <https://doi.org/10.5169/seals-55166>

Rehabilitation of the Gardiner Expressway, Toronto, Canada

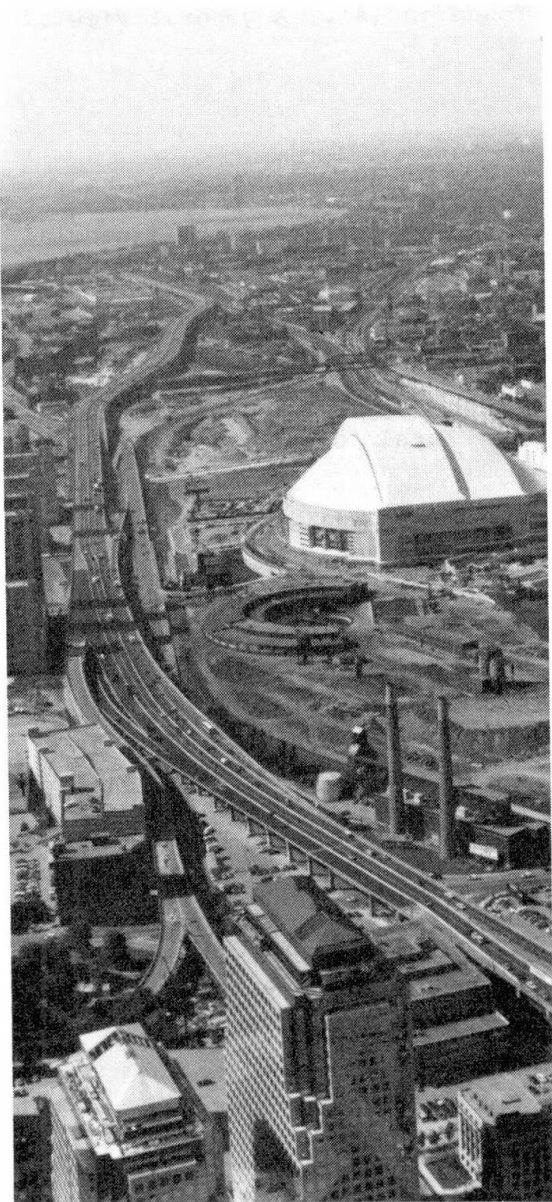
Figure 1
The F.G. Gardiner Expressway
Toronto, Ontario, Canada

1.1 The F.G. Gardiner Expressway in Toronto located on the north shore of Lake Ontario was built in the early sixties. Figure 1 shows a bird's eye view of the elevated portion of the Expressway. The most prominent feature of the 14 km long Expressway is an 8 km elevated roadway, composing of mainly simply supported spans resting on concrete bents. A 6.2 km length of this elevated roadway carrying a major portion of the traffic became the centre of the subsequent rehabilitation study. The main deck of this section was made up of 507 spans with a total deck area of 240,000 square metres. These spans were principally concrete slabs on steel I-girders (79%), concrete overlay on prestressed concrete box girders (16%), or in-situ concrete slab and beams (5%). An expansion joint was generally located at every supporting bent.

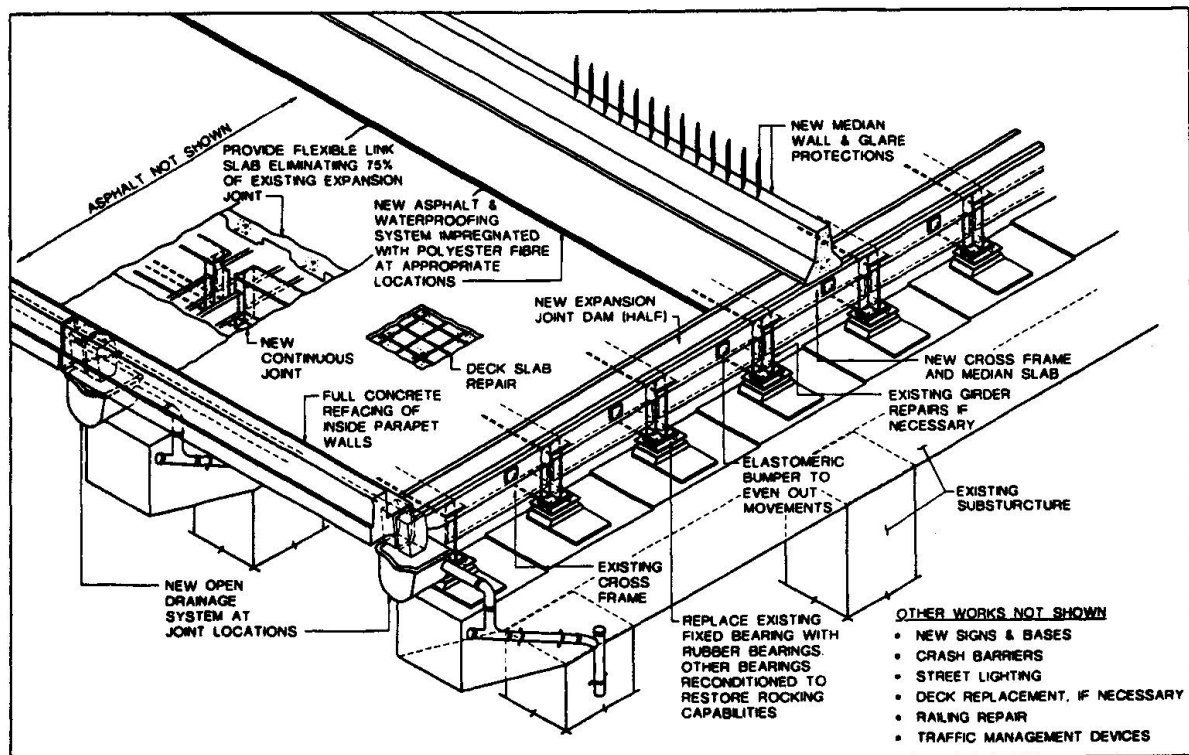
Figure 2 - General Deck Rehabilitation Scheme

3.5 Some of the above design details can be found in [4]. A general view of the repair scheme is shown in Figure 2.

3.2 To accomplish this, it was decided to minimize the number of existing joints. The longitudinal joint between the twin bridges was replaced with a concrete slab and additional cross-frames, essentially tying the 2 bridges together. Three out of four existing expansion joints were eliminated by making the deck continuous for a number of spans. The tying of originally simply supported spans required complete revamping of the bridge articulation system, by providing new bearings and expansion joints. Thermal movements of the tied deck were accommodated by flexing of the supporting bents, while ensuring that the existing fixed bearings would be strong enough to withstand such movements. The tying method chosen was called the "flexible link", which consisted of a thin and highly reinforced concrete slab. This link allowed the connecting spans to continue to behave as simply supported spans, with the end rotations due to traffic loading being accommodated by the flexing action of the link. A more detail description of the link slab can be found in [4]. Such re-arrangement of structural layout in rehabilitation projects was the first designed and built in Canada. All remaining expansion joints were replaced with joints incorporating readily replaceable seals with steel armouring.

1. Repairing damaged deck and parapet areas, by patching and refacing;
2. Incorporating a new bituminous waterproofing layer and asphalt surface;
3. Reconditioning bearings to re-activate their movement capabilities.
