Zeitschrift: IABSE reports = Rapports AIPC = IVBH Berichte
Band: 73/1/73/2 (1995)

Artikel: Rehabilitation of the Gardiner Expressway, Toronto, Canada
Autor: Li, Edward K. / Woodman, Carl W.
DOI: <https://doi.org/10.5169/seals-55166>

Rehabilitation of the Gardiner Expressway, Toronto, Canada

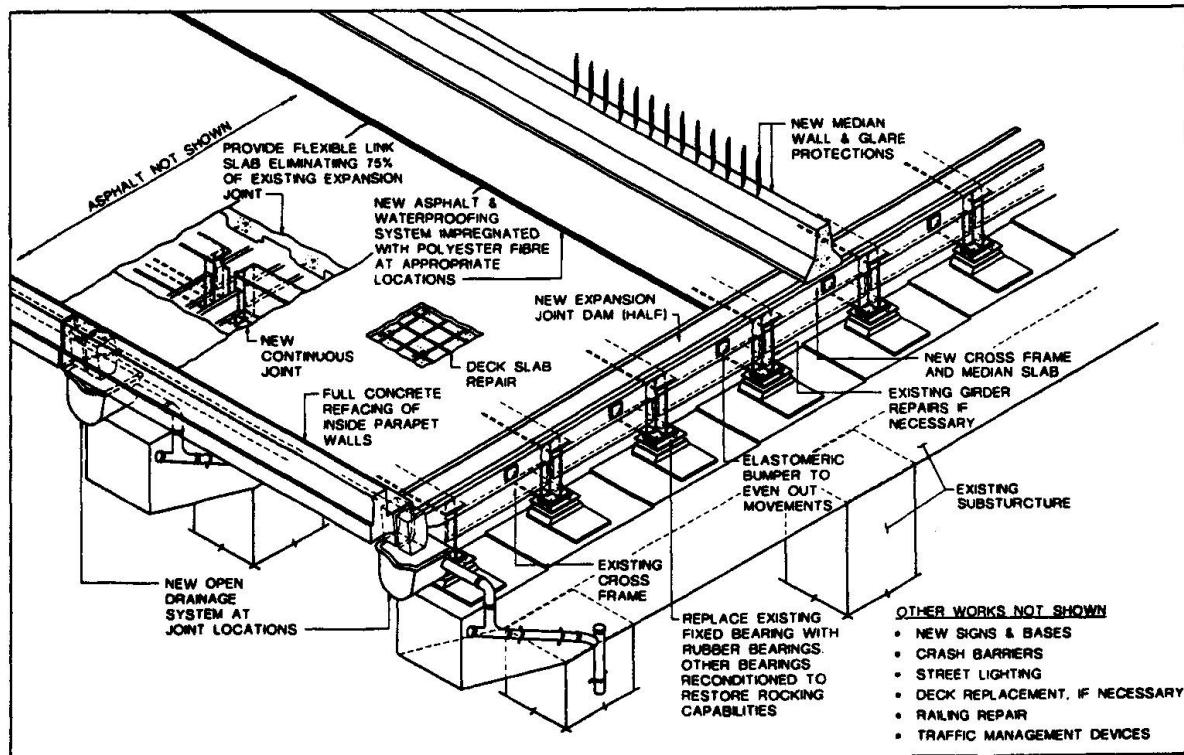
Figure 2 - General Deck Rehabilitation Scheme

3.5 Some of the above design details can be found in [4]. A general view of the repair scheme is shown in Figure 2.

3.2 To accomplish this, it was decided to minimize the number of existing joints. The longitudinal joint between the twin bridges was replaced with a concrete slab and additional cross-frames, essentially tying the 2 bridges together. Three out of four existing expansion joints were eliminated by making the deck continuous for a number of spans. The tying of originally simply supported spans required complete revamping of the bridge articulation system, by providing new bearings and expansion joints. Thermal movements of the tied deck were accommodated by flexing of the supporting bents, while ensuring that the existing fixed bearings would be strong enough to withstand such movements. The tying method chosen was called the "flexible link", which consisted of a thin and highly reinforced concrete slab. This link allowed the connecting spans to continue to behave as simply supported spans, with the end rotations due to traffic loading being accommodated by the flexing action of the link. A more detail description of the link slab can be found in [4]. Such rearrangement of structural layout in rehabilitation projects was the first designed and built in Canada. All remaining expansion joints were replaced with joints incorporating readily replaceable seals with steel armouring.

3.3 An innovative "flood-free" drainage system was devised. The system utilized a fibre-glass hopper mounted on either the girders or the supporting bents. The hopper collected silt and allowed sediment-free water to enter the main drainage network. The inlet was designed to discharge water as quickly as possible and to accommodate a "vacall" type hose for the periodic removal of silt. At those times when the hopper was filled with silt, water could still drain off the deck by overflowing at the hopper.

1. Repairing damaged deck and parapet areas, by patching and refacing;
2. Incorporating a new bituminous waterproofing layer and asphalt surface;
3. Reconditioning bearings to re-activate their movement capabilities.
