Survey on Fatigue Damage in Steel Railway Bridges in Thailand
Dommages par fatigue de ponts ferroviaires métalliques en Thaïlande
Ermüdungsschäden an Stahleisenbahnbrücken in Thailand

Thongpan THAVEE
Director
The State Railway of Thailand
Bangkok, Thailand

The results of the survey of fatigue damage of steel bridges of the State Railway of Thailand are presented. An investigation of the characteristic and the cause of cracks occurring in the welds of stringer necks of through girder bridges was conducted.

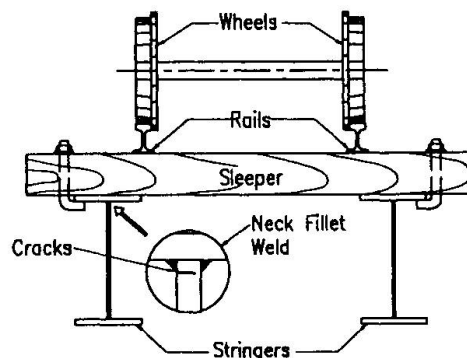
Fig.1 Wheels, track and stringer

The arrangement of stringers and the track and positions where fatigue cracks have occurred are shown in Fig.1. (the same figure used in bibliography 1)

stringer end (some coming from the corner of the notch)

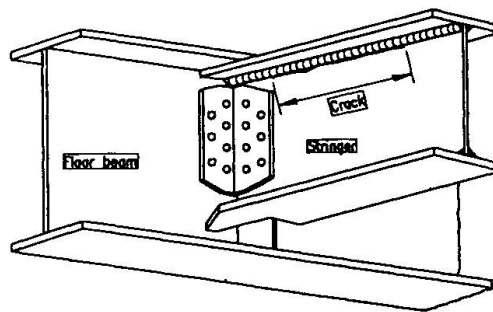
Fig.2 Crack occurring just under the sleeper

Fig.2 shows a crack developing about 700 mm horizontally along the toe on the weld between upper flange and web of stringer (we called "the neck's weld") just under the sleeper. It had, however, not reached the beam's end of the stringer.

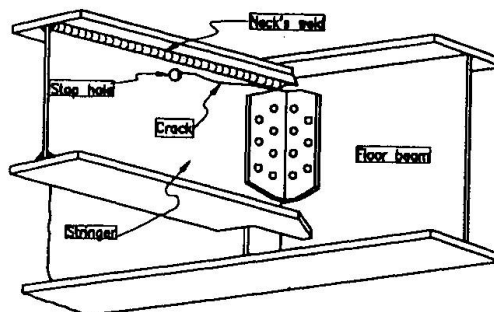
Fig.3 Crack occurring in the beam end

Fig.3 shows a crack occurring in the beam end of a stringer advancing horizontally on the web along the bead toe. At this position, a stop hole is provided at the end of the crack, and found effective to some extent.

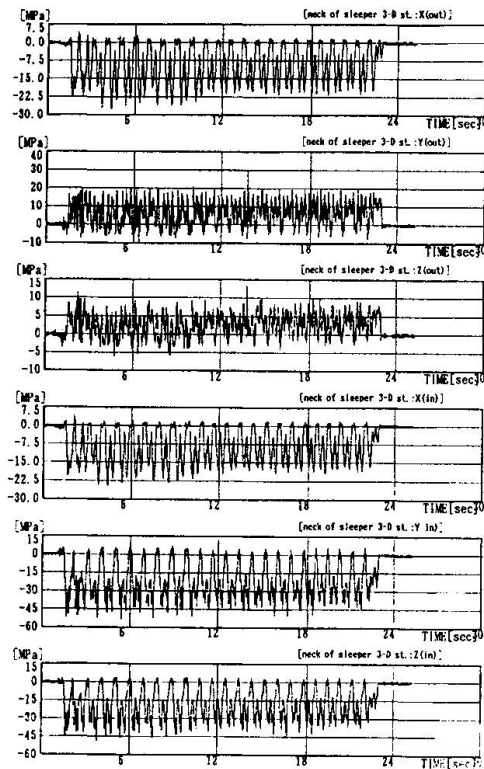
Fig.8 Stress in front and back of the neck just under the sleeper

- (1) Stress in the neck of the stringer just under the sleeper. Measurements were made for ALSTHOM (the sleeper is touching the top flange). Fig. 8 shows three-component stress for the front and the back faces.

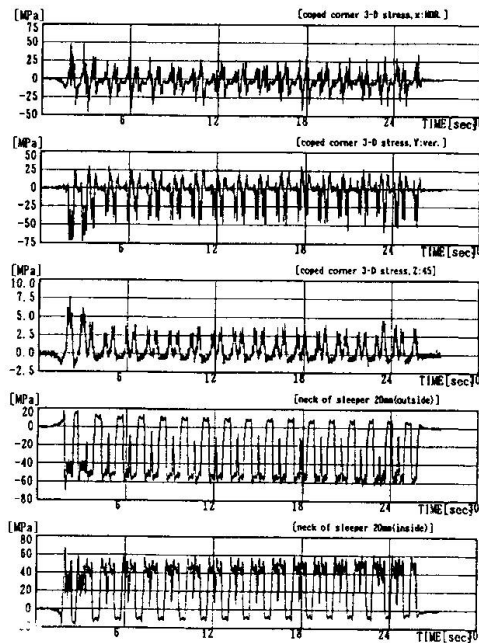
Fig.9 Triaxial stress in the girder end notch and vertical stress of the web

- (2) Stress in the coped corner notch in the stringer end
The train for which measurements were made was new-HITACHI whose axle load is the greatest this line. (The liner plate was inserted just under the sleeper only in the halfway.)
In Fig.9, the upper three waveforms show triaxial stress in the girder end notch, and the lower two waveforms show vertical stress in the front and the back of the web in the halfway of the stringer.

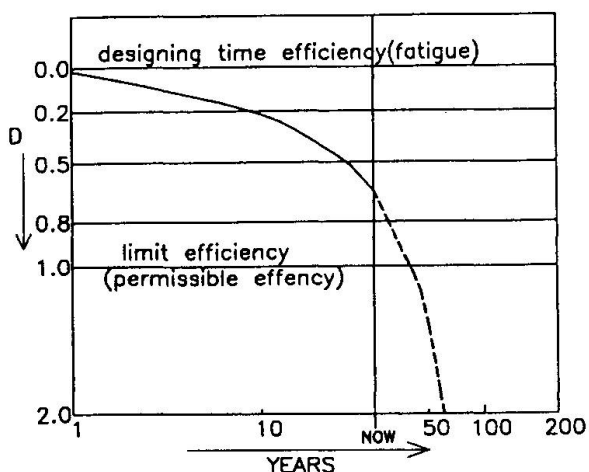
Fig.10 Fatigue crack occurring life of the stringer's crack (under the present condition)

- (1) Vertical stress of about 65 MPa is acting on the neck's weld. It was greater than the stress in the axial direction of the bridge, and was in the reverse phase in the inside and the outside of the web.
- (2) Vertical stress due to out-of-plane bending of the stringer neck was as large as 75 MPa.
- (3) Vertical stress in the notch of the stringer's end was 90 to 100 MPa and main stress was similarly great.
- (4) Fatigue crack occurrence life was calculated to be 9 years for vertical stress acting on the neck's weld. Fatigue crack occurrence life when the sleeper was in loose contact (when the sleeper was completely deviated) was calculated to be 8 years.

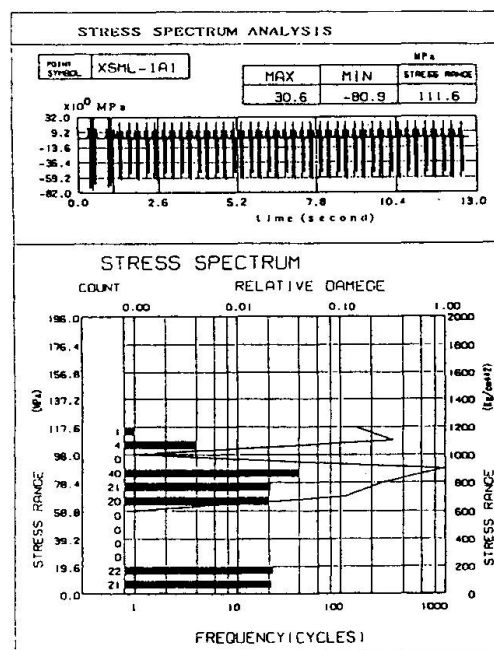
Fig.12 Stress waveform and stress spectrum obtained by simulation

In the analysis of the waveform of stress acting on rails, based on the fact that the crack in the neck's weld was 700 mm long, the rail was assumed as a 1,000 mm span continuous beam with one sleeper lost. In that condition, axial force acting on the rail was obtained by simulation. On this basis, stress "on the railhead in the weld joint" and "bolt holes in the joint bar" was obtained. Stress acting on the bolt holes was obtained by the FEM analysis because it could not be obtained by a simple beam stress calculation. Fig.12 shows the stress waveform and stress spectrum in top-flange of the rail obtained by simulation.
