**Artikel:** Survey on fatigue damage in steel railway bridges in Thailand  
**Autor:** Thavee, Thongpan / Abe, Makoto / Kobayashi, Toshio  
**DOI:** <https://doi.org/10.5169/seals-55312>

## **Survey on Fatigue Damage in Steel Railway Bridges in Thailand**

The results of the survey of fatigue damage of steel bridges of the State Railway of Thailand are presented. An investigation of the characteristic and the cause of cracks occurring in the welds of stringer necks of through girder bridges was conducted.

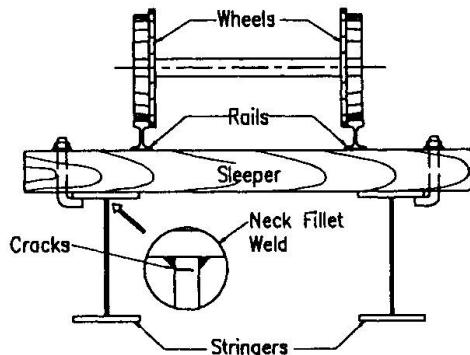
Fig.1 Wheels, track and stringer

The arrangement of stringers and the track and positions where fatigue cracks have occurred are shown in Fig.1. (the same figure used in bibliography 1)

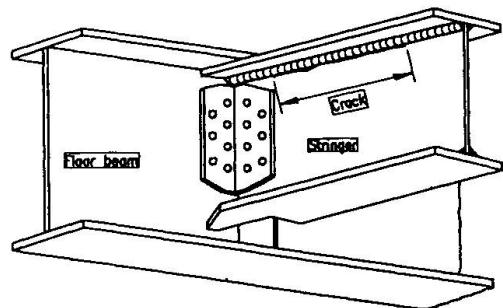
Fig.2 Crack occurring just under the sleeper

Fig.2 shows a crack developing about 700 mm horizontally along the toe on the weld between upper flange and web of stringer (we called "the neck's weld) just under the sleeper. It had, however, not reached the beam's end of the stringer.

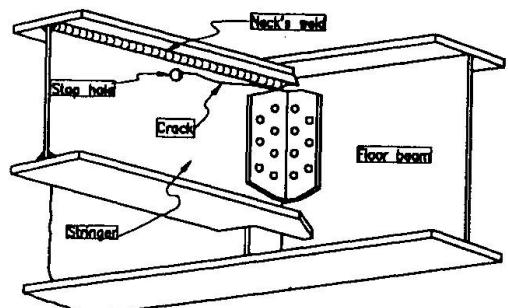
Fig.3 Crack occurring in the beam end

Fig.3 shows a crack occurring in the beam end of a stringer advancing horizontally on the web along the bead toe. At this position, a stop hole is provided at the end of the crack, and found effective to some extent.

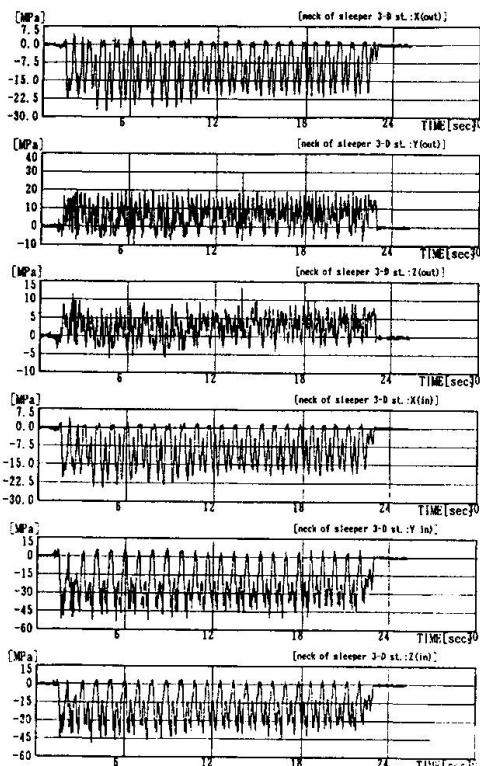
**Fig.8** Stress in front and back of the neck just under the sleeper

- (1) Stress in the neck of the stringer just under the sleeper. Measurements were made for ALSTHOM (the sleeper is touching the top flange). Fig. 8 shows three-component stress for the front and the back faces.

- (1) Vertical stress of about 65 MPa is acting on the neck's weld. It was greater than the stress in the axial direction of the bridge, and was in the reverse phase in the inside and the outside of the web.
- (2) Vertical stress due to out-of-plane bending of the stringer neck was as large as 75 MPa.
- (3) Vertical stress in the notch of the stringer's end was 90 to 100 MPa and main stress was similarly great.
- (4) Fatigue crack occurrence life was calculated to be 9 years for vertical stress acting on the neck's weld. Fatigue crack occurrence life when the sleeper was in loose contact (when the sleeper was completely deviated) was calculated to be 8 years.

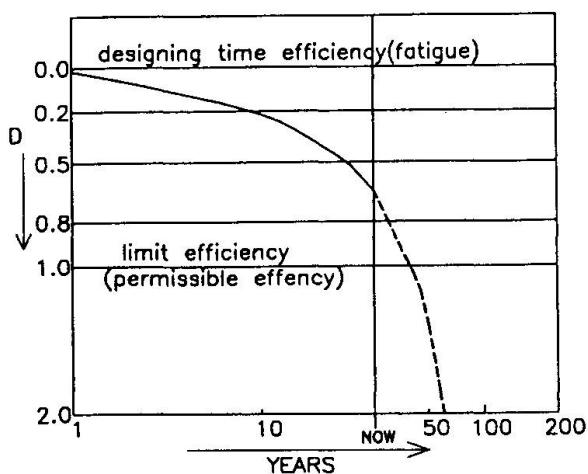
**Fig.10** Fatigue crack occurring life of the stringer's crack (under the present condition)

The method and standards for evaluating fatigue were based on the fatigue design guidelines of Japanese Society of Steel Construction<sup>2)</sup>. The result of fatigue damage evaluations is shown in Fig.10 and Fig.11.

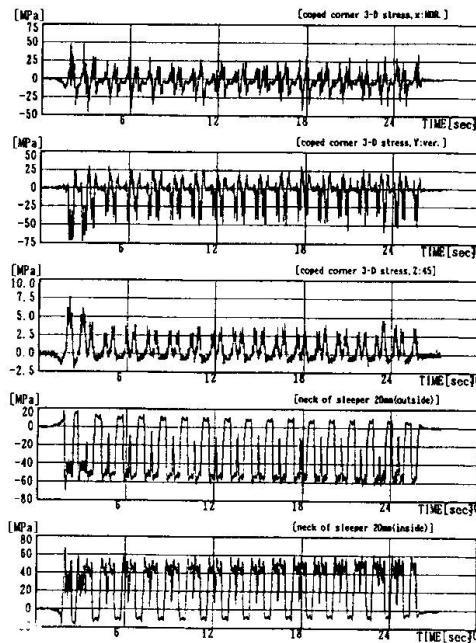
**Fig.9** Triaxial stress in the girder end notch and vertical stress of the web

- (2) Stress in the coped corner notch in the stringer end. The train for which measurements were made was new-HITACHI whose axle load is the greatest this line. (The liner plate was inserted just under the sleeper only in the halfway.) In Fig.9, the upper three waveforms show triaxial stress in the girder end notch, and the lower two waveforms show vertical stress in the front and the back of the web in the halfway of the stringer.

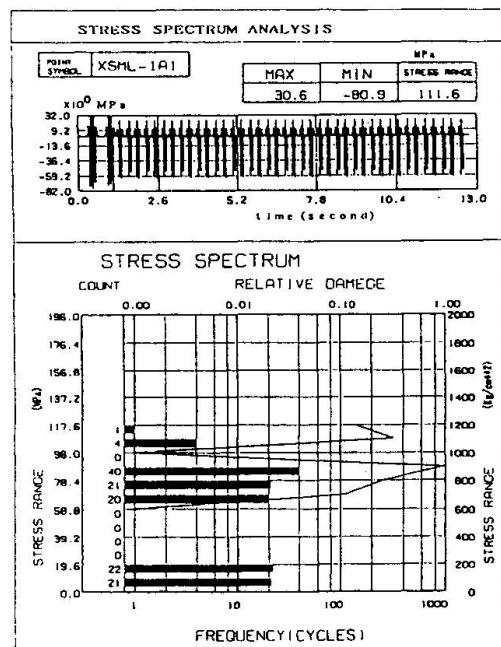
Fig.12 Stress waveform and stress spectrum obtained by simulation

In the analysis of the waveform of stress acting on rails, based on the fact that the crack in the neck's weld was 700 mm long, the rail was assumed as a 1,000 mm span continuous beam with one sleeper lost. In that condition, axial force acting on the rail was obtained by simulation. On this basis, stress "on the railhead in the weld joint" and "bolt holes in the joint bar" was obtained. Stress acting on the bolt holes was obtained by the FEM analysis because it could not be obtained by a simple beam stress calculation. Fig.12 shows the stress waveform and stress spectrum in top-flange of the rail obtained by simulation.
