Artikel: Survey on fatigue damage in steel railway bridges in Thailand
Autor: Thavee, Thongpan / Abe, Makoto / Kobayashi, Toshio
DOI: <https://doi.org/10.5169/seals-55312>

Survey on Fatigue Damage in Steel Railway Bridges in Thailand
Dommages par fatigue de ponts ferroviaires métalliques en Thaïlande
Ermüdungsschäden an Stahleisenbahnbrücken in Thailand

The results of the survey of fatigue damage of steel bridges of the State Railway of Thailand are presented. An investigation of the characteristic and the cause of cracks occurring in the welds of stringer necks of through girder bridges was conducted.

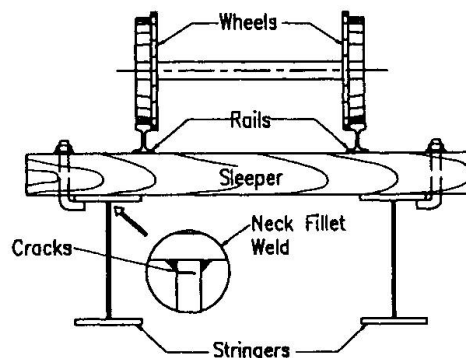
Fig.1 Wheels, track and stringer

The arrangement of stringers and the track and positions where fatigue cracks have occurred are shown in Fig.1. (the same figure used in bibliography 1)

stringer end (some coming from the corner of the notch)

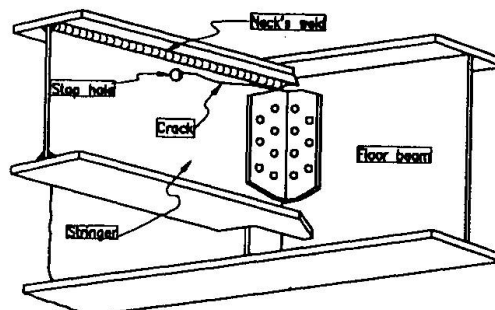
Fig.3 Crack occurring in the beam end

Fig.3 shows a crack occurring in the beam end of a stringer advancing horizontally on the web along the bead toe. At this position, a stop hole is provided at the end of the crack, and found effective to some extent.

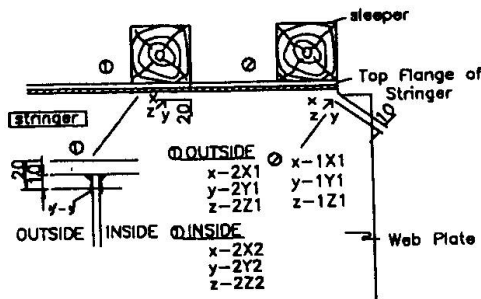
Fig.4 Position of strain gauges

Stress behaviors were examined by sticking a triaxial gauge to the positions as shown in Fig.4 with due consideration to the foregoing.

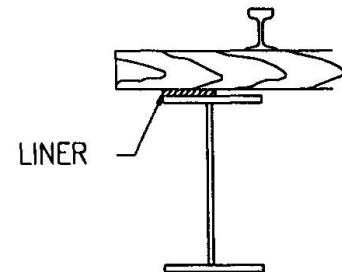
Fig.6 Liner inserted intentionally

- (1) ALSTHOM: (under present conditions: in close contact inside; 0.2 to 0.5 mm apart outside) (See Fig.5)
 - (2) ALSTHOM: (liner inserted intentionally: 2 mm apart inside; in close contact outside) (See Fig.6)
 - (3) new-HITACHI (liner inserted intentionally: 2 mm apart inside; in close contact outside)
- The axle load and spacing of ALSTHOM and new-HITACHI is shown Fig.7.

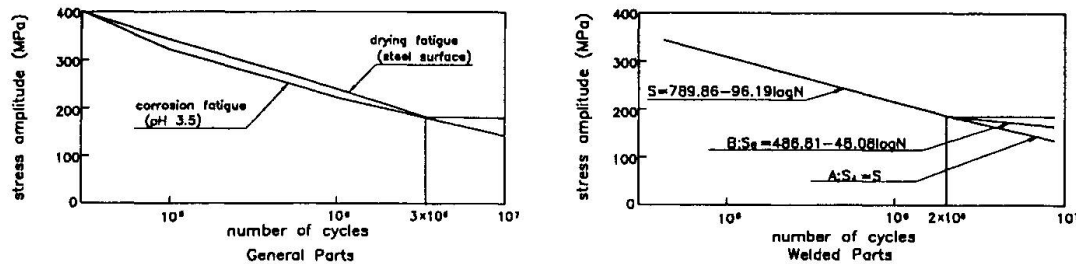
Fig.13 Rail's fatigue strength curve

The fatigue strength curve of rails used for evaluation of fatigue was the one as shown in Fig.13^{3,4)} which is usually used by former Japanese National Railways.
