**Zeitschrift:** IABSE reports = Rapports AIPC = IVBH Berichte  
**Band:** 73/1/73/2 (1995)

**Artikel:** Fatigue life of riveted railway bridges  
**Autor:** Akesson, Björn / Edlund, Bo  
**DOI:** <https://doi.org/10.5169/seals-55314>

# **Fatigue Life of Riveted Railway Bridges**

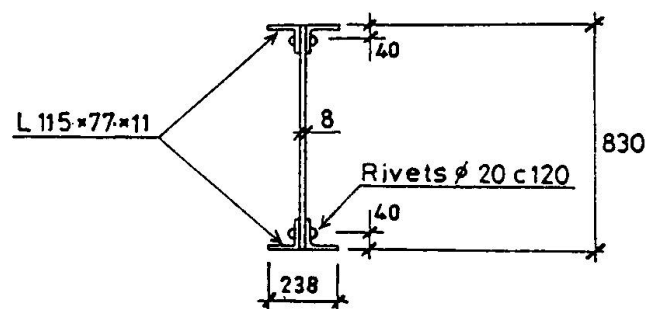
**Fig.1** Dimensions of the built-up I-shaped stringers.

When the old riveted railway bridge over the Vindelälven at Vännäsby (built in 1896) was replaced by the railway authorities in 1993 it was decided that one should take the opportunity to carry out an extensive full-scale fatigue testing programme comprising the stringers and floor-beams from the bridge. In the first series 10 stringers were tested in four-point bending. The stringers were 5,5 meters long (after being flame cut from the bridge) with a depth of 830 mm:
