Artikel: Defects and repairs at an interchange bridge in Tripoli, Libya
Autor: Mallick, D.V. / Tawil, M.M.
DOI: <https://doi.org/10.5169/seals-55168>

Defects and Repairs at an Interchange Bridge in Tripoli, Libya

As a part of Tripoli Corniche Road, three highway interchange flyover concrete bridges Waddan, Karamanli and Hospital have been constructed in eighties in a length of about 5 km. Hospital interchange is the farthest from the city centre at the eastern end of the Tripoli Corniche ring road, and consists of an elevated structure having 18 spans which include adjoining side spans. The interchange was designed by Rendel Palmer and Tritton of Britain in 1986 and, constructed by Daewoo Corporation of S. Korea under the supervision of National Consulting Bureau, Tripoli from 1986 to 1988. The deck of this interchange is a continuous reinforced concrete voided structure. When the first soffit shutters of the bridge deck were removed areas of voids and honeycombing were discovered. Investigations by hammer soundings, Schmidt hammer and by drilling suspect areas were carried out to detect other areas of voiding. Hammer soundings successfully revealed the other additional areas of

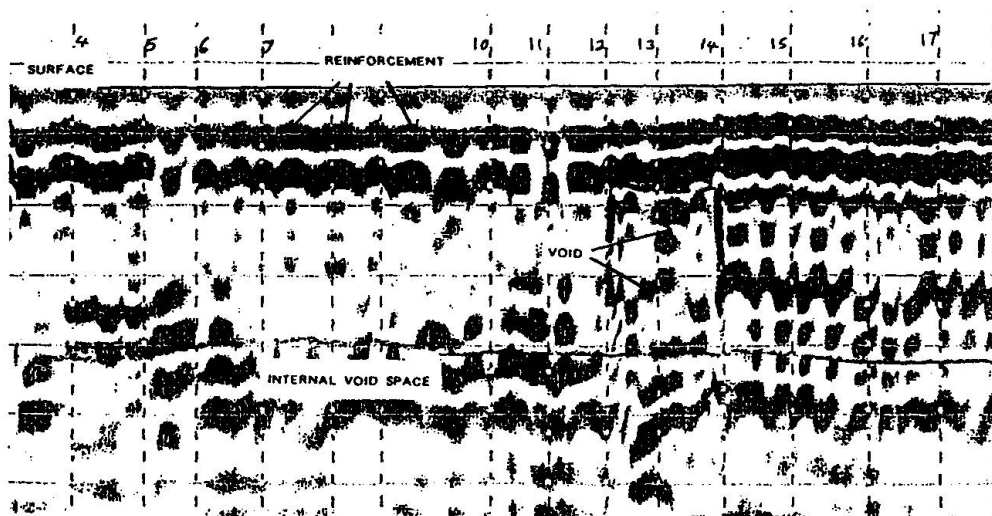
Fig. 3 Radar Output for Longitudinal Scanning Profile (Span 5).

Figure 3 shows data collected with the 900 MHZ transducer along a longitudinal profile of deck 5. It can be seen that the hyperparabolic return from the reinforcement are interrupted: this is caused by the presence of a void reducing the energy coupled to steel thus sharply alternating the returning signal and creating a blank area in the data. The deeper void attenuating located between the reinforcement and the internal void former is not as readily identifiable within the data, but a disturbance or irregularity in the signals can be noted both as a cancellation or attenuation of signals from the reinforcement and also as a phase shift in the response from the metal skin of the internal void former.
