Artikel: Defects and repairs at an interchange bridge in Tripoli, Libya
Autor: Mallick, D.V. / Tawil, M.M.
DOI: <https://doi.org/10.5169/seals-55168>

Defects and Repairs at an Interchange Bridge in Tripoli, Libya

As a part of Tripoli Corniche Road, three highway interchange flyover concrete bridges Waddan, Karamanli and Hospital have been constructed in eighties in a length of about 5 km. Hospital interchange is the farthest from the city centre at the eastern end of the Tripoli Corniche ring road, and consists of an elevated structure having 18 spans which include adjoining side spans. The interchange was designed by Rendel Palmer and Tritton of Britain in 1986 and, constructed by Daewoo Corporation of S. Korea under the supervision of National Consulting Bureau, Tripoli from 1986 to 1988. The deck of this interchange is a continuous reinforced concrete voided structure. When the first soffit shutters of the bridge deck were removed areas of voids and honeycombing were discovered. Investigations by hammer soundings, Schmidt hammer and by drilling suspect areas were carried out to detect other areas of voiding. Hammer soundings successfully revealed the other additional areas of

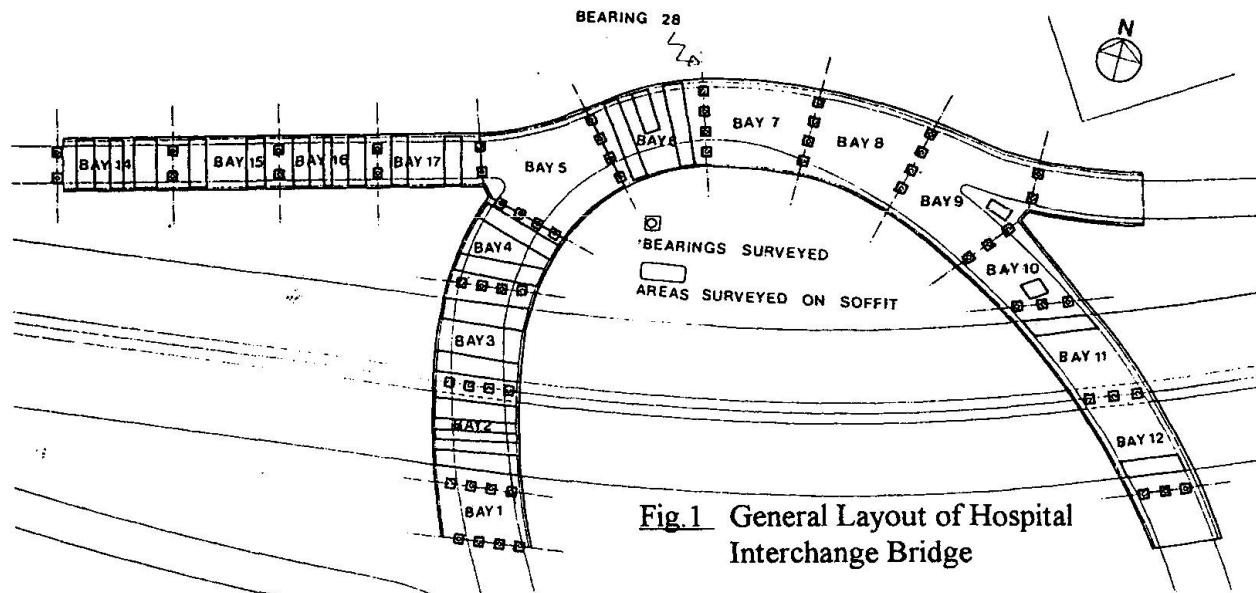
Fig. 1 General Layout of Hospital Interchange Bridge

The areas of the bridge deck selected for impulse radar survey were generally the areas of congested reinforcing steel, particularly around laps in the lower reinforcement. All areas

investigated are shown in Fig. 1. All survey lines, both longitudinal and transverse, were set out on the soffit of the deck in areas marked out by the contractor. The majority of the data was collected from profile lines transverse to the deck and set at 250 mm centres. These line provided a general scan of the concrete condition to a depth of at least 250 mm. The transverse profiles were transacted by longitudinal profiles at 1 m centres arranged to examine the concrete condition immediately below the centre line of each void former. Survey lines were profiled using either the high resolution transducer with centre frequency set at 1000 MHZ, or the slightly lower resolution but deeper penetrating transducer set at 900 MHZ. In some cases both frequencies were used on the same line. This multi-frequencies approach was adopted in order to obtain as much information on the interior of the decks as possible.

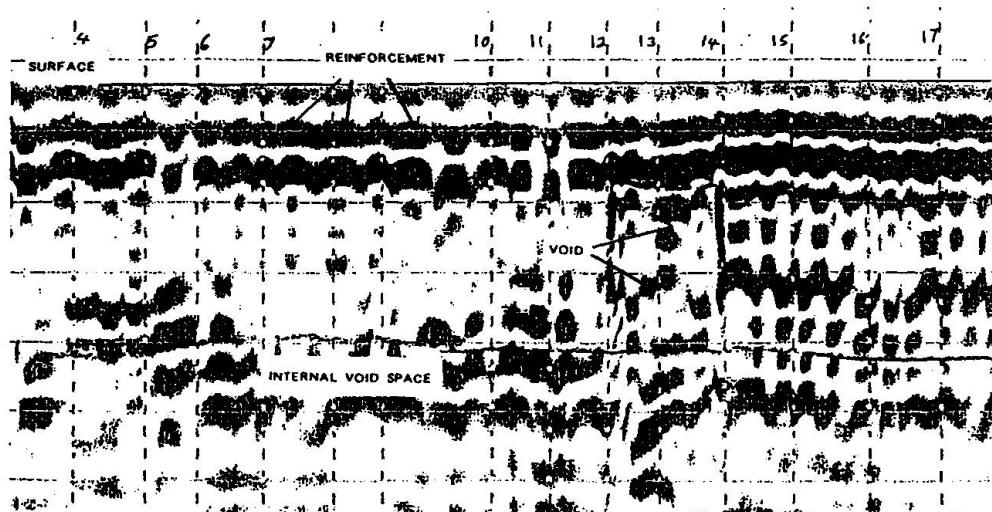
Fig. 3 Radar Output for Longitudinal Scanning Profile (Span 5).

Figure 3 shows data collected with the 900 MHZ transducer along a longitudinal profile of deck 5. It can be seen that the hyperparabolic return from the reinforcement are interrupted: this is caused by the presence of a void reducing the energy coupled to steel thus sharply alternating the returning signal and creating a blank area in the data. The deeper void attenuating located between the reinforcement and the internal void former is not as readily identifiable within the data, but a disturbance or irregularity in the signals can be noted both as a cancellation or attenuation of signals from the reinforcement and also as a phase shift in the response from the metal skin of the internal void former.
