**Zeitschrift:** IABSE reports = Rapports AIPC = IVBH Berichte  
**Band:** 73/1/73/2 (1995)  
**Rubrik:** Session A2: Seismic strengthening of buildings: case studies

## **Session A2**

**Seismic Strengthening of Buildings: Case Studies**  
**Renforcement parasismique des bâtiments: études de cas**  
**Verstärkung bezüglich Erdbeben im Hochbau: Fallstudien**

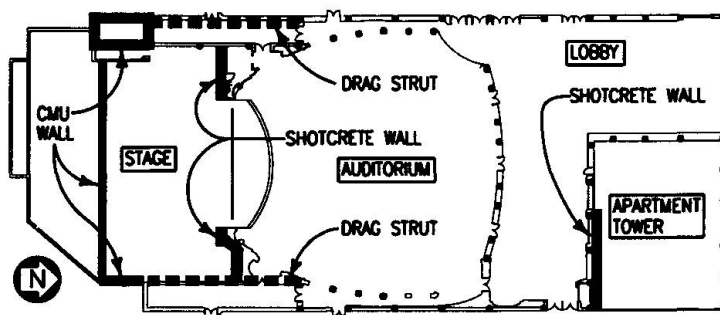
*Fig. 5: New Seismic Elements*

- The roof parapets were unbraced unreinforced masonry.
- The span of some URM walls between supporting steel girts or columns was excessive.
- The projection room above the auditorium was an unbraced hanging structure.
- Hollow clay tile walls existed at several locations above the auditorium.
- A weak story condition existed at the theatre lobby / apartment section of the building.
- There was excessive shear demand at the URM proscenium wall.
- There was excessive shear demand at the URM east and west exterior walls.

For seismic loads in the transverse (east/west) direction, new reinforced masonry and concrete shearwalls were designed to resist the entire seismic base shear. Since the existing backstage (south) wall was removed to accommodate the stage expansion, the new backstage wall of reinforced masonry was designed to resist the seismic forces from the southern portion of the combined building. A new shotcrete wall was placed against the demising wall between the theatre and apartment tower and was designed to resist seismic forces from the northern portion of the theater as well as the apartment tower. This wall eliminated the weak story condition in that portion of the building. In addition to the two main walls, the proscenium wall was strengthened. This strengthening was designed only to provide some measure of ductility at the proscenium opening. This wall was not designed to carry any of the building seismic forces apart from its own weight.

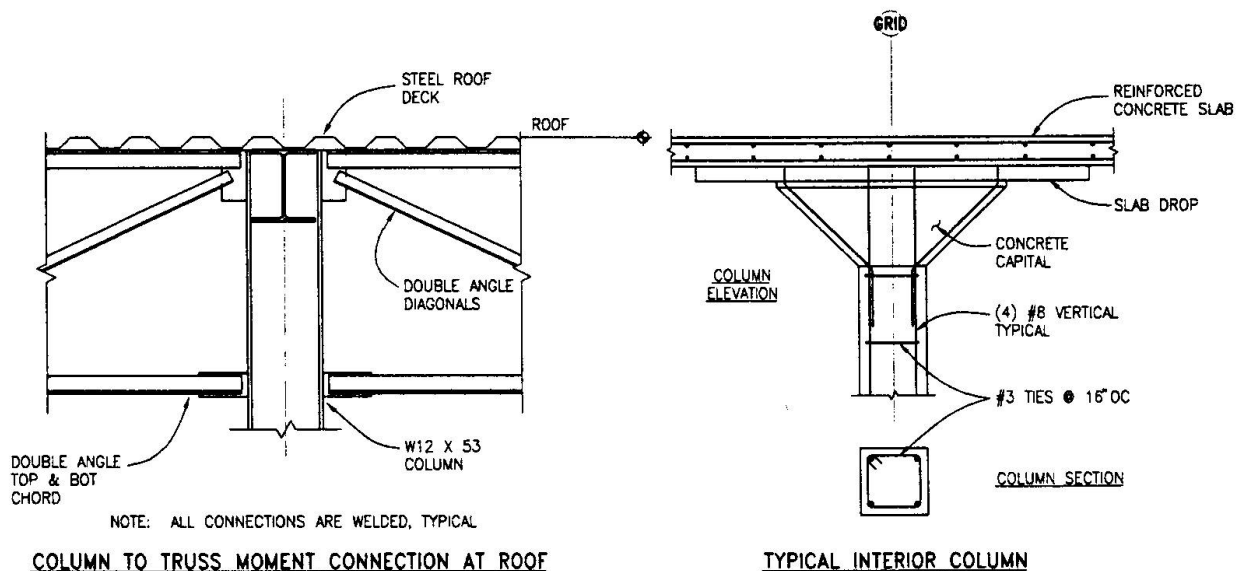
Fig.2 Details of existing framing system.

Except for the stiff first floor system which will not exhibit any considerable story drift during an earthquake, the 2nd and 3rd story horizontal systems lacked the ductility required by modern codes. Therefore, a seismic retrofit became necessary.

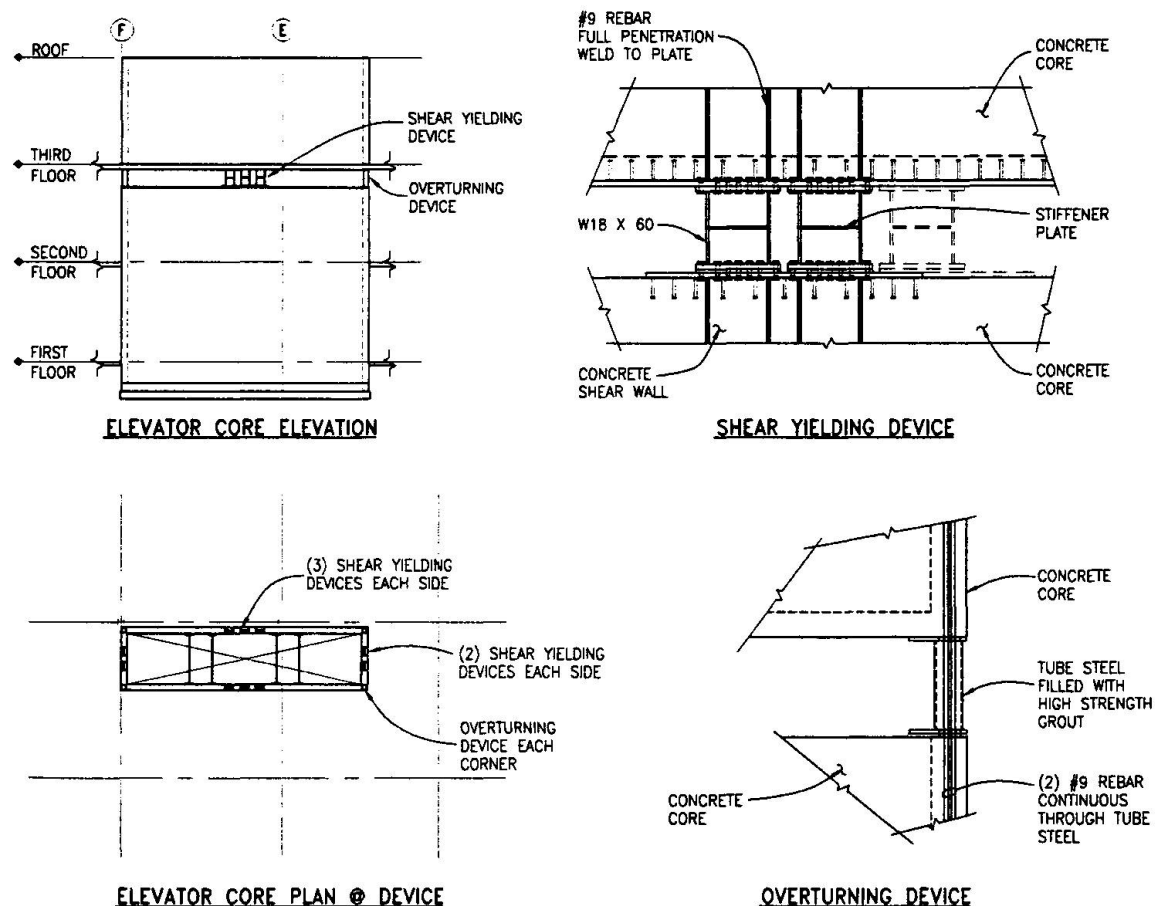
**Fig.3** Elevator core as part of the primary horizontal system (PH-system) with seismic link below the 2nd floor ceiling. Shear panel dampers as hysteretic devices and grouted steel tubes in corners as overturning devices.

In retrofitting, the existing system is often sufficient to act as SH-system. This is the case in the Allstate Building. Here, the new stair and elevator rc-cores provide the PH-system. The seismic links in each core are placed just below the 2nd floor ceiling (FIG. 3).

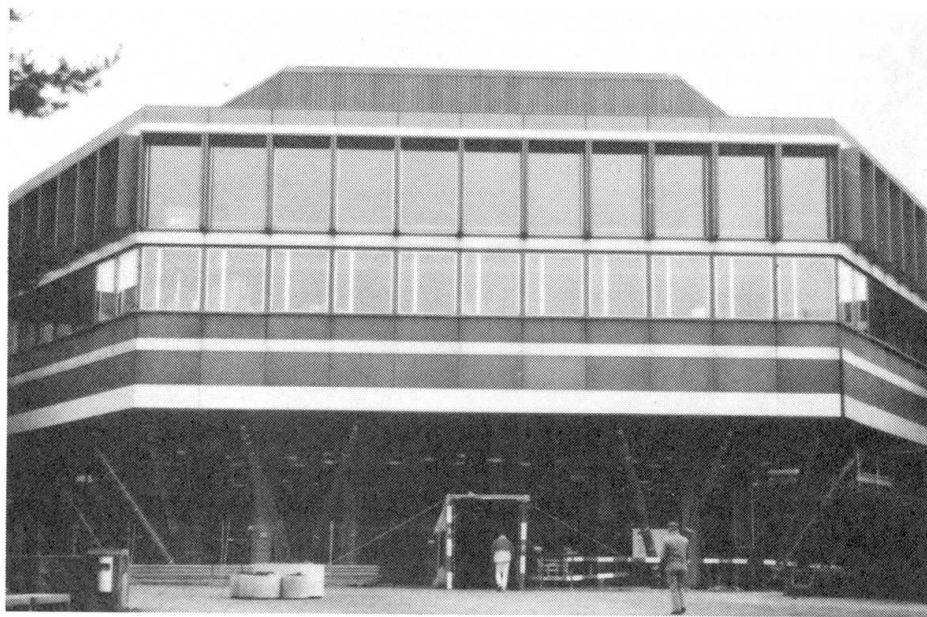
Fig. 1 View from outside towards the upgraded building (during construction). The diagonal steel trusses are the main strengthening elements

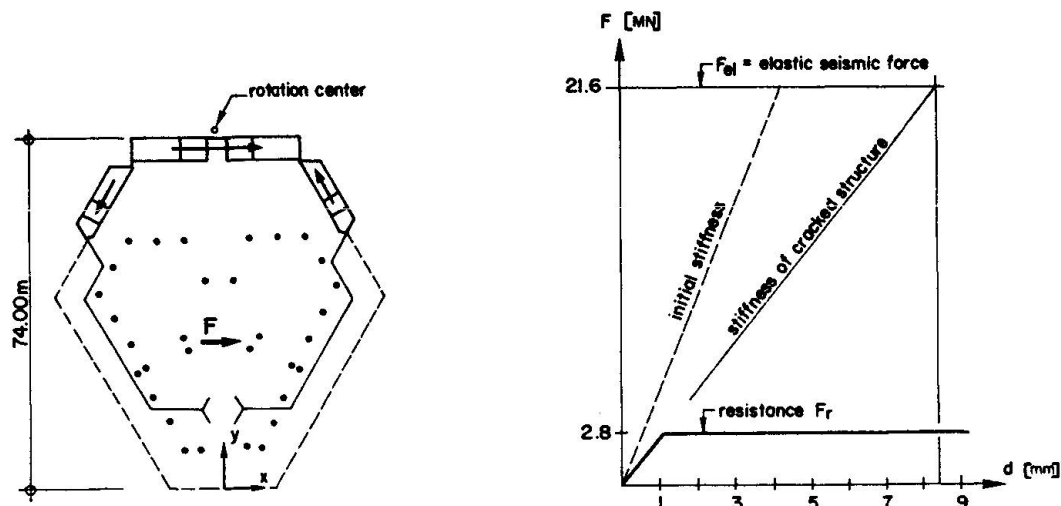
Figure 4 shows the result of the capacity assessment: the resistance is plotted as a function of the horizontal displacement and compared to the elastic seismic force (seismic design force if a purely elastic response of the structure is assumed). The resistance calculated with help of actual material strengths turned out to be far below these forces. Hence, the code requirements can not be fulfilled by the original structure. Even if large inelastic deformations are tolerated, the available ductility would by far not be sufficient to ensure the building's integrity.

Fig. 4 Resistance to overall seismic forces (x-direction) in the first floor before upgrading (d is the horizontal displacement in the mass center, relative to the soil and foundation)

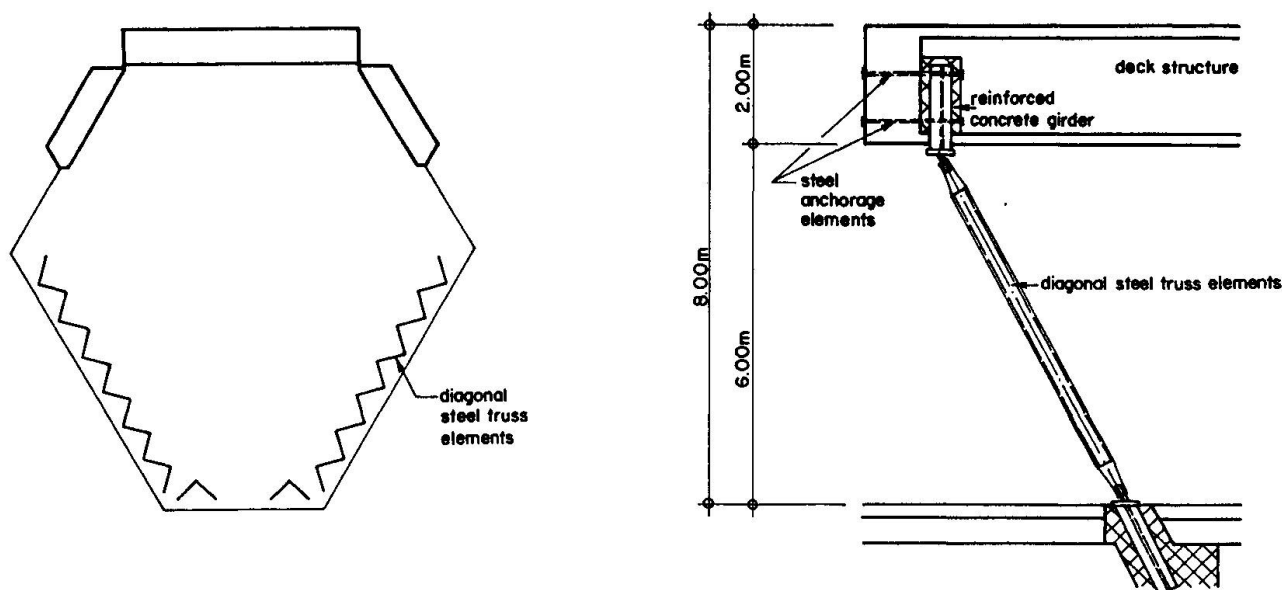
Fig. 6 Realized upgrading variant  
left: plan view of new trusses right: sectional view with construction of support strengthening

The trusses are designed to complement the existing structural walls in the rear part of the building. Simultaneously they enhance the gravity load capacity of the originally cantilevered deck structure.

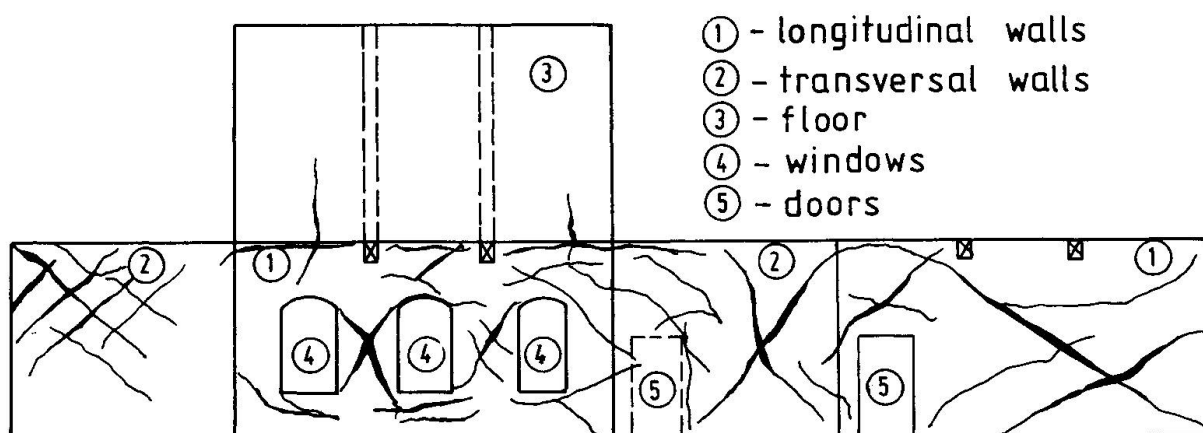
Fig. 2 An example of walls cracking

- the cracking of the majority of the resistance walls (longitudinal and transversal walls), with the following characteristics: horizontal cracks under the floor girdles, vertical cracks at the appearance of the floor joints, crossed cracks from the shearing loads and cracks in the lintels of doors and windows (see Figure 2);
- the appearance of a number of joints in the floors, caused by the cracking of the floors in the connection area between the transversal and longitudinal wings of the building;
- the settlement of the South wing walls foundation and the cracking of these walls;
- the cracking of the walls and stair elements of the staircases "B", "C" and "A" (see Figure 1), with partial wresting of the stair landings from the exterior walls of the staircases "B" and "C";
- the fall of the chimneys, causing damages of the roof and of the attic floors;
