Artikel: Improving the durability of precast concrete bridges
Autor: Siwowski, Tomasz
DOI: <https://doi.org/10.5169/seals-55346>

Improving the Durability of Precast Concrete Bridges

Tomasz SIWOWSKI
Dr. Eng.
University of Technology
Rzeszow, Poland

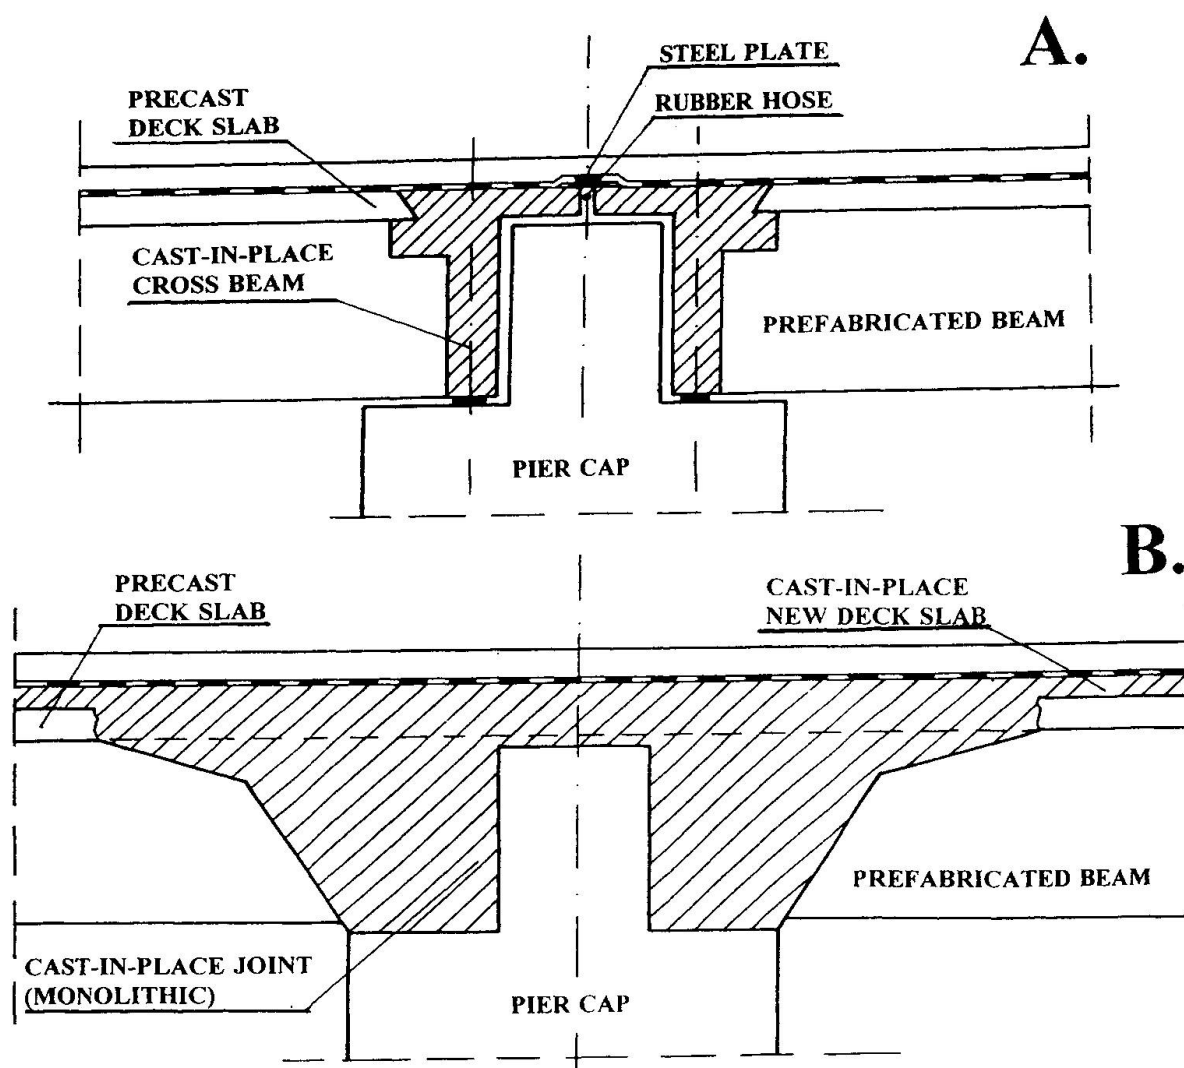
Fig.2. Modernization of the supporting area of piers:
a) before reconstruction; b) after reconstruction.

The caps of piers were the most damaged elements of the bridge structure. Leaky expansion joints and also lack of efficient drainage of the pavement caused extensive and deep losses in the concrete, loosening of the cover to the level of the reinforcement, exposure of the corroding rebars, scalling on the whole surface, etc. Besides, hammerhead piers with such a wide cap form too flexible support for bridge structures. The flexibility could easily be felt when heavy lorries were crossing the bridge. The main rehabilitation stages were the following:

The main goal of making continuity of spans was the upgrading the longitudinal and transverse rigidity of the structure and the elimination of expansion joints, which meant sealing the structure. Concrete cast-in-place joints over the piers create a frame structure. A strongly reinforced joint of considerable size stiffens also the cap of the pier (fig.2).
