**Artikel:** Seismic repair and upgrade of a steel braced frame building  
**Autor:** Bonneville, David R. / Kelly, Dominic J. / Bartoletti, Stacy J.  
**DOI:** <https://doi.org/10.5169/seals-55171>

## **Seismic Repair and Upgrade of a Steel Braced Frame Building**

A modern four-story steel braced frame office building was structurally damaged in the 1994 Northridge, California, earthquake. The building, which was repaired and upgraded, provided an excellent opportunity to study the performance of a typical chevron braced frame system and to compare it analytically with other braced frame options. Linear and simplified nonlinear (static pushover) analyses were conducted on three different braced frame configurations, including the original system and the replacement system.

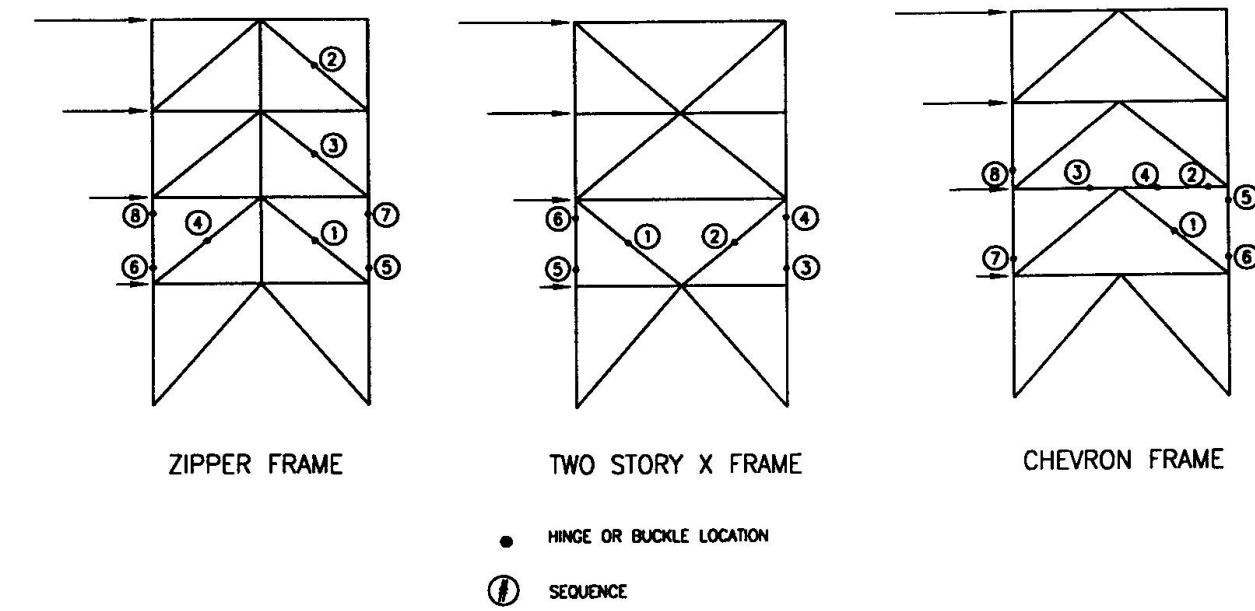
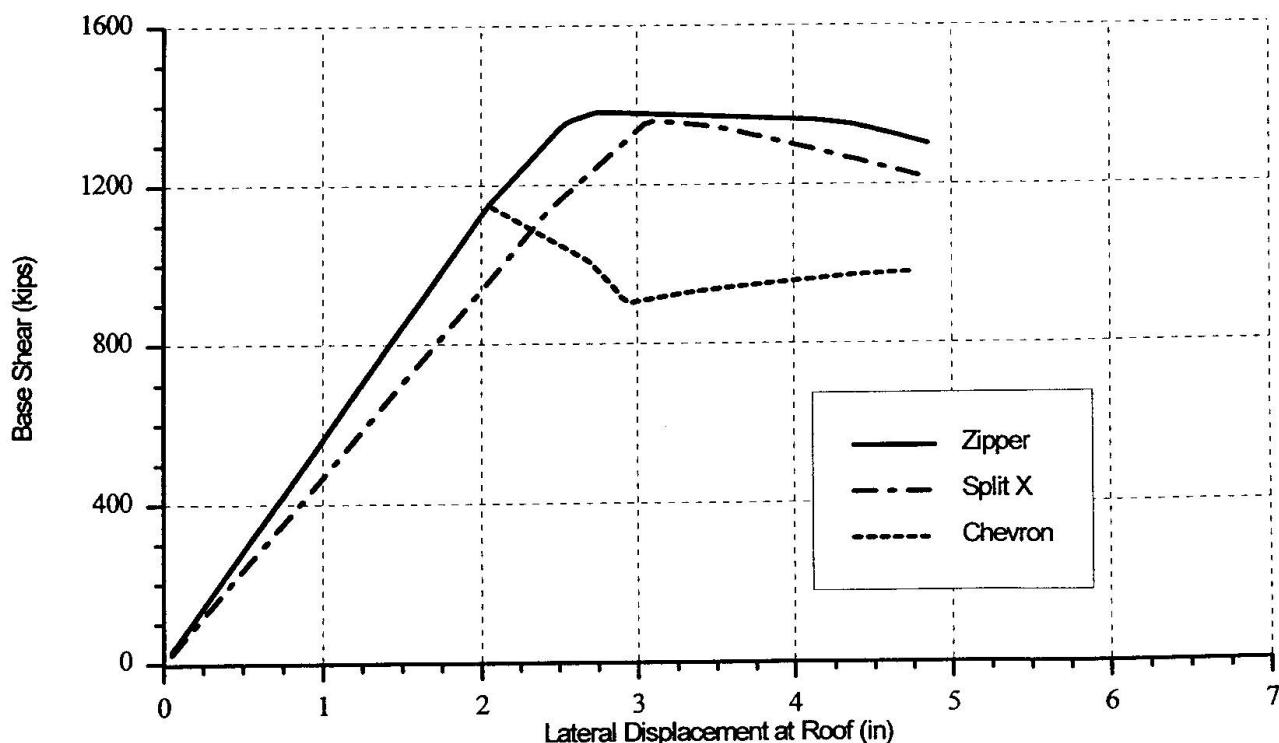
Figure 1 : Load vs Deflection - Fixed Girder to Column Connections

It should be noted that for the subject building, the ground level braces in all configurations were designed to be relatively stronger than the upper floors and, as a result, buckling occurs at the second level. Chevron brace configurations are generally thought to perform poorly in seismic events, thus the UBC [5] requires the brace members to be designed for 1.5 times the otherwise prescribed seismic forces. This requirement reflects the reduction in capacity that occurs for a bay of chevron bracing once the first brace buckles. For the frame studied, the capacity reduced by 20% for rigid beam-to-column connections and 30% for pinned connections. It was found that the post buckling strength and stiffness is highly dependent on the size of the beam intersected by the braces, which must resist the unbalanced vertical component of force between the tension and buckled compression brace. Improved performance can be obtained by using a beam strong enough to meet the UBC provision for special concentrically braced frames with a chevron configuration.

The two-story X configuration was included in the analysis because it is a commonly used lateral system intended to alleviate the problems associated with the chevron system. When one brace buckles, lateral loads are transferred to other brace members rather than forcing the beam to resist the unbalanced vertical force in bending. In the analyses performed, the two-story X frame had a lower elastic stiffness than the other two configurations due to the distribution of overturning forces in the columns and, like the chevron, all yielding occurred in one story. In both the pinned and fixed configurations, a story mechanism formed through buckling and tension yield of the second floor braces followed by hinging of the second floor columns. After initial yield, the frame had additional capacity and reached a maximum capacity close to the maximum capacity of the zipper frame.

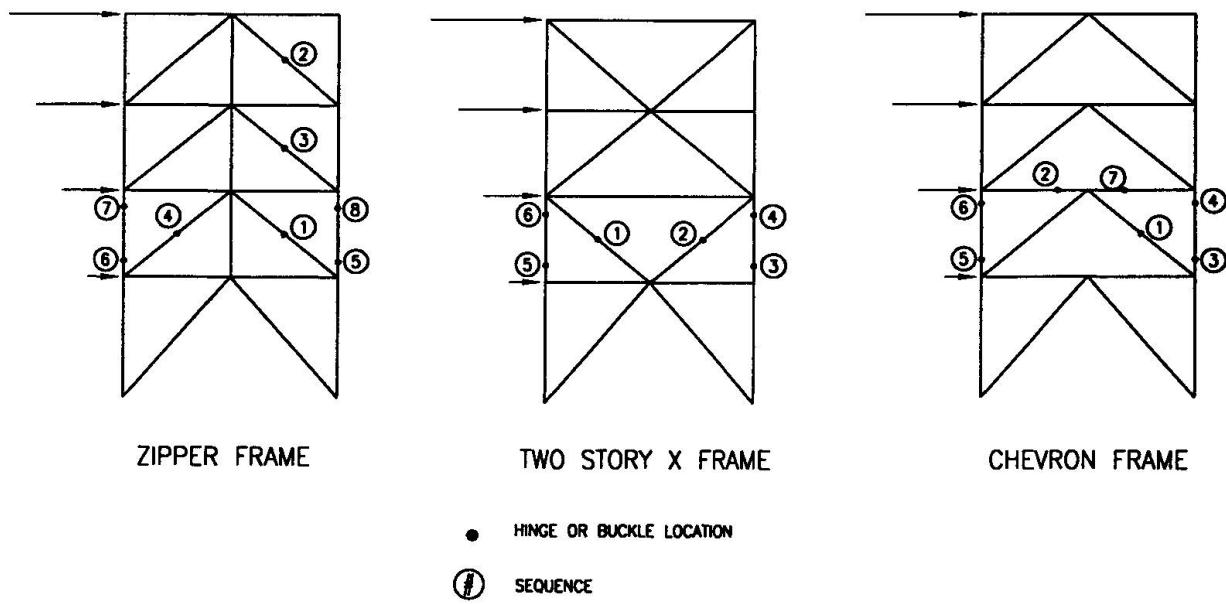
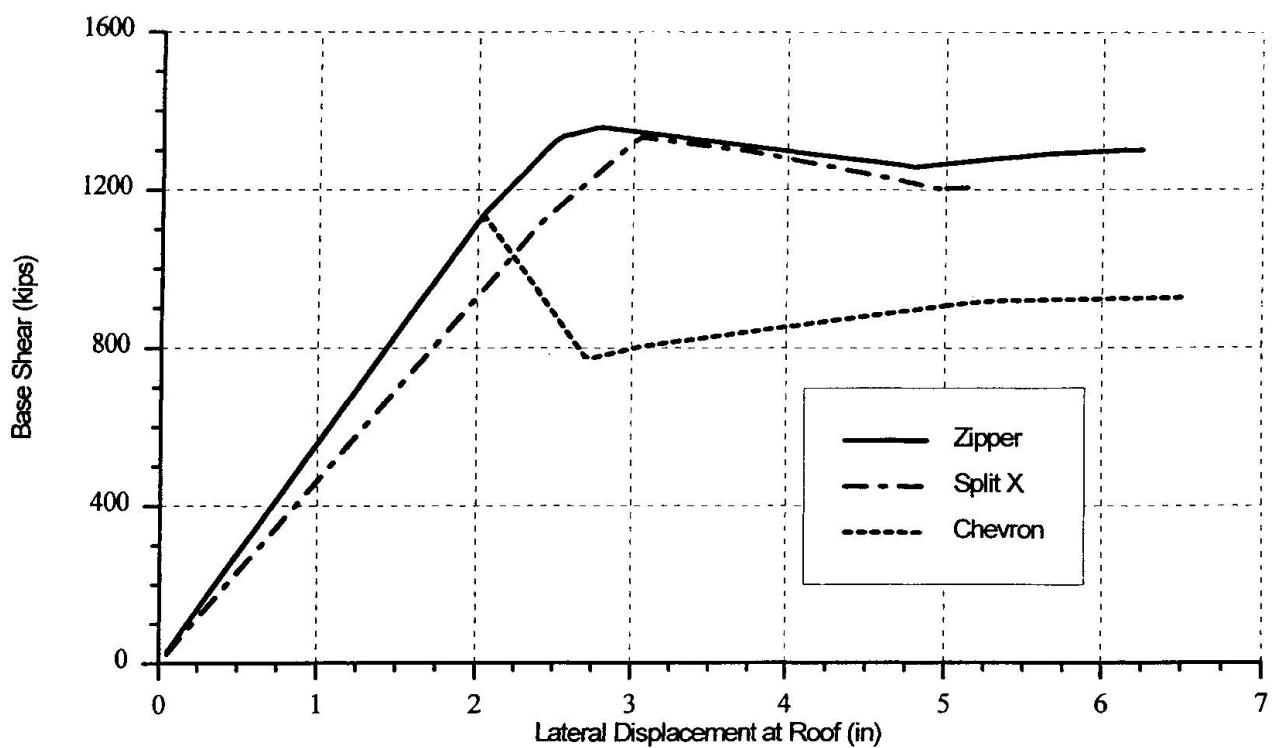
Figure 2 : Load vs Deflection - Pinned Girder to Column Connections

The zipper braced frame is the system used for retrofit of the subject building. The design, based on research done by Khatib, Mahin, and Pister [2], is a modified chevron frame which utilizes vertical members at the beam midspans to redistribute lateral loads up the height of the frame. Figures 1 and 2 show that the zipper frame and chevron frame have identical elastic stiffness. However, while the capacity of the chevron frame drops off immediately after first yield, the capacity of the zipper increases until all three braces above the ground floor have buckled. Then, the second story tension brace yields and hinges form in the second floor columns to form a soft story. As seen with the other two configurations, the pinned condition has slightly less stiffness after first yield and a longer yield plateau as hinges form in the columns. In addition, the zipper

frame maintains greater lateral capacity than both the chevron or the two-story X configuration.
