Artikel: Seismic repair and upgrade of a steel braced frame building

Seismic Repair and Upgrade of a Steel Braced Frame Building

David R. BONNEVILLE

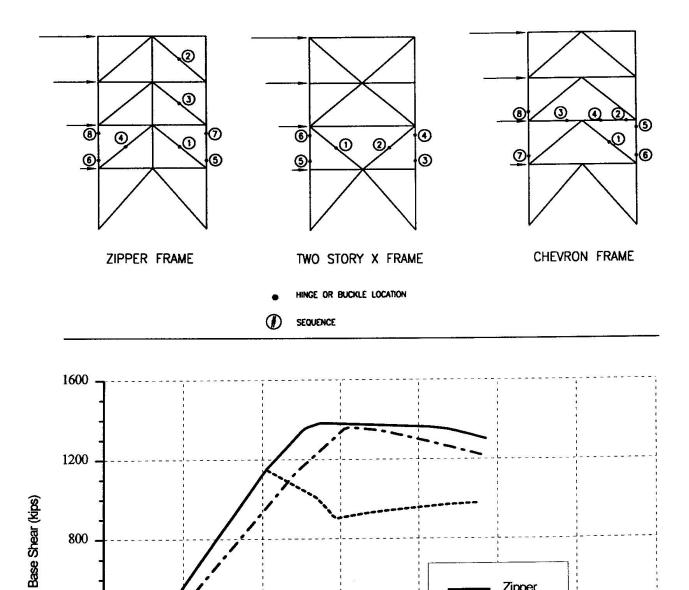
Figure 1: Load vs Deflection - Fixed Girder to Column Connections

It should be noted that for the subject building, the ground level braces in all configurations were designed to be relatively stronger than the upper floors and, as a result, buckling occurs at the second level. Chevron brace configurations are generally thought to perform poorly in seismic events, thus the UBC [5] requires the brace members to be designed for 1.5 times the otherwise prescribed seismic forces. This requirement reflects the reduction in capacity that occurs for a bay of chevron bracing once the first brace buckles. For the frame studied, the capacity reduced by 20% for rigid beam-to-column connections and 30% for pinned connections. It was found that the post buckling strength and stiffness is highly dependent on the size of the beam intersected by the braces, which must resist the unbalanced vertical component of force between the tension and buckled compression brace. Improved performance can be obtained by using a beam strong enough to meet the UBC provision for special concentrically braced frames with a chevron configuration.

The two-story X configuration was included in the analysis because it is a commonly used lateral system intended to alleviate the problems associated with the chevron system. When one brace buckles, lateral loads are transferred to other brace members rather than forcing the beam to resist the unbalanced vertical force in bending. In the analyses performed, the two-story X frame had a lower elastic stiffness than the other two configurations due to the distribution of overturning forces in the columns and, like the chevron, all yielding occurred in one story. In both the pinned and fixed configurations, a story mechanism formed through buckling and tension yield of the second floor braces followed by hinging of the second floor columns. After initial yield, the frame had additional capacity and reached a maximum capacity close to the maximum capacity of the zipper frame.

The zipper braced frame is the system used for retrofit of the subject building. The design, based on research done by Khatib, Mahin, and Pister [2], is a modified chevron frame which utilizes vertical members at the beam midspans to redistribute lateral loads up the height of the frame. Figures 1 and 2 show that the zipper frame and chevron frame have identical elastic stiffness. However, while the capacity of the chevron frame drops off immediately after first yield, the capacity of the zipper increases until all three braces above the ground floor have buckled. Then, the second story tension brace yields and hinges form in the second floor columns to form a soft story. As seen with the other two configurations, the pinned condition has slightly less stiffness after first yield and a longer yield plateau as hinges form in the columns. In addition, the zipper

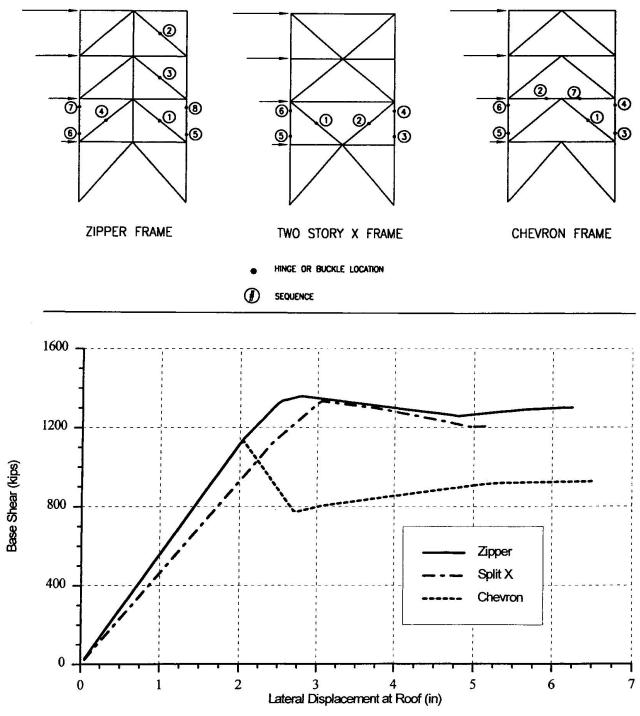
Figure 2: Load vs Deflection - Pinned Girder to Column Connections

frame maintains greater lateral capacity than both the chevron or the two-story X configuration.
