Repair and/or Strengthening in Function of the Diagnosis on the Structural Failure

Leon A. GRILL
Consulting Engineer
Sydney, Australia

SUMMARY

Five case studies of structural failures are presented where the successful result of the repairs, in terms of a satisfactory behaviour and an acceptable performance, was based on the correct assessment of the cause of the distress, and on the appropriate decision with regards to relating the kind of repair or structural modification to the actual cause of the structural failure.

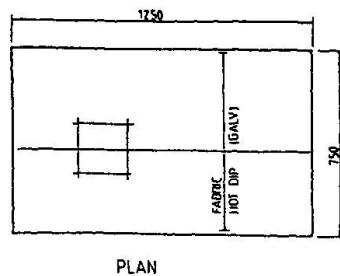
FIGURE 2.1.1

In a high-rise building a sizeable number of the precast stair-treads (Fig. 2.1.1) developed flexural cracks in the underside even before the completion of the building. The cracks appeared near mid span: one single major crack on some treads, or two closely spaced cracks on other treads. The width of most cracks exceeded the acceptable upper limit of 0.3mm.

- i) The dimensions of the precast treads are such that the reinforcement provided is near or at the neutral axis of the section and is therefore unutilized when the first loading occurs.

At this stage the treads will behave as precast mass concrete units, where the concrete alone has to withstand the tensile stresses in the underside. As soon as the modulus of rupture is exceeded, cracks appear. In our opinion the assumption that the initial cracks will slowly propagate under repeated loading till they reach the reinforcement, and from then on, the section will behave as a normal cracked section in bending (as shown on calculations), is nothing else but wishful thinking.

It seems that once small cracks appear under the first passing load, they develop with great speed under subsequent loads, causing a sudden excessive permanent deflection or even a complete "V" shape collapse of the tread associated with crushing of the concrete in compression.

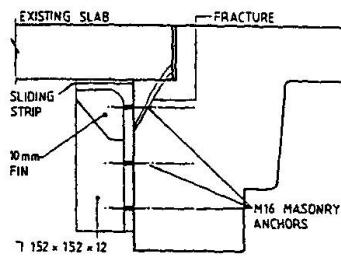
FIGURE 2.2.1

Figures 2.2.1 and 2.2.1 (a), show how the joint was originally detailed and the extent of the subsequent damage.

It can be appreciated that the insufficient width of seating, the erroneous detailing of the reinforcement and the total lack of any kind of sliding strip to reduce friction, led inevitably to the result shown on Figure 2.2.1 (a).

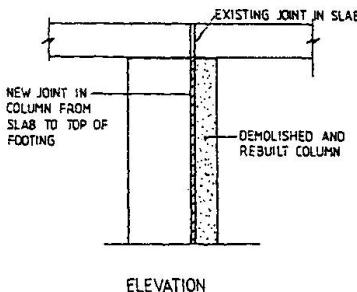
FIGURE 2.3.1

At one end of the control joint, both sides of the structure were supported by the same massive column, 2500 x 450 in section. (See Fig. 2.3.1)

The problem was that an approximately vertical crack developed in the column. It started at the top of the column in the vicinity of the slab control joint, and extended down for about 2m.

The design was inherently faulty: the initially correct introduction of a Control Joint was not carried through to its logical conclusion. It is true that the slabs were not poured monolithically with the column, but no sliding pads were used to allow for movement.

The substantial vertical load combined with the high friction co-efficient concrete to concrete produced an unacceptable restraint to shrinkage.

To make things worse, starter bars connected the column to both slabs, contradicting still more the concept of a control joint.
