Artikel: Repair and/or strengthening in function of the diagnosis on the structural failure
Autor: Grill, Leon A.
DOI: <https://doi.org/10.5169/seals-55354>

Repair and/or Strengthening in Function of the Diagnosis on the Structural Failure

Leon A. GRILL
Consulting Engineer
Sydney, Australia

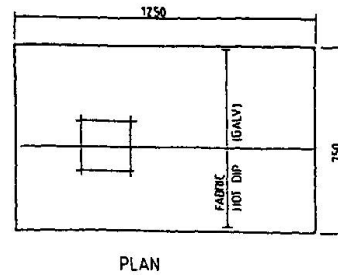
FIGURE 2-1-3

The existing failed treads were discarded. Being confident of the validity of the diagnosis described in i) and ii) the new precast treads were increased in depth to 60mm in order to improve, even if very little, the ratio between the concrete mass and the live load mass, and also to permit a more rational location of the reinforcement. (Fig. 2.1.3)

Also, in order to have the reinforcement as far as possible from the neutral axis, the mesh was located at only 10mm from the bottom of the precast plank, disregarding the Code recommendation for cover. Being in sheltered conditions we considered that the risk of corrosion was negligible.

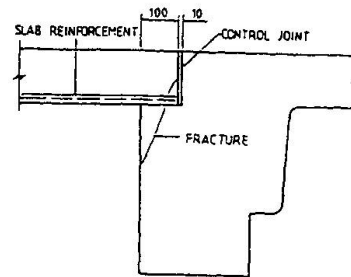
FIGURE 2.2.1

Figures 2.2.1 and 2.2.1 (a), show how the joint was originally detailed and the extent of the subsequent damage.

It can be appreciated that the insufficient width of seating, the erroneous detailing of the reinforcement and the total lack of any kind of sliding strip to reduce friction, led inevitably to the result shown on Figure 2.2.1 (a).

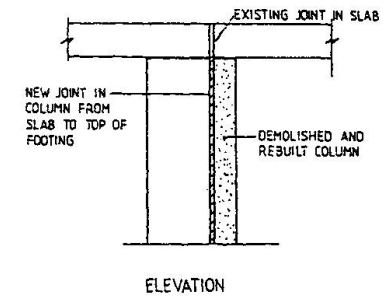
FIGURE 2.3.1

At one end of the control joint, both sides of the structure were supported by the same massive column, 2500 x 450 in section. (See Fig. 2.3.1)

The problem was that an approximately vertical crack developed in the column. It started at the top of the column in the vicinity of the slab control joint, and extended down for about 2m.

The design was inherently faulty: the initially correct introduction of a Control Joint was not carried through to its logical conclusion. It is true that the slabs were not poured monolithically with the column, but no sliding pads were used to allow for movement.

The substantial vertical load combined with the high friction co-efficient concrete to concrete produced an unacceptable restraint to shrinkage.

To make things worse, starter bars connected the column to both slabs, contradicting still more the concept of a control joint.
