Artikel: Correcting design deficiencies in a new five-story building
Autor: Suarez, Mario G. / McCarthy, Daniel J.
DOI: <https://doi.org/10.5169/seals-55357>

Correcting Design Deficiencies in a New Five-Story Building

A five-story office building was investigated to assess its structural integrity immediately following construction, prior to occupancy. Each floor level consisted typically of two-way post-tensioned concrete slabs, except the fourth level which was built in reinforced concrete. Significant structural deficiencies were identified. Some elements had little or no reserve against failure at normal service loads. A proposed load test was judged to be inappropriate, as it would have likely resulted in failure of structural elements. Repair and strengthening measures involving various methods and materials were engineered.

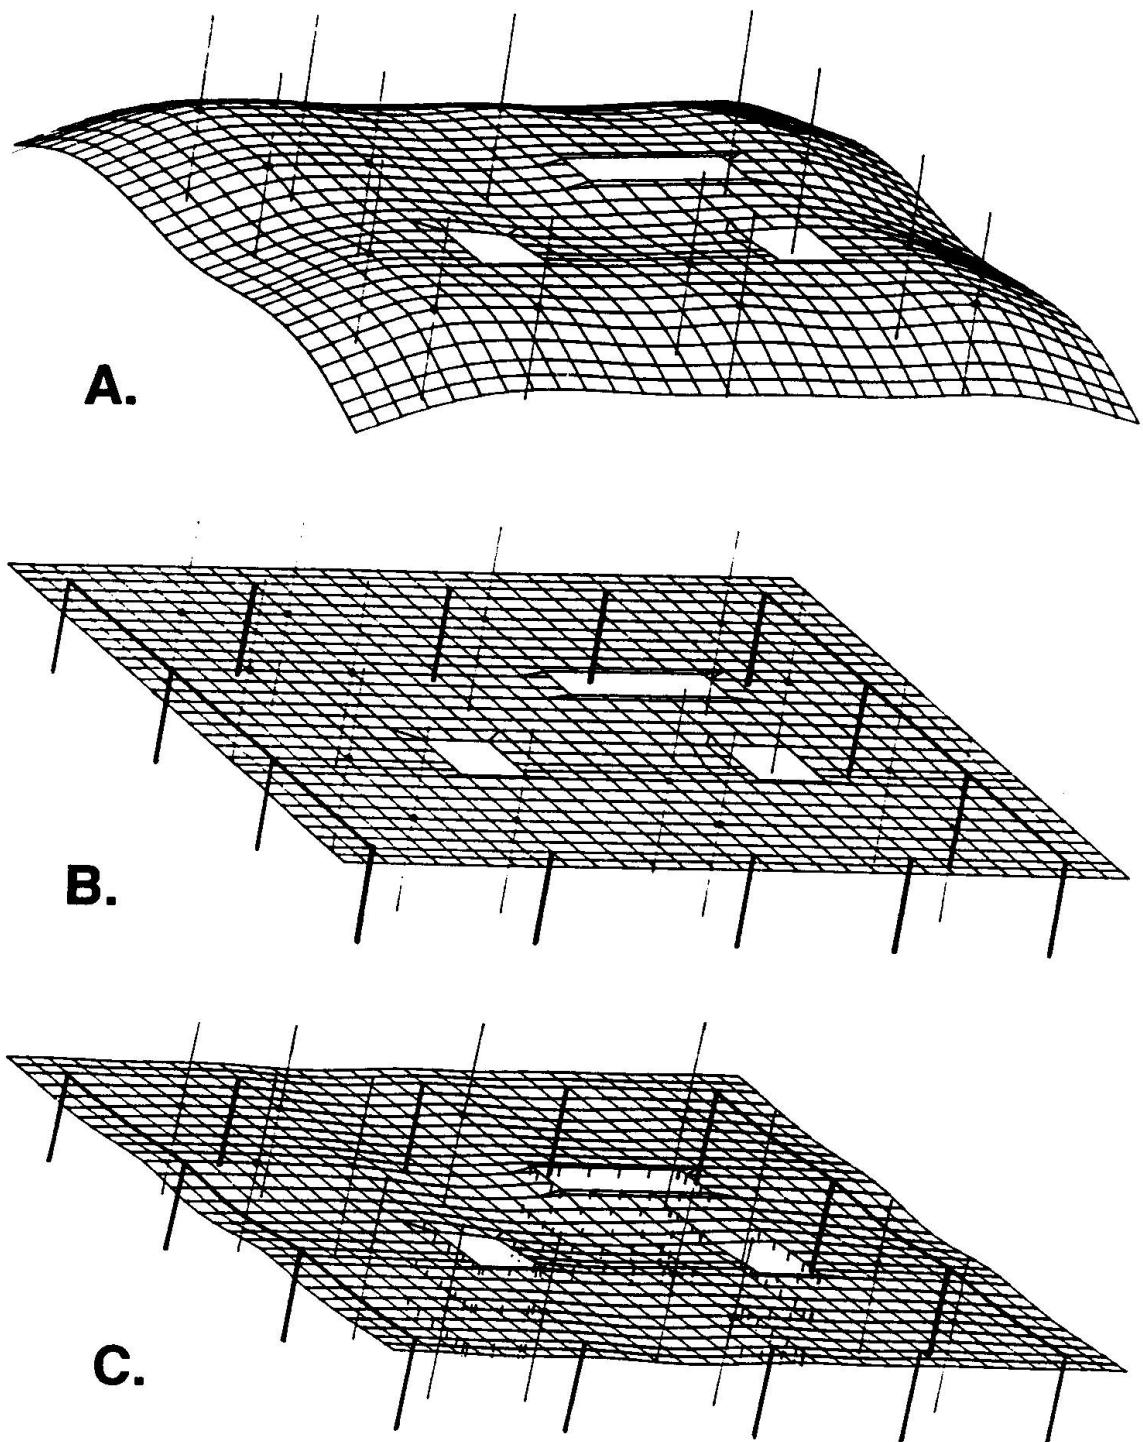
Fig. 2 Finite element models of fifth floor two way posttensioned slab system:

The principal deficiencies determined by analysis were: the cantilevered slab/beam assemblies were under-designed and had excessive deflections; most of the supporting columns, especially the perimeter ones supporting the overhangs, were also found to be significantly under-designed.

Fig. 2A shows the deflected shape, as determined by analysis, of the fifth floor slab system, as originally designed, under full service load. It is quite apparent that the slab deflections, especially those of the cantilever overhangs, are excessive, possibly implying that the slab is overstressed. There was some visual evidence of this overstress in the form of slab top and column cracking. Fortunately, the fact that the cantilevered slabs had remained shored all along must have limited the amount and size of cracking observed.

It was estimated that some portions of the cantilevered slab and some peripheral

- A. Deflected shape under full service loads as originally designed (scale factor = 50).
- B. Location of added steel beams and perimeter columns (shown bold or undelected model).
- C. Deflected shape under full service load with added steel beams and perimeter columns (scale factor = 50).

columns would possibly have failed had full service loads ever been achieved. Therefore, a code load test, as requested by the Engineer, was judged to be inappropriate as it would have likely resulted in permanent damage to or partial failure of the structure.

The major strengthening was accomplished by adding a new line of steel columns (in effect, "permanent" shores) around the periphery of the floor to reduce the slab cantilever (see Fig. 2B). A steel beam was placed on top of the columns parallel to the north and south slab edges in order to control the cantilever deflections in the uniform spaced tendons direction. The new steel beams were preloaded by shimming to predetermined beam deflections, in order to pick up, at least, part of the dead load. The steel columns on the east and west sides were shimmed directly under the short cantilever beams. All the new steel columns sit directly on top of the periphery concrete columns supporting the fourth floor. Consequently, the loads picked up by them is directly transferred down the structure to the footings. This strengthening scheme was chosen because of its relative ease and speed of implementation, and its relatively minor disruption of lease space.

Fig. 2C represents the deflected shape of the strengthened fifth floor under full service loads. Comparing this figure with Fig. 2A, it is readily evident that the cantilever slab deflection and, thus, tensile stresses, have been substantially reduced. The latter, as shown by analysis, appear to be within allowable code levels.

Where analysis indicated several local regions of slab bottom overstress, these areas were locally strengthened by adding supplemental reinforcing steel bonded to the slab soffit with latex modified shotcrete. A slab top area near the elevator core which analysis indicated was overstressed, since no top steel was called for in the original design, was strengthened by placing reinforcing bars in slots cut into the slab and bonding the bar to the slab with latex modified mortar.

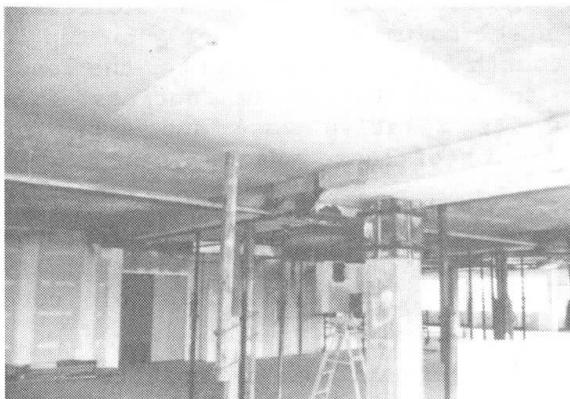
The principal design-related deficiencies found were: the shallow, reinforced concrete transfer girders, as well as a number of their supporting columns were significantly under-designed; some local slab areas were found to be overstressed (in tension). It is not known why the fourth floor slab was designed in conventional reinforced concrete, when post-tensioning could have been particularly beneficial.

Evidence of the probable distress which could be anticipated in the transfer girders, under full service loads, was the observed extensive flexural cracking

under dead load only, principally under the columns supported by the girders. The magnitude of the cracking of the transfer girders, under partial dead load and relatively light construction loads, clearly indicated a lack of structural strength.

The columns below, supporting the transfer girders, also had evidence of distress under reduced dead load conditions in the form of flexural cracking. Because of the heavy concentrated column load coming down at about midspan of the transfer girders, the top of the supporting columns would bend in towards the center of the building, with cracking thus expected on the outside faces of the columns. This cracking was clearly evident under partial dead load conditions only. Excessive deflections and failure of some structural elements might have occurred had full service loads ever been achieved.

Fig. 3 External post-tensioning of transfer girders and steel collars confining column tops

The most practical solution to retrofit the transfer girders was determined to be the use of external post-tensioning (see Fig. 3). To fully resolve all structural deficiencies resulting from the analysis would have been impractical. Therefore, a re-analysis of the fourth floor allowing for plastic deformation of the concrete (the creation of hinges) at factored load conditions was carried out. In this way, moments were redistributed to girder and slab regions which would be more convenient to reinforce. Yet, up to factored load conditions, no structural integrity would be compromised.

Based on this re-analysis, using plasticity principles, the external post-tensioning was designed to ensure that the transfer girders achieve ultimate strength at factored load conditions. The deficient top and bottom slab regions were strengthened with additional reinforcement bonded to the slab (as was done on the fifth floor level). The re-analysis revealed that the strengthened slab system would perform adequately if the tops of the 7 deficient columns were allowed to develop a plastic hinge as a To ensure the safe plastic deformation of was provided using steel angle collars

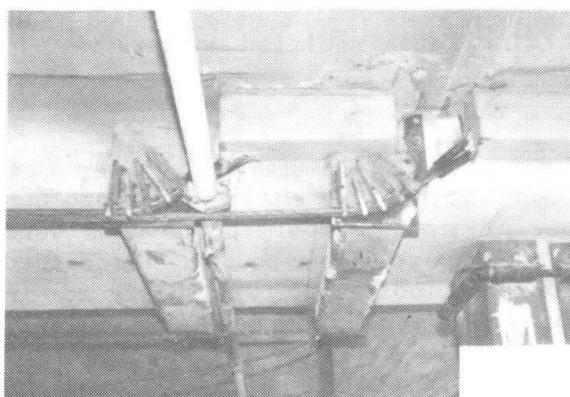
Fig. 4 Close-up of external post-tensioning tendon deviation saddles at transfer girder

connection to the concrete beams above. the concrete column tops, confinement tightened together by high-strength bolts to achieve about 3.4 MPa of lateral pressure (see Fig. 4).
