Zeitschrift: IABSE reports = Rapports AIPC = IVBH Berichte
Band: 73/1/73/2 (1995)

Artikel: Renovation of Seattle's historic Paramount Theatre
Autor: Lundein, Terry R. / Harriott, James D.
DOI: <https://doi.org/10.5169/seals-55172>

Renovation of Seattle's Historic Paramount Theatre

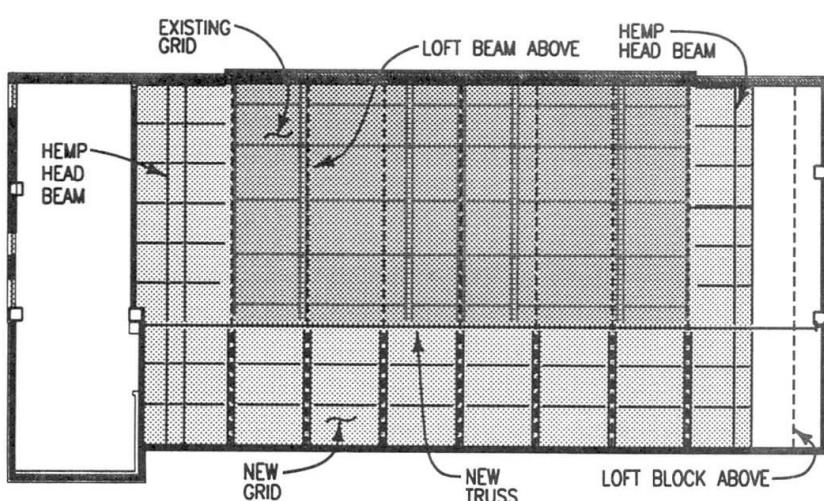
Fig. 3: Major Stage Rigging Elements

Another important improvement during this renovation was the modification of the rigging arrangement. Originally, the stage rigging system was mounted to the gridiron 21 m above the stage and 3 m below the roof. This arrangement created a congested web of loft lines at the gridiron, making access to spot lines very difficult. In modern theatres, rigging consists of loft lines pulled vertically through sheaves which are attached to roof beams and hemp lines which thread through pulleys mounted on the gridiron. The loft lines support scenery and are spaced at 20 cm on center upstage and downstage and spaced at 3 m on center side to side. The loft lines are collected on the head block at stage right and then drop down to a counterbalance pit below stage level. The hemp lines support spot loads on the stage and pass through hemp head beams on each side of the gridiron. A plan view of the gridiron showing major elements is given in Figure 3.

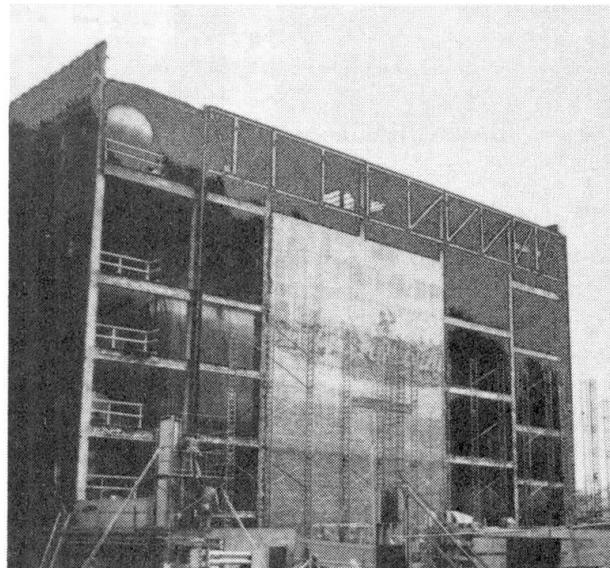
Fig. 2: New Truss

With the necessary removal of the back wall structure, the existing roof structure required new support. New support was provided by installation of a 3 m deep steel truss spanning 27 m over the new stage. The new truss can be seen in Figure 2. This photo was taken prior to demolition of the rear wall and existing columns.

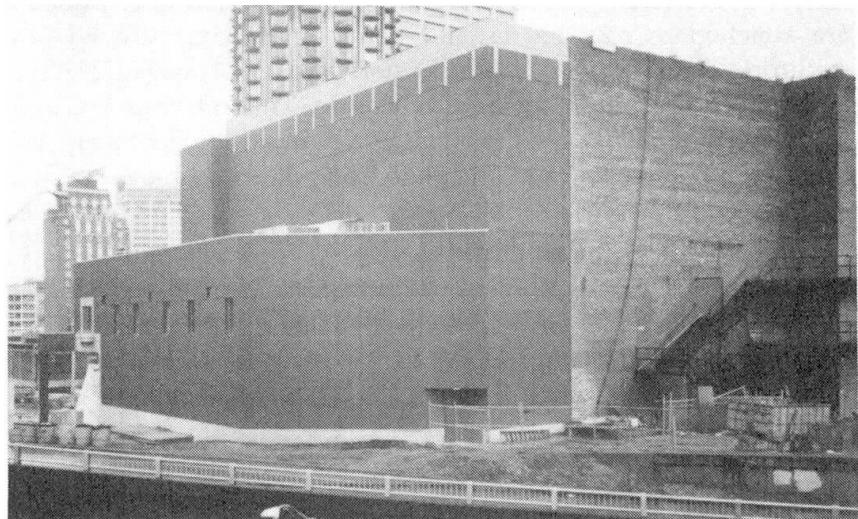
Fig. 4: Backstage Addition

The foundation of the new structure consisted of concrete augercast piles in combination with the steel soldier piles, which were attached to the concrete walls for transfer of permanent gravity loads. The loading dock is a cast-in-place concrete structure designed for highway truck loads. The dressing rooms and roof are conventional steel frame floor systems supported on steel tube columns at the exterior and concrete masonry unit (CMU) walls at the backstage wall. This tall slender 19 cm CMU wall also supports a portion of the expanded stage roof. A photograph of the building showing the backstage addition is given in Figure 4.

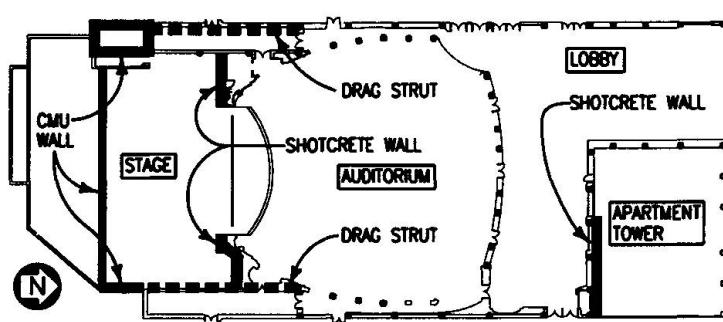
Fig. 5: New Seismic Elements

The new concrete shearwalls were located at the walls demising the different functions of the building in order to minimize the impact to the architectural program. A key plan showing major lateral force resisting elements is given in Figure 5.

For seismic loads in the transverse (east/west) direction, new reinforced masonry and concrete shearwalls were designed to resist the entire seismic base shear. Since the existing backstage (south) wall was removed to accommodate the stage expansion, the new backstage wall of reinforced masonry was designed to resist the seismic forces from the southern portion of the combined building. A new shotcrete wall was placed against the demising wall between the theatre and apartment tower and was designed to resist seismic forces from the northern portion of the theater as well as the apartment tower. This wall eliminated the weak story condition in that portion of the building. In addition to the two main walls, the proscenium wall was strengthened. This strengthening was designed only to provide some measure of ductility at the proscenium opening. This wall was not designed to carry any of the building seismic forces apart from its own weight.
