Zeitschrift: IABSE reports = Rapports AIPC = IVBH Berichte
Band: 73/1/73/2 (1995)

Artikel: Renovation of Seattle's historic Paramount Theatre
Autor: Lundeen, Terry R. / Harriott, James D.
DOI: <https://doi.org/10.5169/seals-55172>

Renovation of Seattle's Historic Paramount Theatre

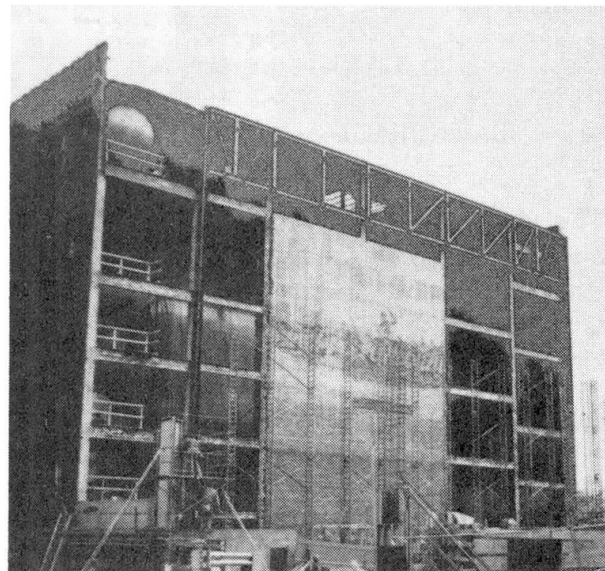
Fig. 2: New Truss

With the necessary removal of the back wall structure, the existing roof structure required new support. New support was provided by installation of a 3 m deep steel truss spanning 27 m over the new stage. The new truss can be seen in Figure 2. This photo was taken prior to demolition of the rear wall and existing columns.

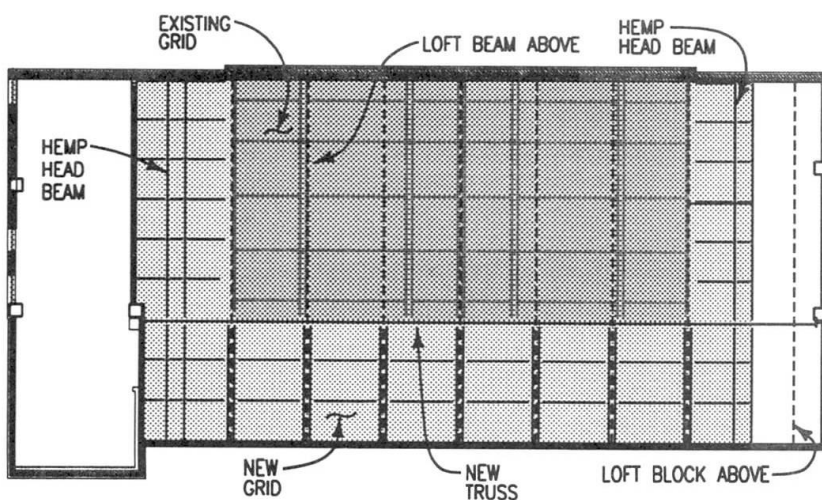
Fig. 3: Major Stage Rigging Elements

Another important improvement during this renovation was the modification of the rigging arrangement. Originally, the stage rigging system was mounted to the gridiron 21 m above the stage and 3 m below the roof. This arrangement created a congested web of loft lines at the gridiron, making access to spot lines very difficult. In modern theatres, rigging consists of loft lines pulled vertically through sheaves which are attached to roof beams and hemp lines which thread through pulleys mounted on the gridiron. The loft lines support scenery and are spaced at 20 cm on center upstage and downstage and spaced at 3 m on center side to side. The loft lines are collected on the head block at stage right and then drop down to a counterbalance pit below stage level. The hemp lines support spot loads on the stage and pass through hemp head beams on each side of the gridiron. A plan view of the gridiron showing major elements is given in Figure 3.

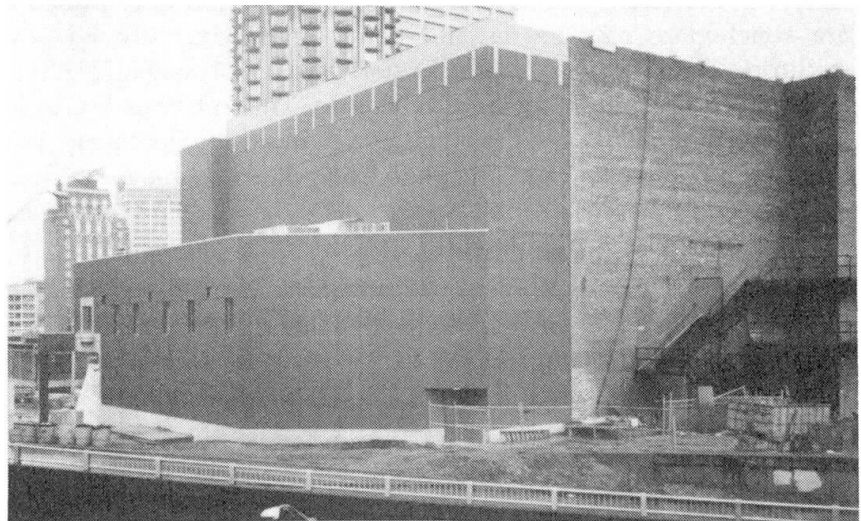
Fig. 4: Backstage Addition

The foundation of the new structure consisted of concrete augercast piles in combination with the steel soldier piles, which were attached to the concrete walls for transfer of permanent gravity loads. The loading dock is a cast-in-place concrete structure designed for highway truck loads. The dressing rooms and roof are conventional steel frame floor systems supported on steel tube columns at the exterior and concrete masonry unit (CMU) walls at the backstage wall. This tall slender 19 cm CMU wall also supports a portion of the expanded stage roof. A photograph of the building showing the backstage addition is given in Figure 4.
