Artikel: Deterioration and evaluation of Chien-Kou Viaduct in Taipei

Deterioration and Evaluation of Chien-Kou Viaduct in Taipei

Chien-Kou Viaduct was the first urban expressway built in Taiwan in 1983. The traffic growth increased rapidly since then. Traffic volume of the viaduct had already reached its capacity, and some damages were observed in the past years. This paper focuses on the damage assessment and the safety evaluation of the viaduct, especially, the non-destructive test for the investigation of corrosion rate of steel rebar.

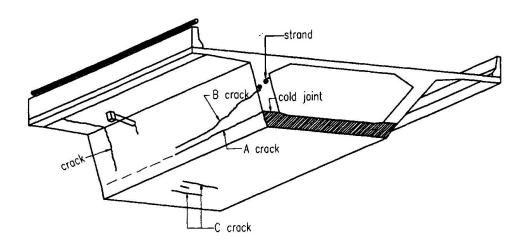
Figure 4. Cracks on P.C. Box Girder

(1) Cracks on P.C. box girders: This kind of cracks included three different types - type A crack on the cold joint of bottom slab and web, type B crack on girder web along the strand and type C crack on the bottom slab as shown in Figure 4. There was some water found on type A and C cracks because of the broken drainage pipe. The reason that caused type C crack was related to the service loading.

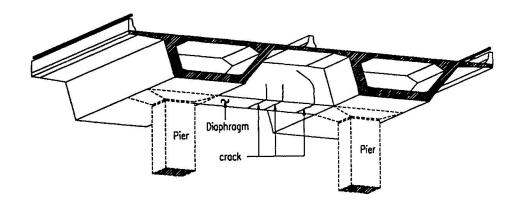
Figure 8 Cracks on Diaphragm

(3) Cracks on diaphragm: There were cracks on the bottom of girder diaphragm as shown in Figure 8
