Artikel: Deterioration and evaluation of Chien-Kou Viaduct in Taipei
Autor: Lin, Shuh-Juh / Yeh, Ming-Huang / Wang, Jaw-Lieh
DOI: <https://doi.org/10.5169/seals-55381>

Deterioration and Evaluation of Chien-Kou Viaduct in Taipei

Chien-Kou Viaduct was the first urban expressway built in Taiwan in 1983. The traffic growth increased rapidly since then. Traffic volume of the viaduct had already reached its capacity, and some damages were observed in the past years. This paper focuses on the damage assessment and the safety evaluation of the viaduct, especially, the non-destructive test for the investigation of corrosion rate of steel rebar.

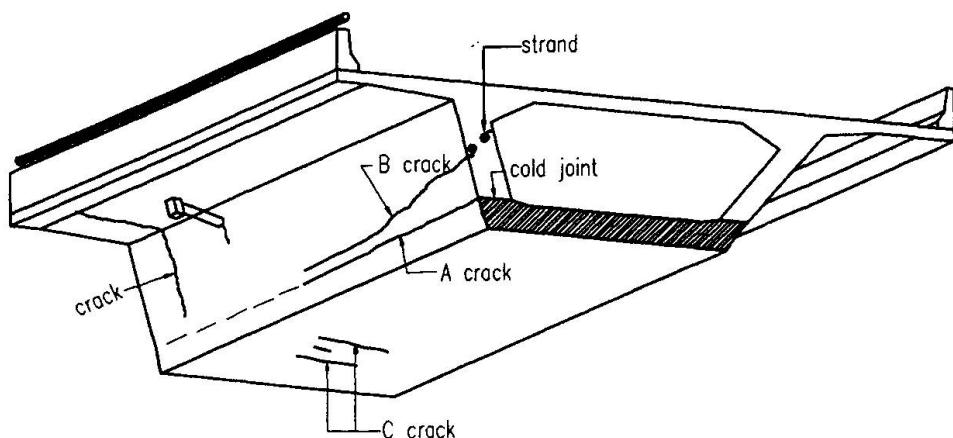
Figure 4. Cracks on P.C. Box Girder

(1) Cracks on P.C. box girders : This kind of cracks included three different types - type A crack on the cold joint of bottom slab and web, type B crack on girder web along the strand and type C crack on the bottom slab as shown in Figure 4. There was some water found on type A and C cracks because of the broken drainage pipe. The reason that caused type C crack was related to the service loading.

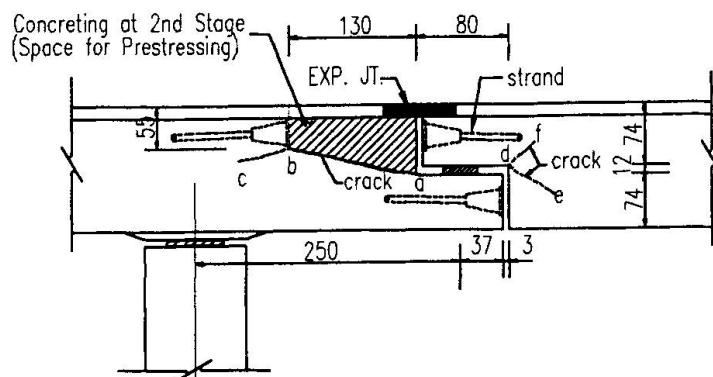
Figure 5. Cracks on Connection Joint

(2) Cracks on connection joint: The main crack on side face of connection joint was alone point a to point b as shown in Figure 5. This kind of crack was caused by differential shrinkage and creep of two different age or strength of concretes. There were also cracks on bottom face of connection joint as shown in Figure 6. This kind of crack was caused by principal stress of bearing reactions as shown in Figure 7. There were no cracks observed on the corner of girder or anchor zone of strand since a detail study was done for the reinforcement design of the connection joint.

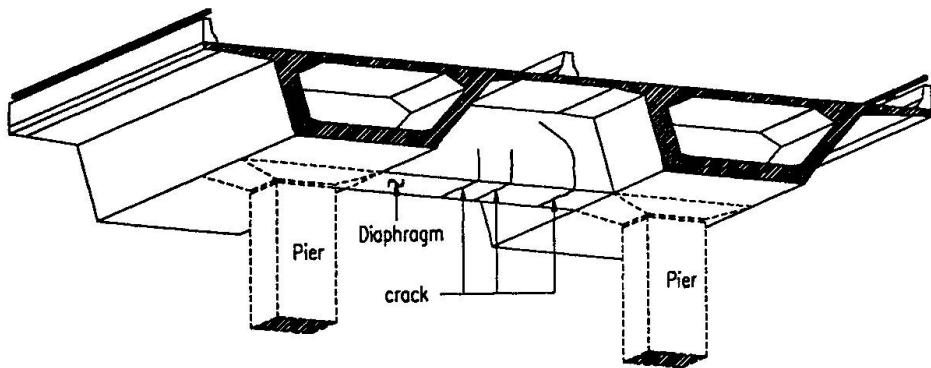
Figure 8. Cracks on Diaphragm

(3) Cracks on diaphragm: There were cracks on the bottom of girder diaphragm as shown in Figure 8.
