Artikel: Deterioration and evaluation of Chien-Kou Viaduct in Taipei
Autor: Lin, Shuh-Juh / Yeh, Ming-Huang / Wang, Jaw-Lieh
DOI: <https://doi.org/10.5169/seals-55381>

Deterioration and Evaluation of Chien-Kou Viaduct in Taipei
Détérioration et évaluation du viaduc Chien-Kou à Taipei
Schäden und Zustandsbeurteilung des Chien-Kou-Viadukts in Taipei

Chien-Kou Viaduct was the first urban expressway built in Taiwan in 1983. The traffic growth increased rapidly since then. Traffic volume of the viaduct had already reached its capacity, and some damages were observed in the past years. This paper focuses on the damage assessment and the safety evaluation of the viaduct, especially, the non-destructive test for the investigation of corrosion rate of steel rebar.

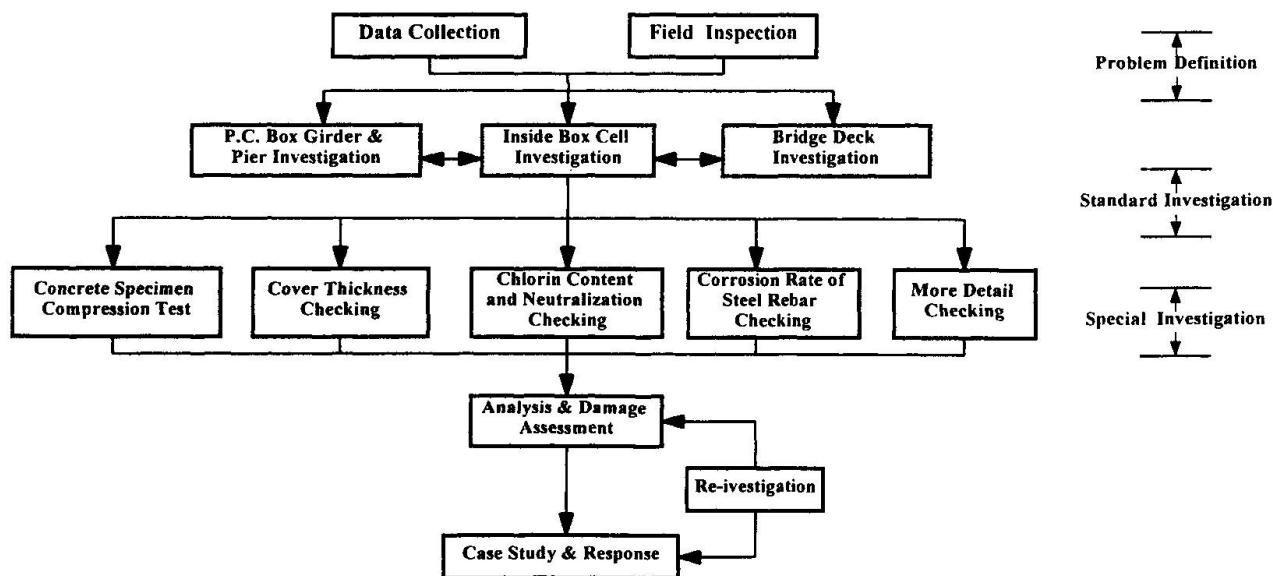
Figure 3. Inpsection of Chien Kou Viaduct

The structure of viaduct was mainly P.C. box girders and R.C. piers. The resisting capacity of the viaduct depends mainly on the strengths of concrete and reinforcement. Therefore, the inspections were focus on the damage assessment of these two materials. The checking items were damage assessment on main structure, evaluation of concrete strength and concrete deterioration, and investigation of rebar corrosion.

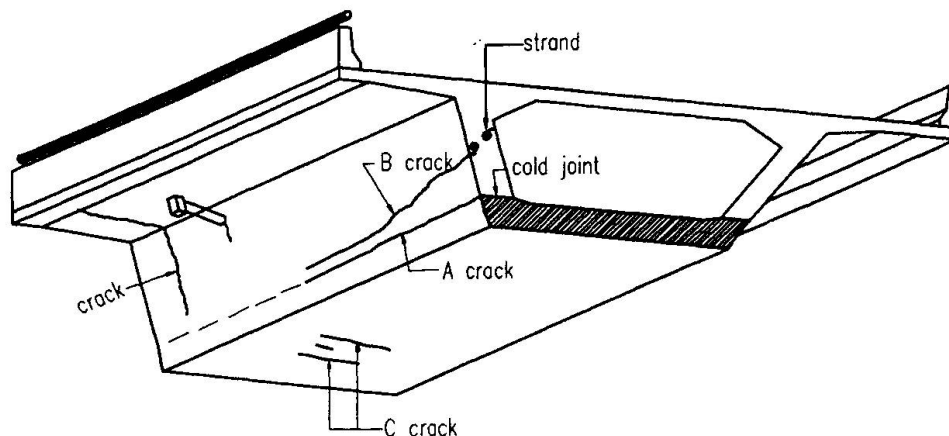
Figure 4. Cracks on P.C. Box Girder

(1) Cracks on P.C. box girders : This kind of cracks included three different types - type A crack on the cold joint of bottom slab and web, type B crack on girder web along the strand and type C crack on the bottom slab as shown in Figure 4. There was some water found on type A and C cracks because of the broken drainage pipe. The reason that caused type C crack was related to the service loading.

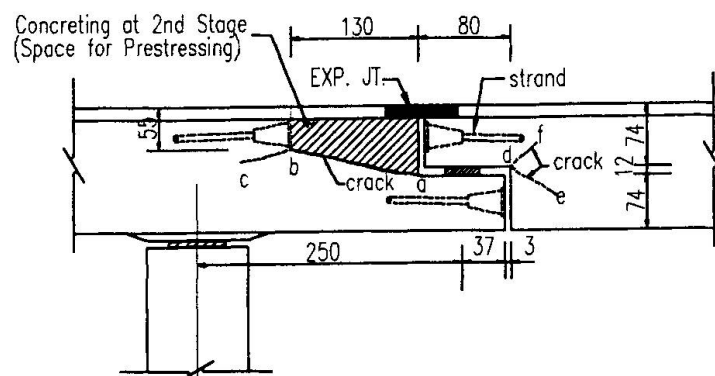
Figure 5. Cracks on Connection Joint

(2) Cracks on connection joint: The main crack on side face of connection joint was along point a to point b as shown in Figure 5. This kind of crack was caused by differential shrinkage and creep of two different age or strength of concretes. There were also cracks on bottom face of connection joint as shown in Figure 6. This kind of crack was caused by principal stress of bearing reactions as shown in Figure 7. There were no cracks observed on the corner of girder or anchor zone of strand since a detail study was done for the reinforcement design of the connection joint.

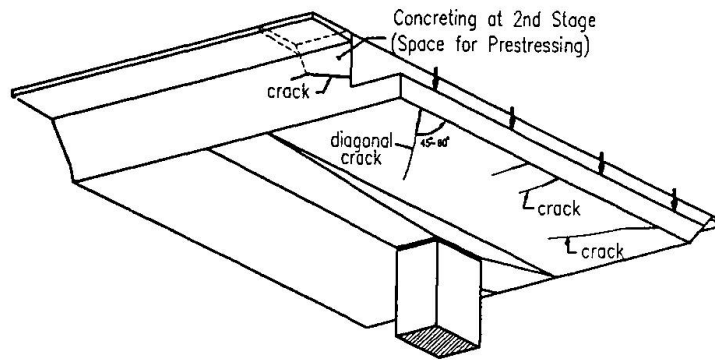
Figure 6. Cracks on Bottom of Connection Joint

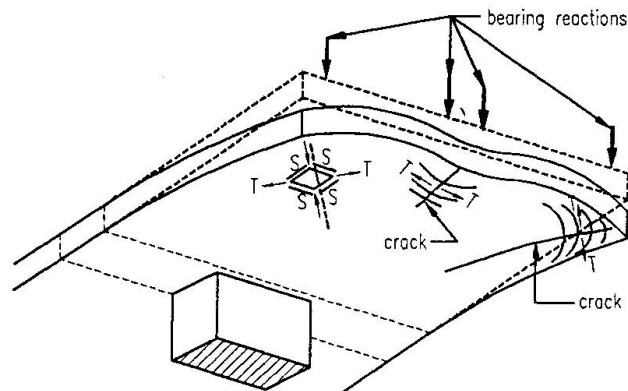
Figure 7. Cracks Caused by Principal Stress of Bearing Reactions

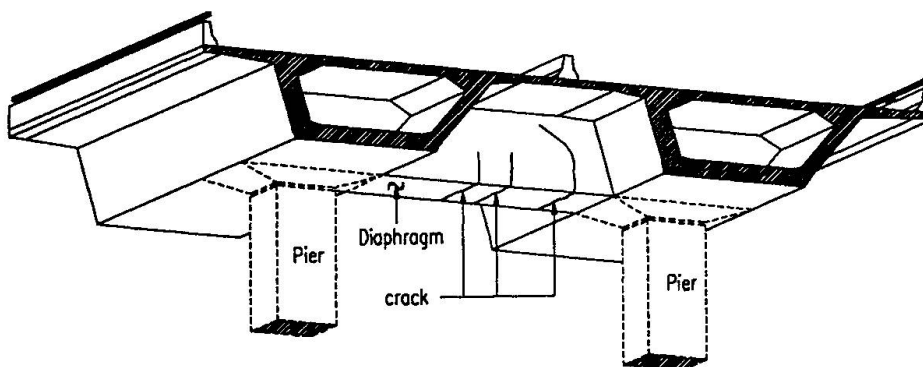
Figure 8 Cracks on Diaphragm

(3) Cracks on diaphragm: There were cracks on the bottom of girder diaphragm as shown in Figure 8.
