**Artikel:** Strengthening of an unreinforced masonry building

**Autor:** Heintz, Jon A. / Wosser, Thomas D.

## Strengthening of an Unreinforced Masonry Building

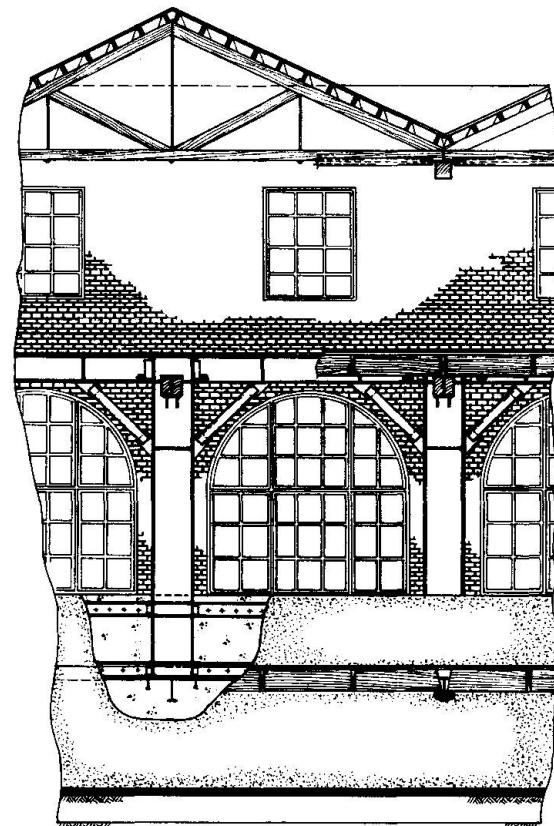
**Fig. 2** Drawing of Knee-Braced Frame System

The massive nature of the construction at 50 Green Street, so strong for vertical loads, was actually contributing to the seismic deficiencies of the building. Code prescribed capacities for brick walls and wood diaphragms were not adequate for the seismic forces generated in the building. It was an interesting challenge to point out walls, 71 cm thick, and heavy timber framing to an owner who is very proud of his building, and attempt to explain just how "weak" they can be. In-plane wall strengthening was required in both directions, and diaphragm strengthening was required at all levels. The thick exterior walls satisfied UMB Ordinance slenderness requirements, but the thinner interior walls required out-of-plane stabilization.

A steel knee-braced frame was selected to supplement the longitudinal walls. A relative rigidity analysis was performed using the structural analysis program, RISA-2D, to verify that the knee-braced system would draw load from the existing brick walls. The resulting W36x150 column members are stiffness controlled. They are embedded in a concrete foundation wall that extends up to the sill of the arched windows, providing a fixed base and shortened effective story height. Centered on the arched piers, the new columns must support the existing floor girders that frame into the wall at the same location. The girders were shored, cut back from the wall to erect the columns, and then seated on a bracket welded to the column web.

The most critical connections occurred along the length of the drag strut which delivered load to the knee-braced frames located at one end of the building. The drag consists of a large tube section running along the wall just below the floor joists. At each pier the existing wood girders interrupted the continuity of the drag. Horizontal slots were drilled through the girders to allow splice plates to pass through and weld to the tube on either side. The drag strut also served as a horizontal strong-back, anchoring the walls to the heavy floor girders for out-of-plane loads. Diaphragm to wall connections were made using threaded epoxy anchors, installed after the drag strut was in place. The anchors were drilled to within 5 cm of the exterior surface of the wall, and were responsible for both in-plane shear transfer and out-of-plane wall anchorage.

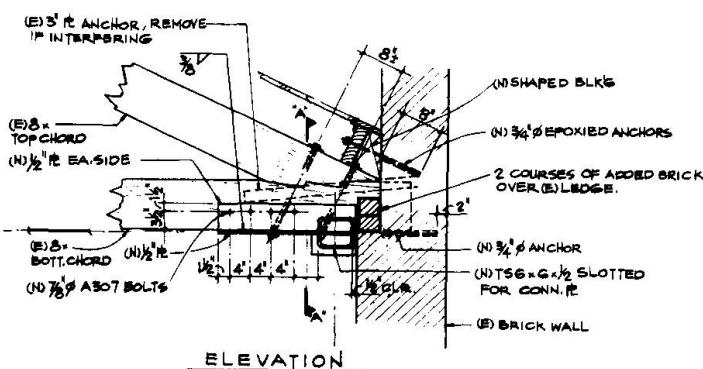
**Fig. 4** Roof Diaphragm Connection at Truss

Another concern was a new roof membrane that was recently installed. The owner wanted to leave it intact, so roof diaphragm strengthening was restricted to inside the building, and conventional plywood sheathing was not an option.

To avoid the new roof membrane, a steel tension rod diaphragm was installed at the bottom chord of the roof trusses. Slotted tube connections, clevises, and turnbuckles allowed fit up tolerance and angular adjustments during erection. In anticipation of inevitable variations in field conditions, a liberal safety factor was incorporated into the design. This came in handy when existing conditions were not "square" and eccentricities had to be built into the system. Particularly challenging, were connections between the new steel elements and the integral wood trusses. Connection brackets were prefabricated, and consisted of vertical tabs for bolting into the side of the truss, welded to horizontal gusset plates. Extra bolt holes were provided in the tabs in case non-typical truss connections interfered with a prefabricated bolt location.
