Artikel: Strengthening of an unreinforced masonry building
Autor: Heintz, Jon A. / Wosser, Thomas D.
DOI: <https://doi.org/10.5169/seals-55176>

Strengthening of an Unreinforced Masonry Building

Jon A. HEINTZ
Design Engineer
Degenkolb Engineers
San Francisco, CA, USA

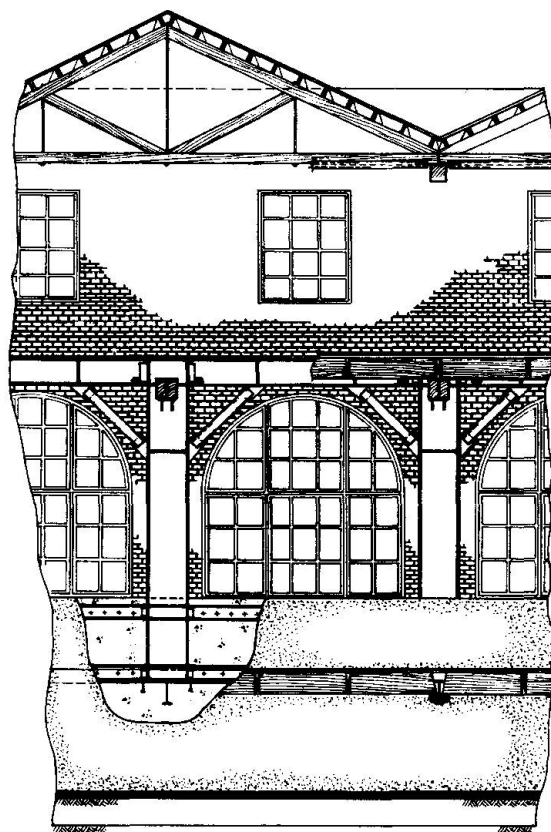
A steel knee-braced frame was selected to supplement the longitudinal walls. A relative rigidity analysis was performed using the structural analysis program, RISA-2D, to verify that the knee-braced system would draw load from the existing brick walls. The resulting W36x150 column members are stiffness controlled. They are embedded in a concrete foundation wall that extends up to the sill of the arched windows, providing a fixed base and shortened effective story height. Centered on the arched piers, the new columns must support the existing floor girders that frame into the wall at the same location. The girders were shored, cut back from the wall to erect the columns, and then seated on a bracket welded to the column web.

The most critical connections occurred along the length of the drag strut which delivered load to the knee-braced frames located at one end of the building. The drag consists of a large tube section running along the wall just below the floor joists. At each pier the existing wood girders interrupted the continuity of the drag. Horizontal slots were drilled through the girders to allow splice plates to pass through and weld to the tube on either side. The drag strut also served as a horizontal strong-back, anchoring the walls to the heavy floor girders for out-of-plane loads. Diaphragm to wall connections were made using threaded epoxy anchors, installed after the drag strut was in place. The anchors were drilled to within 5 cm of the exterior surface of the wall, and were responsible for both in-plane shear transfer and out-of-plane wall anchorage.

Fig. 2 Drawing of Knee-Braced Frame System

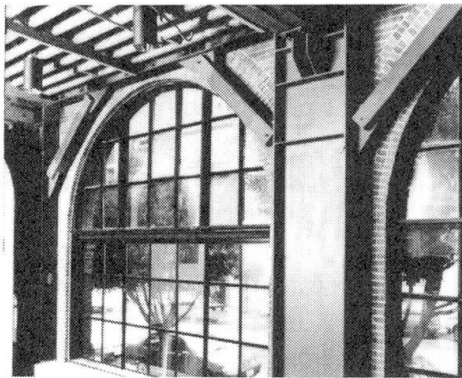
Fig. 5 Completed Knee-Braced Frame
