Artikel: Strengthening of an unreinforced masonry building
Autor: Heintz, Jon A. / Wosser, Thomas D.
DOI: <https://doi.org/10.5169/seals-55176>

Strengthening of an Unreinforced Masonry Building

50 Green Street is a two-story brick structure located north of Market Street in San Francisco's warehouse district. It occupies the entire city block between Green, Commerce, Battery, and Front Streets. The exterior facade consists of an arcade of slender piers and graceful semicircular arches along all four elevations. Ornate brick relief patterns around the arches, raised detailing in the four corners, and corbelled courses of brick at the parapet give the building a distinctive appearance.

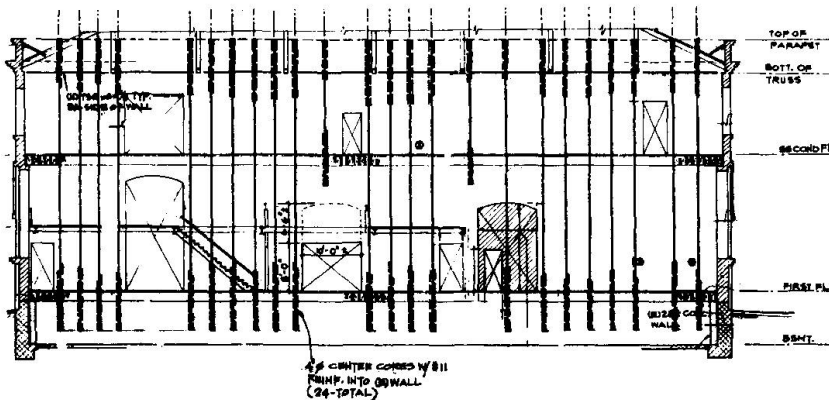
Fig. 3 Interior Elevation of CenterCore Locations

In the transverse direction, a more favorable pier configuration existed, allowing the use of the existing brick walls for transverse lateral force resistance. To strengthen the walls, deformed reinforcing bars were installed using the CenterCore technique. Cores were added at wall locations that were highly stressed for in-plane shear, and at window and door jambs to provide trim reinforcement wherever possible. CenterCores provided reinforcement to stabilize the slender interior walls for out-of-plane forces, and were designed using standard reinforced masonry principles.

The CenterCore technique involves core drilling vertically through the wall from parapet to foundation, and installing grouted reinforcing bars. Coring specifications allowed a tolerance of two inches out of plumb at the base of the wall, 15 meters below the top of the parapet. Occasional repairs to wall surfaces were required when the bit broke through the side of the wall after being forced off line by unexpected iron embedded in the wall. A dry coring method was selected to avoid the disruption of water associated with wet coring operations. This resulted in dust migrating through micro-cracks in the walls during coring operations. Dust became so severe that the entire length of each wall within the building was wrapped in plastic and ventilated with negative air machines to prevent infiltration throughout the tenant spaces. Based on lower unit cost and superior performance noted in the Breiholz report, polyester based resins were specified for grouting the cores. The resin

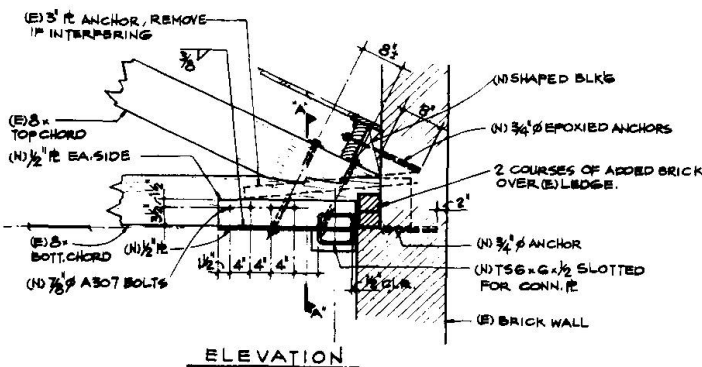
Fig. 4 Roof Diaphragm Connection at Truss

To avoid the new roof membrane, a steel tension rod diaphragm was installed at the bottom chord of the roof trusses. Slotted tube connections, clevises, and turnbuckles allowed fit up tolerance and angular adjustments during erection. In anticipation of inevitable variations in field conditions, a liberal safety factor was incorporated into the design. This came in handy when existing conditions were not "square" and eccentricities had to be built into the system. Particularly challenging, were connections between the new steel elements and the integral wood trusses. Connection brackets were prefabricated, and consisted of vertical tabs for bolting into the side of the truss, welded to horizontal gusset plates. Extra bolt holes were provided in the tabs in case non-typical truss connections interfered with a prefabricated bolt location.
