Repair and Consolidation of the Masonry Structure of a Building

Sevastean Ioan IANCA

Associate Professor
Technical University
Timisoara, Romania

The paper presents a study of a case about the damages caused by the 1977 earthquake to the structure of a building in Craiova, Romania, as well as repairing and consolidation solutions for this structure. The proposed solutions intend to restore the initial bearing capacity of the structure and its safety.

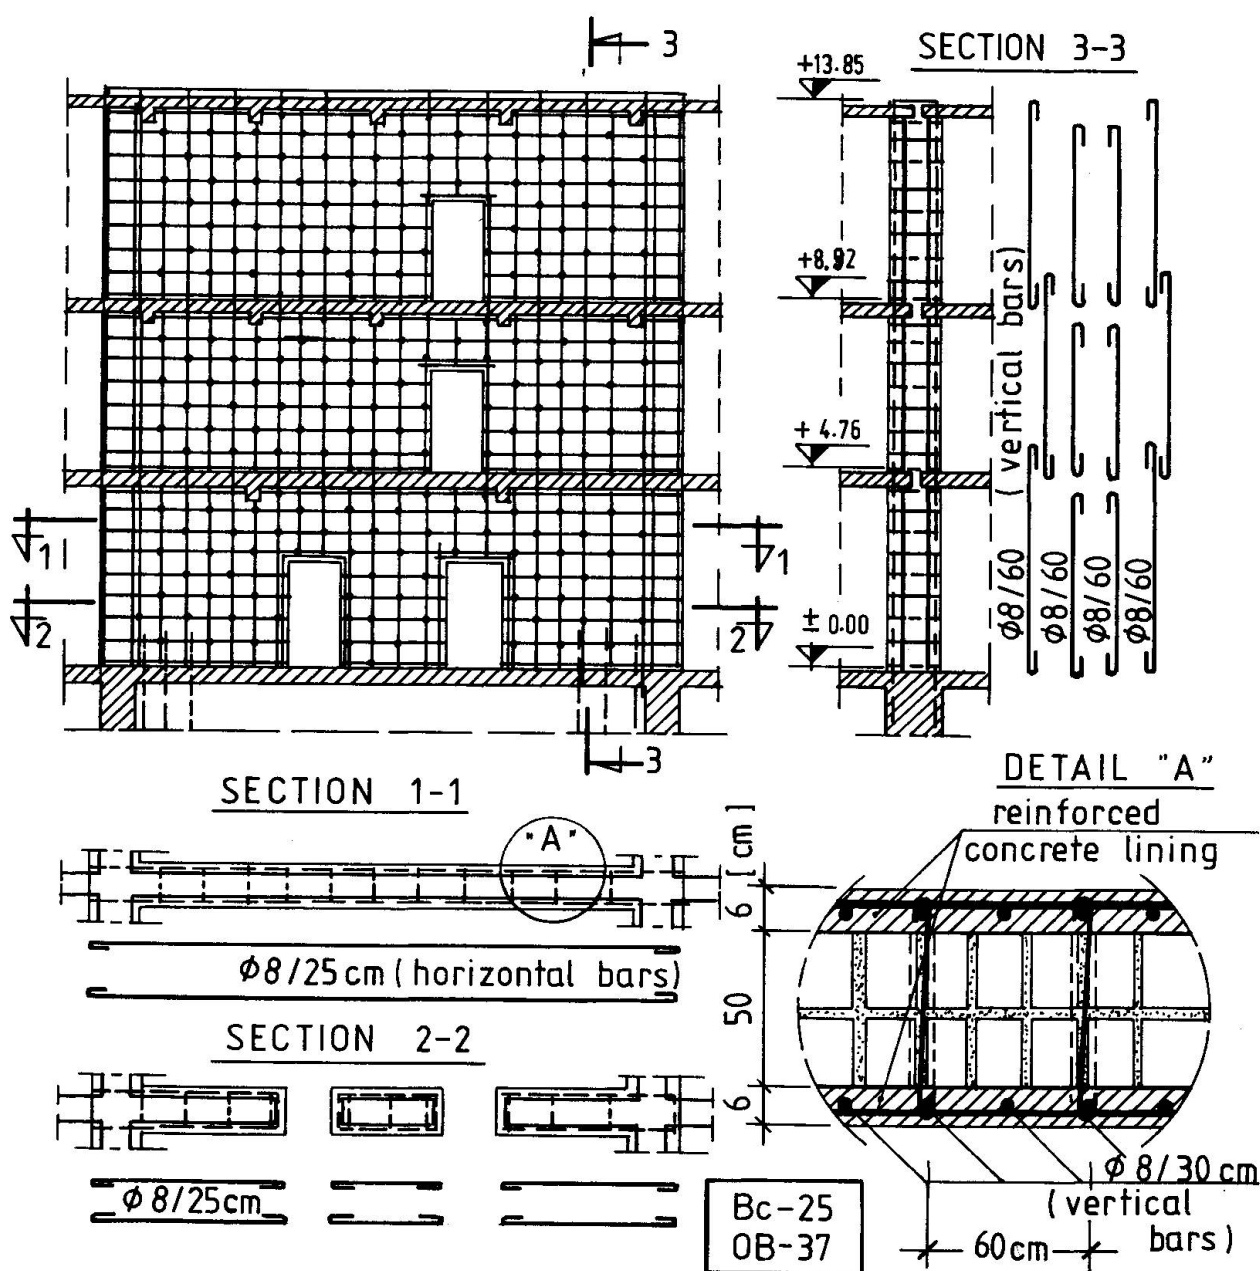
Fig. 3 The lining of the resistance masonry walls

- the lining on both sides of the longitudinal and transversal walls of the structure, with thin monolith reinforced concrete shear walls (having a thickness of 6 cm). There must be pointed out the necessity of the continuity of the vertical reinforcements from the concrete shear walls on both sides of the masonry wall (by piercing the floors), and the linking of the steel reinforcements on both sides of the masonry wall, with reinforcement nets traversing the wall (see Figure 3).

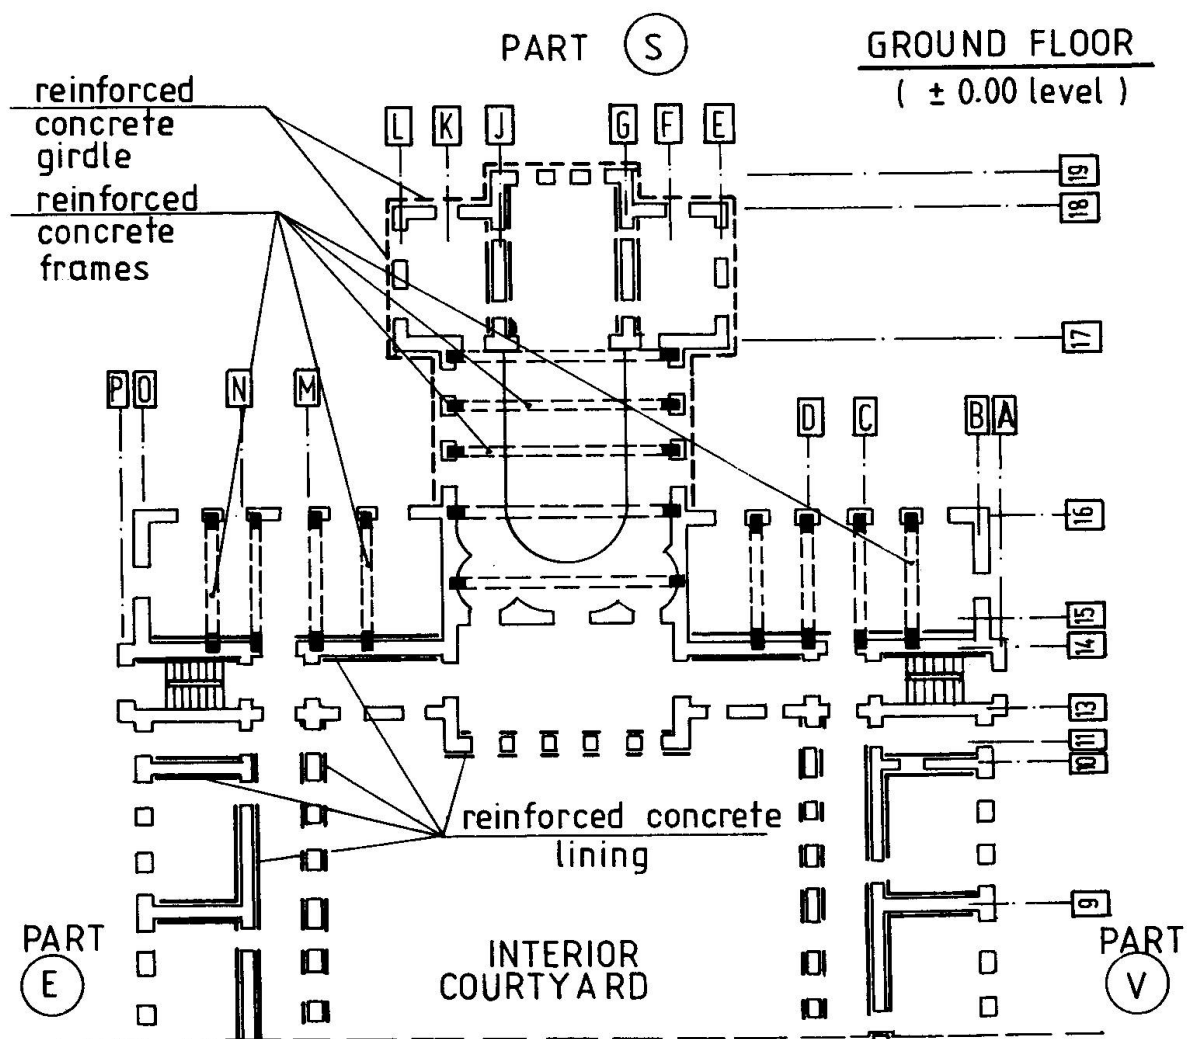
Fig. 4 The consolidation of the South wing of the building

- the making of eight reinforced concrete transversal frames in the South wing linked to the masonry walls and the existing floors (see Figure 4). The beams of these frames can be made including the existing monolith reinforced concrete beams of the floor, in the new beams of the frames and the monolith reinforced concrete columns can be made inside the two large rooms having their own foundations linked to the existing foundations of the walls.

- the consolidation of the amphitheatre by introducing the reinforced concrete transversal frames on the height of the basement, ground floor and first storey (see Figure 4). These frames will be linked with the exterior walls and with the existing transversal beams of the reinforced concrete floor above the amphitheatre;
