Repair and Consolidation of the Masonry Structure of a Building

Sevastean Ioan IANCA

The paper presents a study of a case about the damages caused by the 1977 earthquake to the structure of a building in Craiova, Romania, as well as repairing and consolidation solutions for this structure. The proposed solutions intend to restore the initial bearing capacity of the structure and its safety.

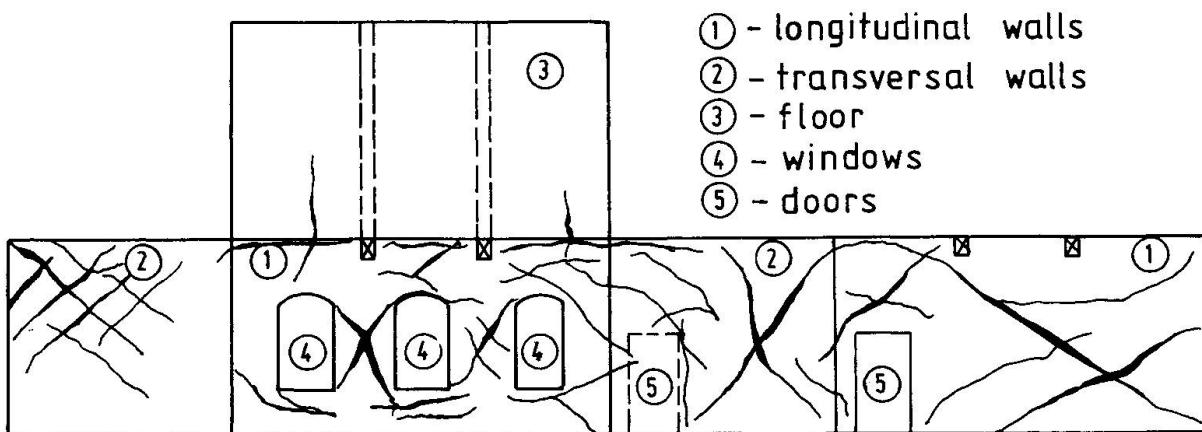
- the cracking of the majority of the resistance walls (longitudinal and transversal walls), with the following characteristics: horizontal cracks under the floor girdles, vertical cracks at the appearance of the floor joints, crossed cracks from the shearing loads and cracks in the lintels of doors and windows (see Figure 2);
- the appearance of a number of joints in the floors, caused by the cracking of the floors in the connection area between the transversal and longitudinal wings of the building;
- the settlement of the South wing walls foundation and the cracking of these walls;
- the cracking of the walls and stair elements of the staircases "B", "C" and "A" (see Figure 1), with partial wresting of the stair landings from the exterior walls of the staircases "B" and "C";
- the fall of the chimneys, causing damages of the roof and of the altic floors;

Fig. 2 An example of walls cracking

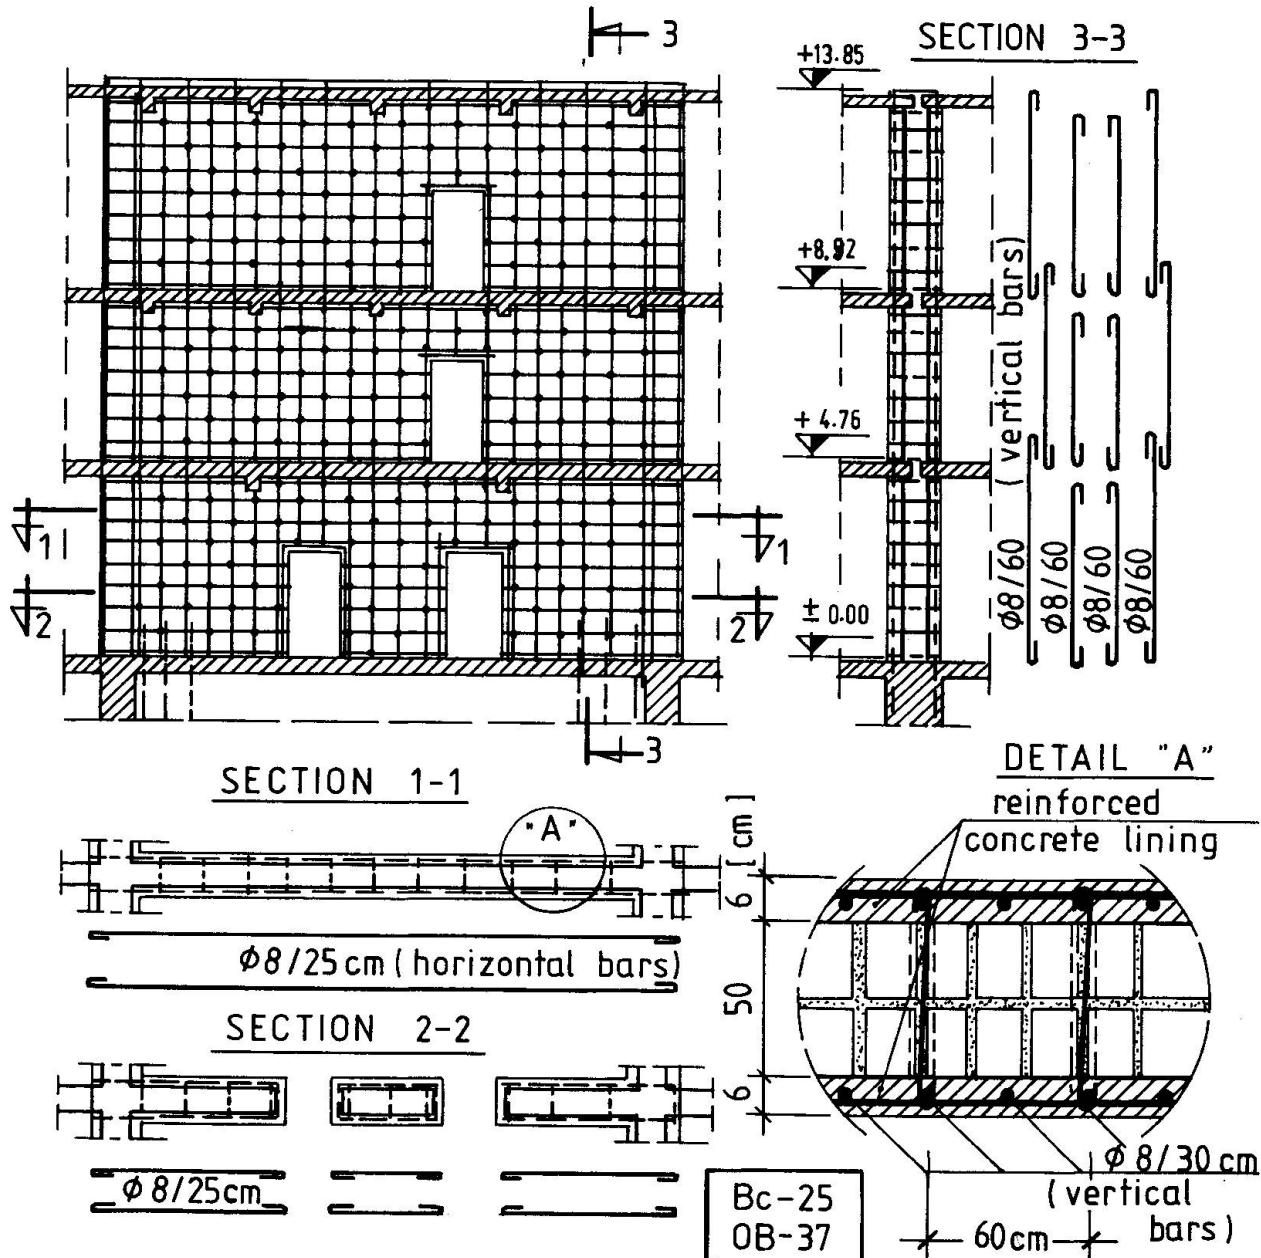
Fig. 3 The lining of the resistance masonry walls

- the lining on both sides of the longitudinal and transversal walls of the structure, with thin monolith reinforced concrete shear walls (having a thickness of 6 cm). There must be pointed out the necessity of the continuity of the vertical reinforcements from the concrete shear walls on both sides of the masonry wall (by piercing the floors), and the linking of the steel reinforcements on both sides of the masonry wall, with reinforcement nets traversing the wall (see Figure 3).

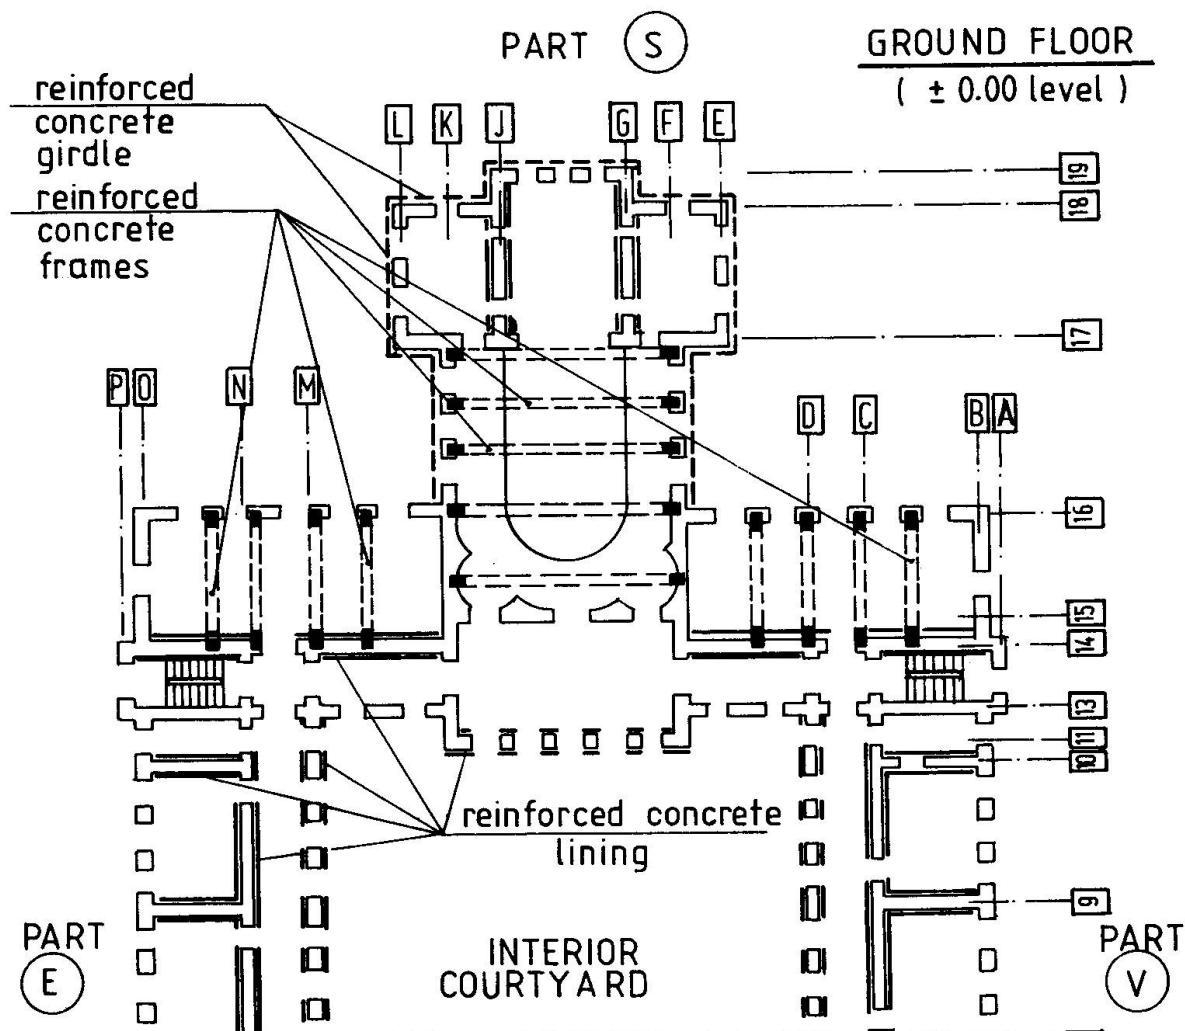
Fig. 4 The consolidation of the South wing of the building

- the making of eight reinforced concrete transversal frames in the South wing linked to the masonry walls and the existing floors (see Figure 4). The beams of these frames can be made including the existing monolith reinforced concrete beams of the floor, in the new beams of the frames and the monolith reinforced concrete columns can be made inside the two large rooms having their own foundations linked to the existing foundations of the walls.

- the consolidation of the amphitheatre by introducing the reinforced concrete transversal frames on the height of the basement, ground floor and first storey (see Figure 4). These frames will be linked with the exterior walls and with the existing transversal beams of the reinforced concrete floor above the amphitheatre;
