Repair and Consolidation of the Masonry Structure of a Building

Sevastean Ioan IANCA

The paper presents a study of a case about the damages caused by the 1977 earthquake to the structure of a building in Craiova, Romania, as well as repairing and consolidation solutions for this structure. The proposed solutions intend to restore the initial bearing capacity of the structure and its safety.

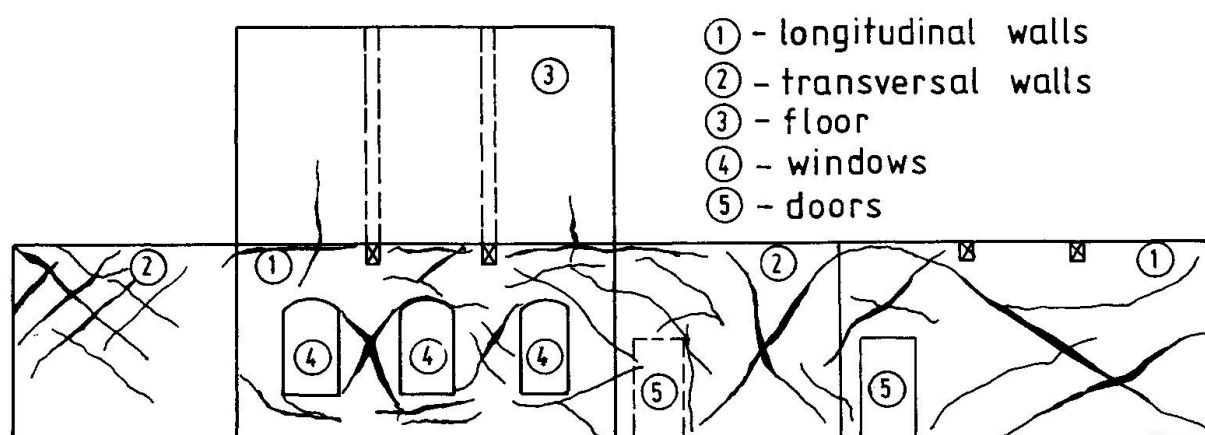
- the cracking of the majority of the resistance walls (longitudinal and transversal walls), with the following characteristics: horizontal cracks under the floor girdles, vertical cracks at the appearance of the floor joints, crossed cracks from the shearing loads and cracks in the lintels of doors and windows (see Figure 2);
- the appearance of a number of joints in the floors, caused by the cracking of the floors in the connection area between the transversal and longitudinal wings of the building;
- the settlement of the South wing walls foundation and the cracking of these walls;
- the cracking of the walls and stair elements of the staircases "B", "C" and "A" (see Figure 1), with partial wresting of the stair landings from the exterior walls of the staircases "B" and "C";
- the fall of the chimneys, causing damages of the roof and of the attic floors;

Fig. 2 An example of walls cracking
