Case Study of a Damaged Reinforced Concrete Bridge

Arlindo GONÇALVES

Lab. Nac. de Engenharia Civil
Lisbon, Portugal

This paper presents the results of an inspection carried out in one bridge built 50 years ago, aiming at identifying the origins of general concrete cracking. The results of the observations and tests made it possible to conclude that the cracking was due to alkali-silica reactions. Subsequently, the corrosion of the reinforcing steel caused larger cracks and concrete spalling.

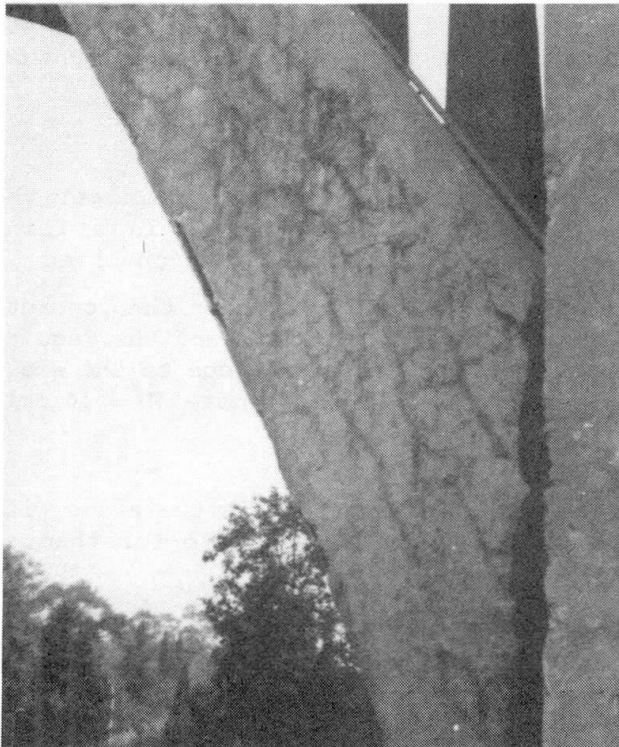
The areas of greater deterioration were located in the central arch, below which the road traffic is more intense, in places more exposed to rain and sunshine. Figs. 2 and 3 show typical examples of cracking observed in concrete.

Fig. 2 Central Arch, southern view. Map cracking

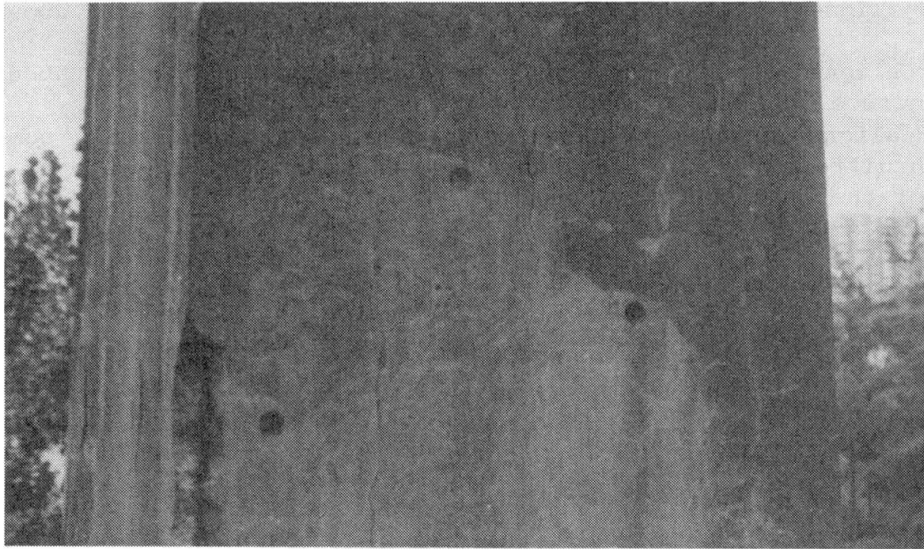
Fig. 3 Column of the Central Arch, facing the south. Cracking aligned with the main reinforcing bars

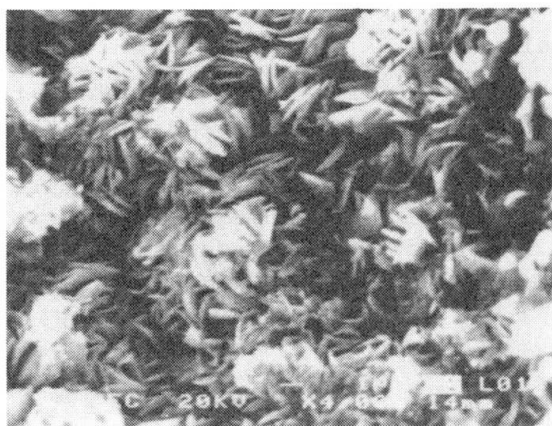
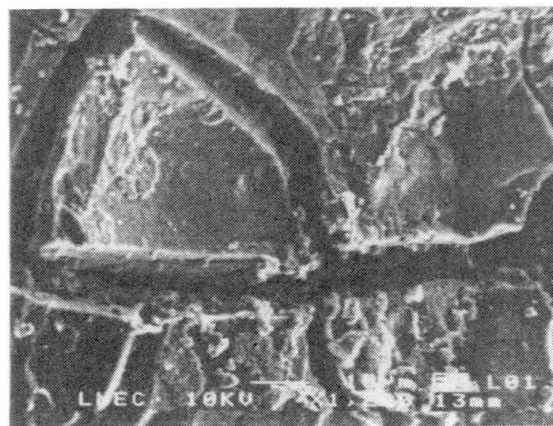
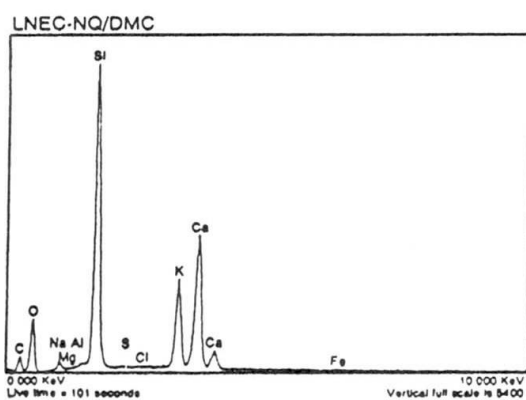
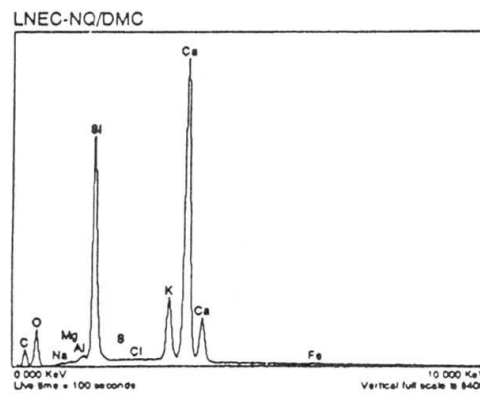
Observations were also carried out on other samples taken from more cracked areas of the Central Arch. These observations showed in limestone/paste interfaces the presence of typical compounds of alkali-silica reaction (Fig. 4), such as hydrated calcium and potassium silicates (crystalline and amorphous), as well as ettringite, either in the characteristic form of acicular crystals, or in a massive form. Other authors [6] have observed similar morphologies in the presence of alkali-silica reactions.

Fig. 4 Products of alkali-silica reaction (calcium and potassium silicates) in a limestone/paste interface.

- a) Crystalline products and corresponding X-ray spectrum;
b) Cracked gel and corresponding X-ray spectrum.

The visual observation of cores, the results of the SEM/EDX tests, and the X-ray diffraction analysis, suggest that the concrete cracking results from the alkali-silica reactions between the alkalis of cement and reactive silica inclusions of limestone aggregate. A slight attack by sulphates of external origin, resulting from the atmospheric pollution (SO_2) may also be present. Subsequently concrete cracking, may have provided, in some places, the conditions for depassivation of the reinforcing steel and the consequent emergence of corrosion, causing thus the increase of cracks width and concrete spalling.
