Zeitschrift: IABSE reports = Rapports AIPC = IVBH Berichte

Artikel: Case study of a damaged reinforced concrete bridge

Autor: Gonçalves, Arlindo

Case Study of a Damaged Reinforced Concrete Bridge

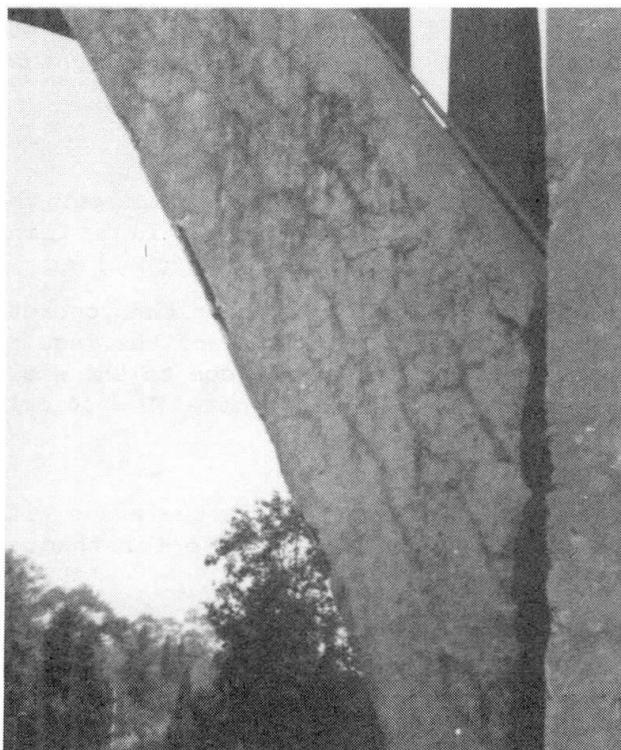
The areas of greater deterioration were located in the central arch, below which the road traffic is more intense, in places more exposed to rain and sunshine. Figs. 2 and 3 show typical examples of cracking observed in concrete.

Fig. 2 Central Arch, southern view. Map cracking

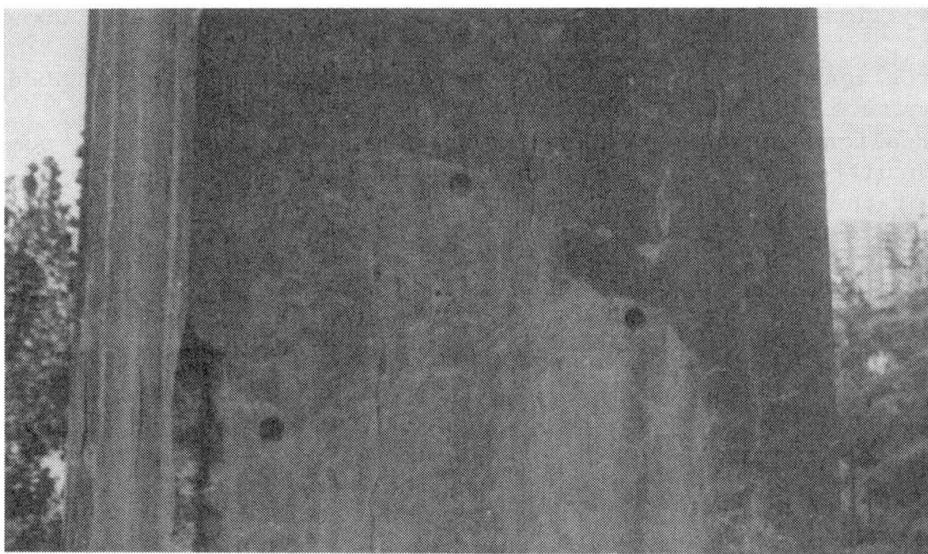
Fig. 3 Column of the Central Arch, facing the south. Cracking aligned with the main reinforcing bars

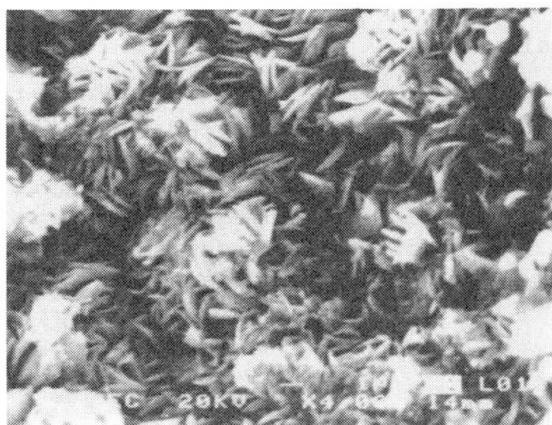
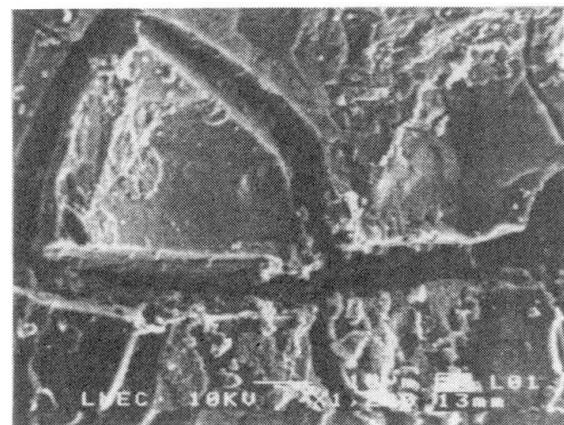
Observations were also carried out on other samples taken from more cracked areas of the Central Arch. These observations showed in limestone/paste interfaces the presence of typical compounds of alkali-silica reaction (Fig. 4), such as hydrated calcium and potassium silicates (crystalline and amorphous), as well as ettringite, either in the characteristic form of acicular crystals, or in a massive form. Other authors [6] have observed similar morphologies in the presence of alkali-silica reactions.

Fig. 4 Products of alkali-silica reaction (calcium and potassium silicates) in a limestone/paste interface.

- a) Crystalline products and corresponding X-ray spectrum;
- b) Cracked gel and corresponding X-ray spectrum.
