Zeitschrift: IABSE reports = Rapports AIPC = IVBH Berichte
Band: 73/1/73/2 (1995)

Artikel: Deck cracking of Shelby Creek Bridge
Autor: Kuzmanovic, Bogdan O. / Sanchez, Manuel R.
DOI: <https://doi.org/10.5169/seals-55240>

Deck Cracking of Shelby Creek Bridge

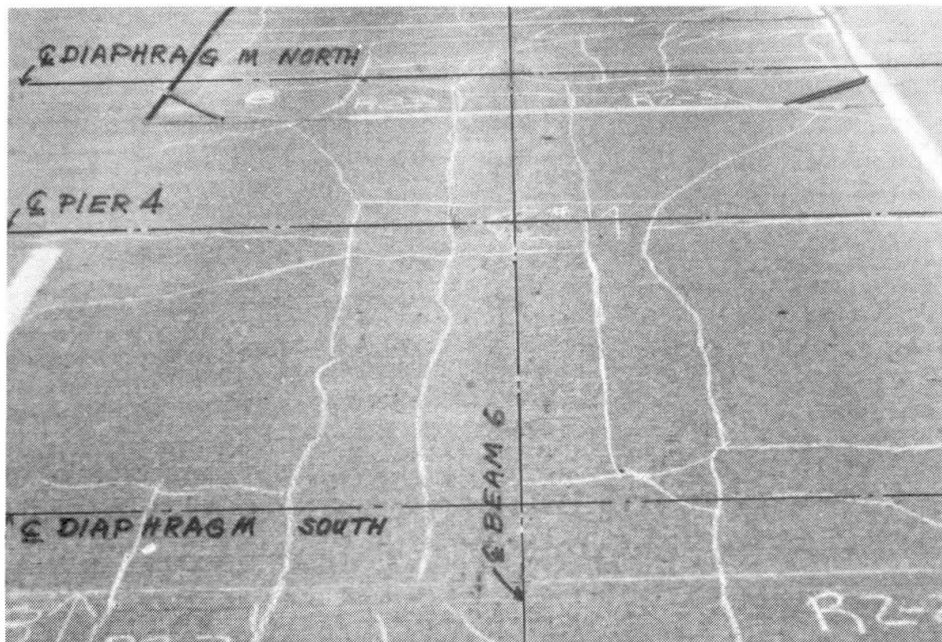
Fig. 2 Cracks at Pier 4

Cracks at Piers. In Fig. 2, the typical pattern of enhanced cracks at pier 4 are shown. Both external lanes are almost centered on the first interior beams, and the longitudinal cracks are developed on both sides of beam's top flange. Transverse cracks crisscross them in the deck within the two pier curtain walls (diaphragms) in a way almost symmetrical to the pier centerline. Longitudinal beams and transverse diaphragms (curtain walls) produce deck panels 3.82 by 4.57m exposed to two dimensional restraints for any overlay displacement, including one due to the shrinkage. Due to this two-dimensional restraining effect, the corresponding stresses, developed in deck, produce tensile principle stresses at variable angles with bridge axis, i.e. the corresponding cracks in the overlay are semicircular.

- **Two diaphragms at curtain walls of piers.** These massive diaphragms, 0.91cm thick and 4.57m apart, Fig. 4, with main beams produce rigid two dimensional restraints in addition to the previous rectangular pattern. Therefore, cracking above piers is more intense than in the spans.

As the cracks proved to be stabilized after three months of observation and measurement (March 1993-May 1993) and the concrete was already 1.5 years old, the only repair required was sealing the cracks.
