**Zeitschrift:** IABSE reports = Rapports AIPC = IVBH Berichte  
**Band:** 73/1/73/2 (1995)

**Artikel:** Deck cracking of Shelby Creek Bridge  
**Autor:** Kuzmanovic, Bogdan O. / Sanchez, Manuel R.  
**DOI:** <https://doi.org/10.5169/seals-55240>

## Deck Cracking of Shelby Creek Bridge

### **SUMMARY**

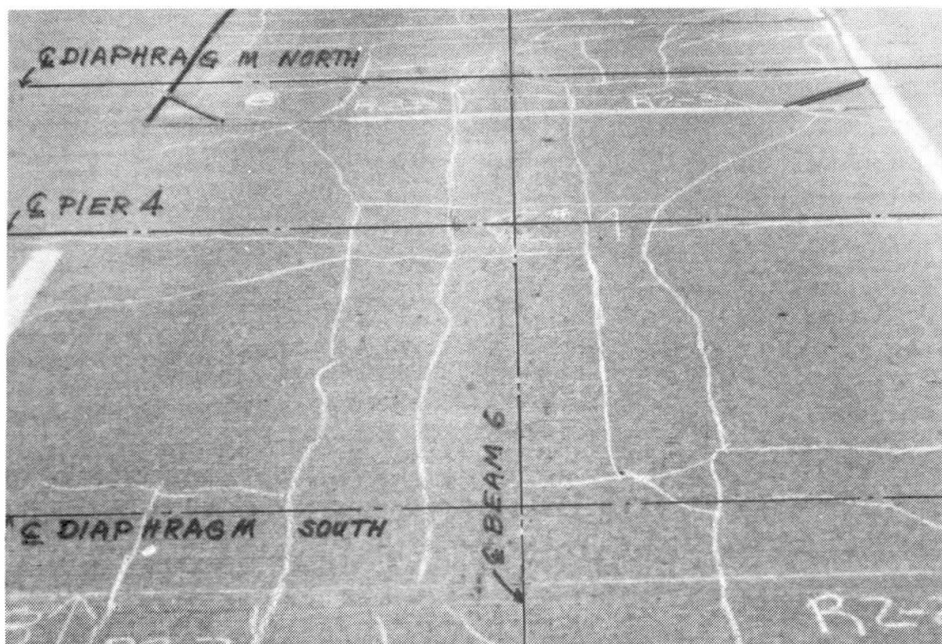
Fig. 2 Cracks at Pier 4

**Cracks at Piers.** In Fig. 2, the typical pattern of enhanced cracks at pier 4 are shown. Both external lanes are almost centered on the first interior beams, and the longitudinal cracks are developed on both sides of beam's top flange. Transverse cracks crisscross them in the deck within the two pier curtain walls (diaphragms) in a way almost symmetrical to the pier centerline. Longitudinal beams and transverse diaphragms (curtain walls) produce deck panels 3.82 by 4.57m exposed to two dimensional restraints for any overlay displacement, including one due to the shrinkage. Due to this two-dimensional restraining effect, the corresponding stresses, developed in deck, produce tensile principle stresses at variable angles with bridge axis, i.e. the corresponding cracks in the overlay are semicircular.

- **Two diaphragms at curtain walls of piers.** These massive diaphragms, 0.91cm thick and 4.57m apart, Fig. 4, with main beams produce rigid two dimensional restraints in addition to the previous rectangular pattern. Therefore, cracking above piers is more intense than in the spans.

As the cracks proved to be stabilized after three months of observation and measurement (March 1993-May 1993) and the concrete was already 1.5 years old, the only repair required was sealing the cracks.

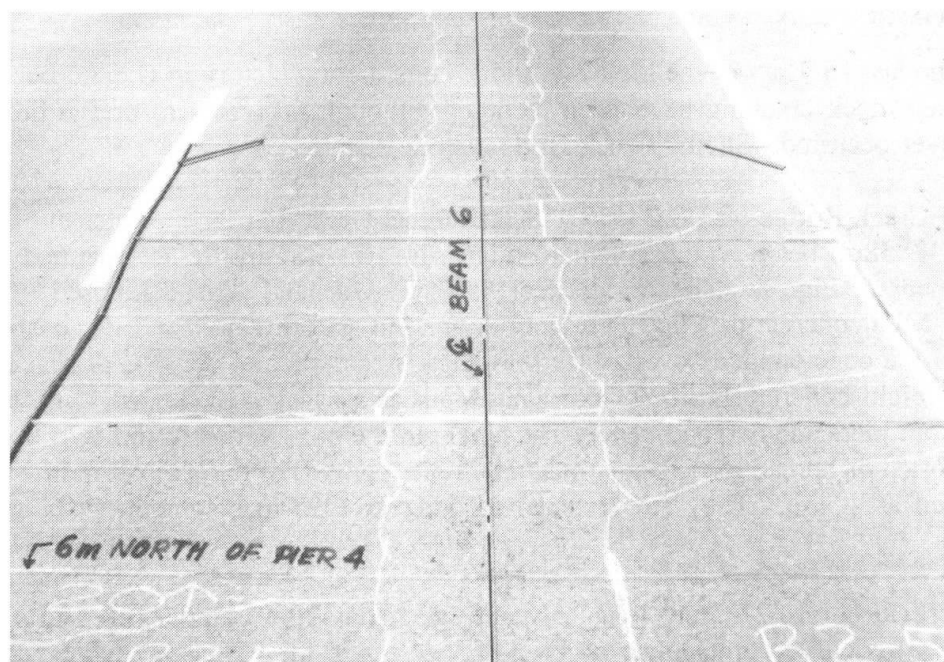
Fig. 3 Cracks Away of Piers

**Cracks in Spans.** In Fig. 3, enhanced longitudinal cracks in the last span from 6 to 11m north of pier 4 are shown. Cracks are almost parallel, and they are centered above the first interior beams, i.e. beams 2 and 6. They are spaced about 0.65 to 0.85m apart. This distance is approximately equal to the space (0.75m) between ends of precast prestressed concrete panels (P.P.C.) above the beam flanges. Later on in the span, the interior crack eventually stops and only the exterior one runs further and then stops.

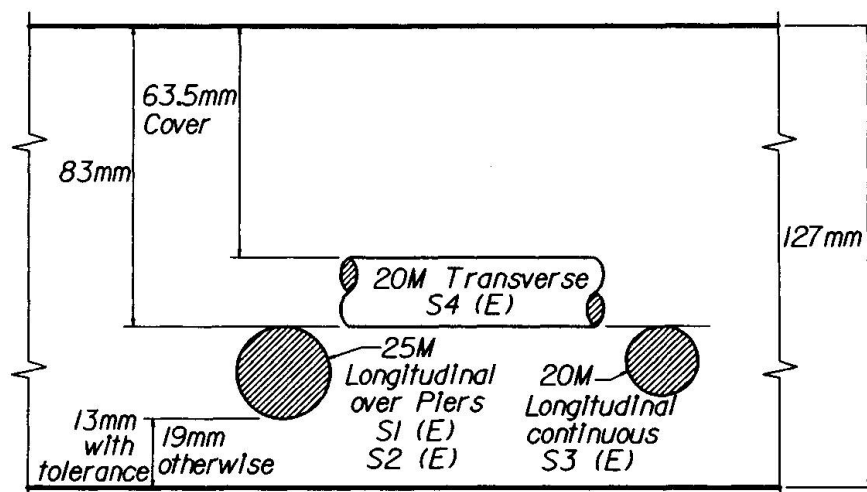
Fig. 5 Detail of topping overlay

Unwanted cracks caused by inadequate design or construction were not present. The cracks are "restraining cracks" caused by the restrained volume changes due to shrinkage, creep, elastic shortening and temperature gradient. It is known that about two thirds of any slab shortening is due to shrinkage. Many of the restrainers previously discussed, as well as sudden volume changes, produce differential shrinkage and hydration temperature gradient, which consequently can cause the cracking. Large clear cover of epoxy-coated bars also contributed to the cracking, Fig. 5.
