**Artikel:** Deck cracking of Shelby Creek Bridge

**Autor:** Kuzmanovic, Bogdan O. / Sanchez, Manuel R.

## Deck Cracking of Shelby Creek Bridge

Early cracking of a cast-in-place reinforced concrete overlay of a sandwich concrete deck of Shelby Creek Bridge is investigated. Independent numerical checking proved that the bridge design was correct. Shrinkage cracking was enhanced by several factors. This enhancement was due to the special features of the bridge.

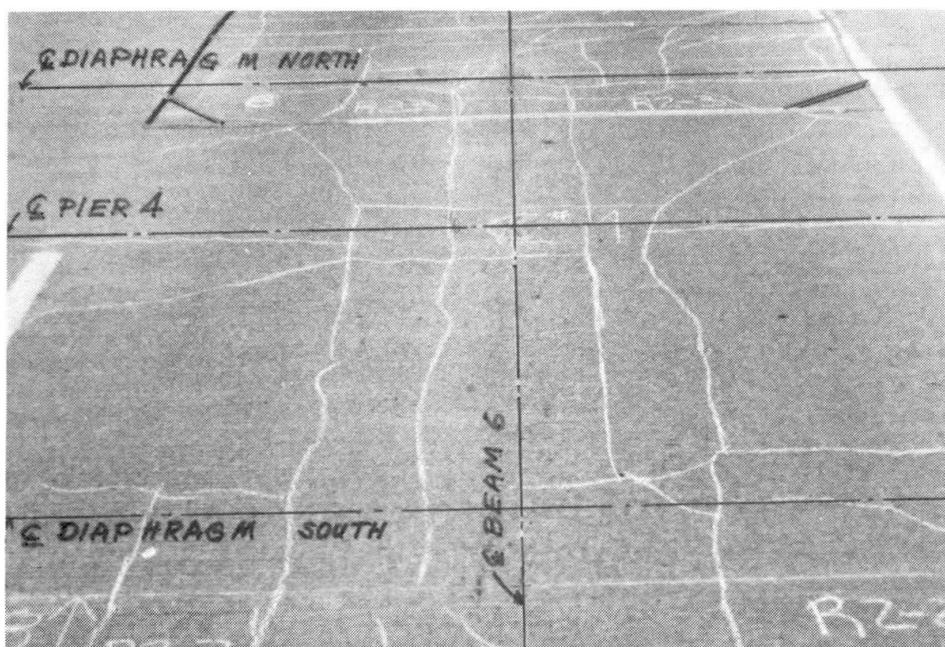
Fig. 2 Cracks at Pier 4

(curtain walls) Fig. 2 and 2) in the spans, away from piers, Fig. 3. Common to all cracks is more intense cracking in the exterior lanes of both traffic directions, than in the other two interior lanes, i.e., between the second and third beam of both bridge side faces. Next, cracks are more pronounced at piers 3 and 4 than piers 1 and 2, and the longitudinal cracks in spans are mainly developed along one or both sides of top flanges of both first interior beams.

**Cracks at Piers.** In Fig. 2, the typical pattern of enhanced cracks at pier 4 are shown. Both external lanes are almost centered on the first interior beams, and the longitudinal cracks are developed on both sides of beam's top flange. Transverse cracks crisscross them in the deck within the two pier curtain walls (diaphragms) in a way almost symmetrical to the pier centerline. Longitudinal beams and transverse diaphragms (curtain walls) produce deck panels 3.82 by 4.57m exposed to two dimensional restraints for any overlay displacement, including one due to the shrinkage. Due to this two-dimensional restraining effect, the corresponding stresses, developed in deck, produce tensile principle stresses at variable angles with bridge axis, i.e. the corresponding cracks in the overlay are semicircular.

As the cracks proved to be stabilized after three months of observation and measurement (March 1993-May 1993) and the concrete was already 1.5 years old, the only repair required was sealing the cracks.

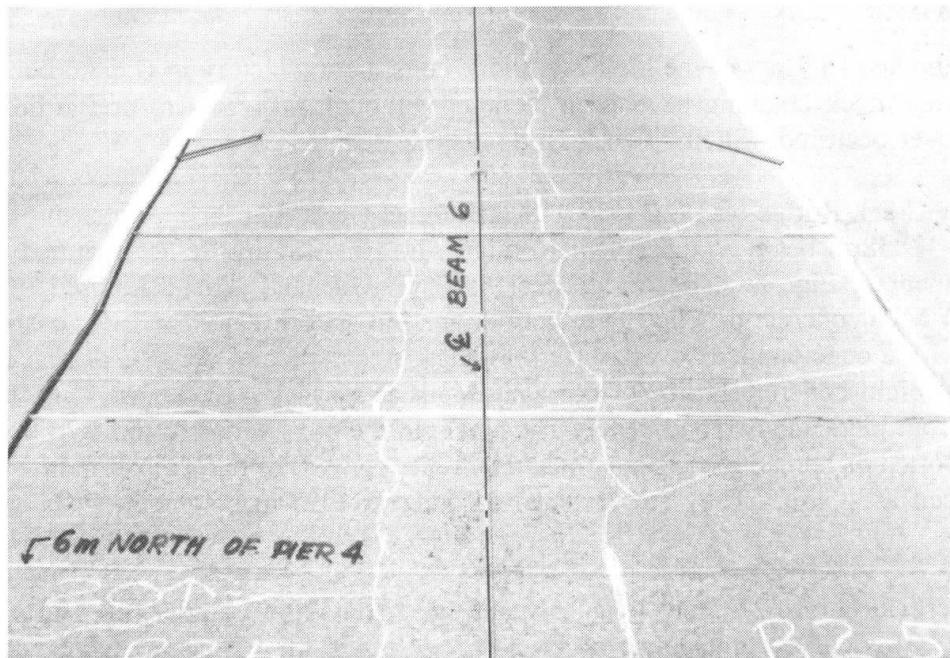
Fig. 3 Cracks Away of Piers

**Cracks in Spans.** In Fig. 3, enhanced longitudinal cracks in the last span from 6 to 11m north of pier 4 are shown. Cracks are almost parallel, and they are centered above the first interior beams, i.e. beams 2 and 6. They are spaced about 0.65 to 0.85m apart. This distance is approximately equal to the space (0.75m) between ends of precast prestressed concrete panels (P.P.C.) above the beam flanges. Later on in the span, the interior crack eventually stops and only the exterior one runs further and then stops.

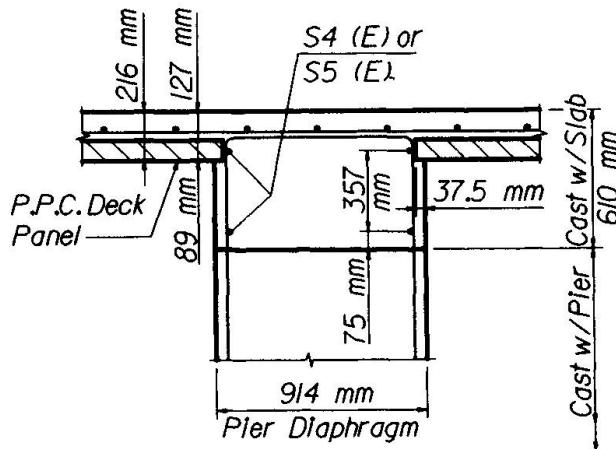
*Fig. 4 Section at pier diaphragm*

- **Two diaphragms at curtain walls of piers.** These massive diaphragms, 0.91cm thick and 4.57m apart, Fig. 4, with main beams produce rigid two dimensional restraints in addition to the previous rectangular pattern. Therefore, cracking above piers is more intense than in the spans.

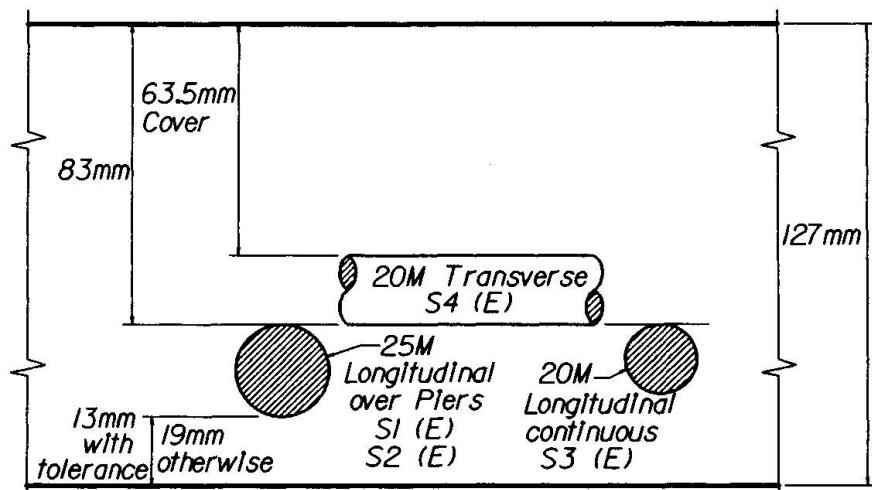
Fig. 5 Detail of topping overlay

Unwanted cracks caused by inadequate design or construction were not present. The cracks are "restraining cracks" caused by the restrained volume changes due to shrinkage, creep, elastic shortening and temperature gradient. It is known that about two thirds of any slab shortening is due to shrinkage. Many of the restrainers previously discussed, as well as sudden volume changes, produce differential shrinkage and hydration temperature gradient, which consequently can cause the cracking. Large clear cover of epoxy-coated bars also contributed to the cracking, Fig. 5.
